# Detected DIF output bugs

Kostiantyn Shpak (LLR), 7.04.2016

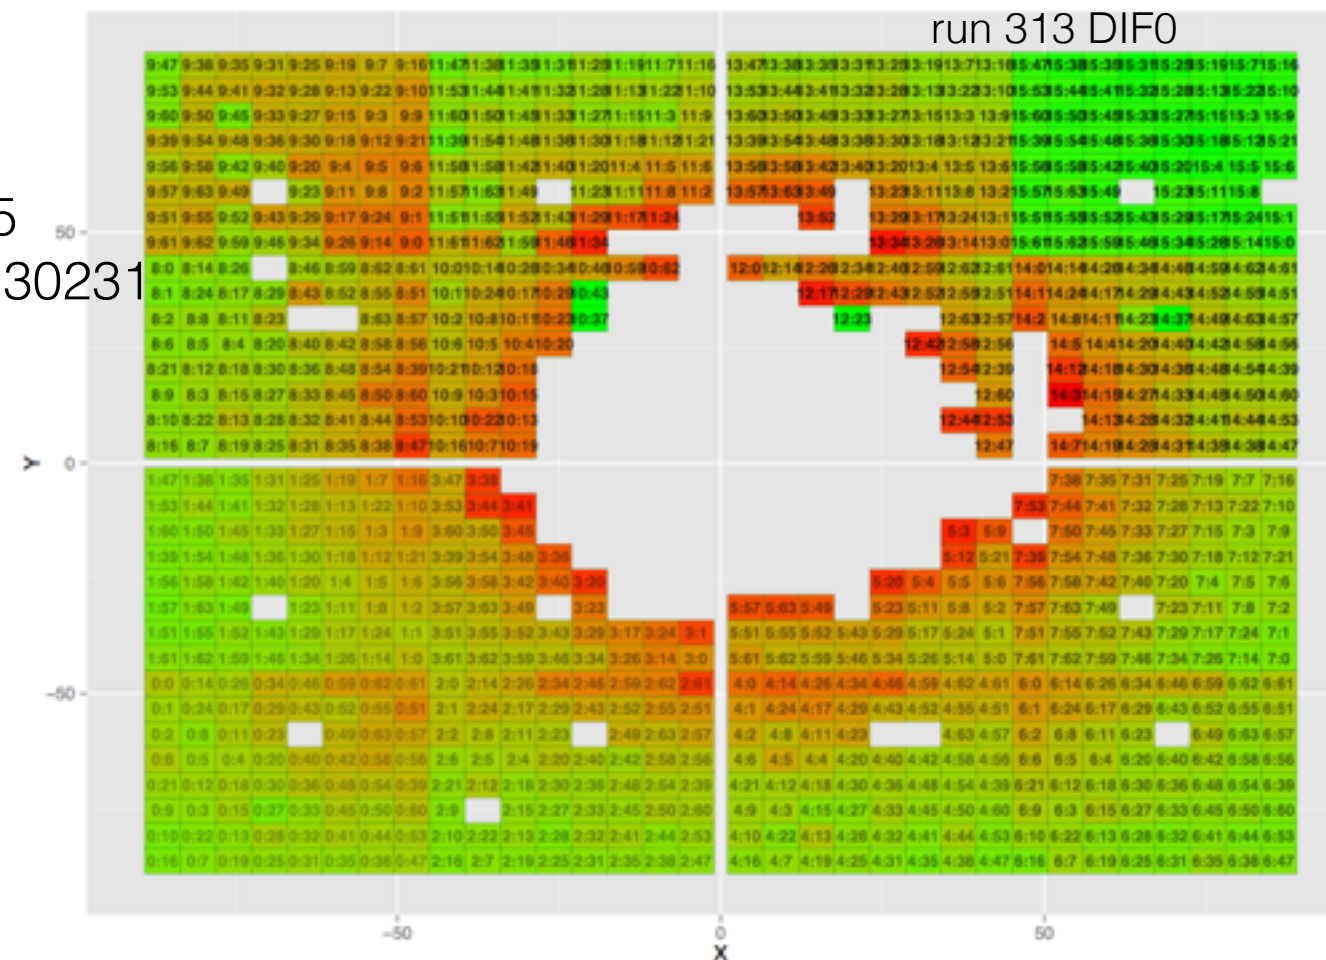
TB elog entry 618

With  $t=50\text{msec}$  and  $f=5\text{ Hz}$ , chip 15 is missing because next spill header is written inside chip 15 data block.  
Could also be inside chip 14.

(strange increasing of effect)

run312 #problemsDIF0,1,2=(32, 16, 52) #ACQ=13115

run313 #problemsDIF0,1,2=(3275, 3274, 3274) #ACQ=30231

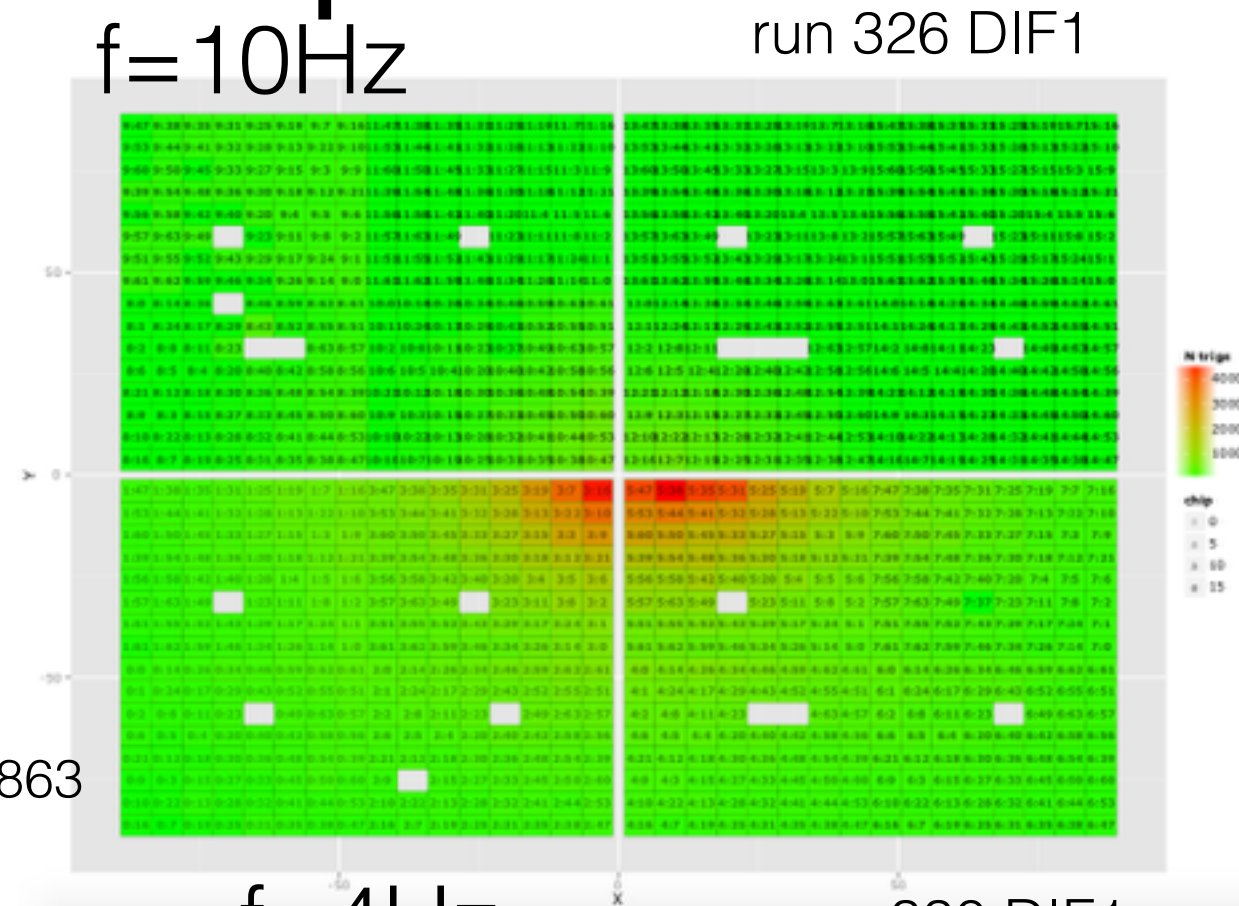
TB elog entry 650

With  $t=97.5\text{msec}$  and  $f=10\text{ Hz}$ , more chips are missing because next spill header is written inside some chip data block (earlier than 15).

run326 #problemsDIF0,1,2=(1528, 1494, 1580) #ACQ=13863

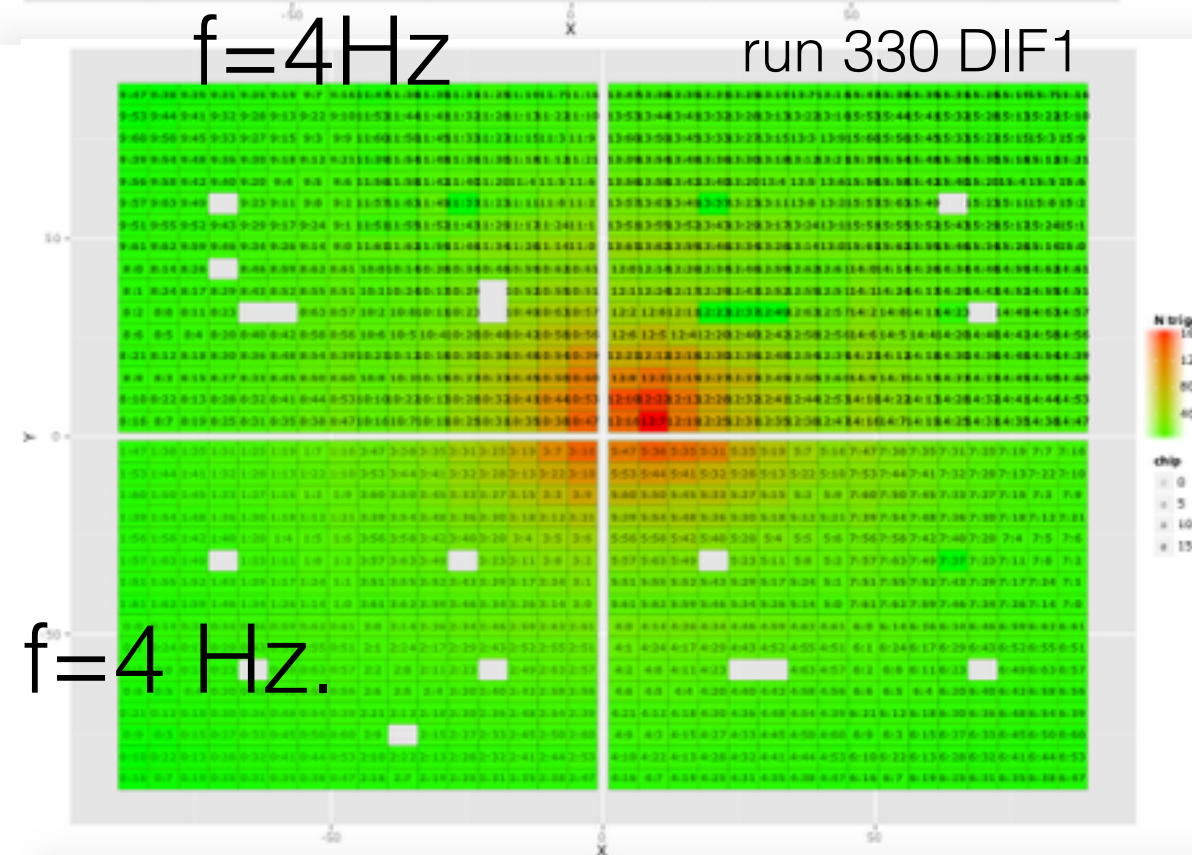
TB elog entry 658

With  $t=274.5\text{msec}$  and  $f=4\text{ Hz}$ , effect disappears.

run326 #problemsDIF0,1,2=(0, 0, 0) #ACQ=21003

Dependent on  $f$ , disappeared with  $f=4\text{ Hz}$ .
