SDE Upgrade

WP5 ECRs

ECRs (Dec 2018) for the next UUB version 3

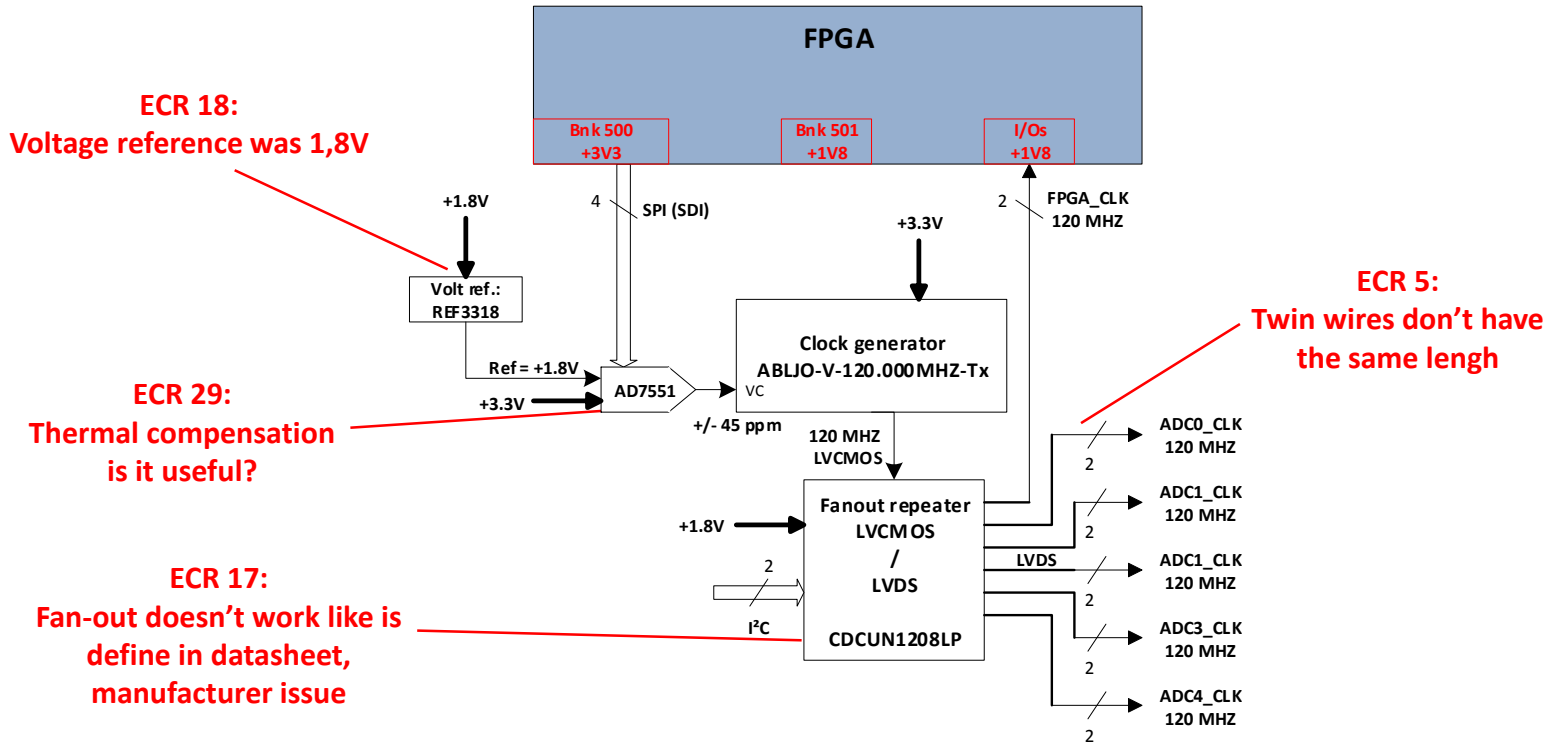
ECR 5, 17, 19 & 29: 120 MHz clock 1/2

The Fan-out component must be changed. It is not conform to the manufacturer specification

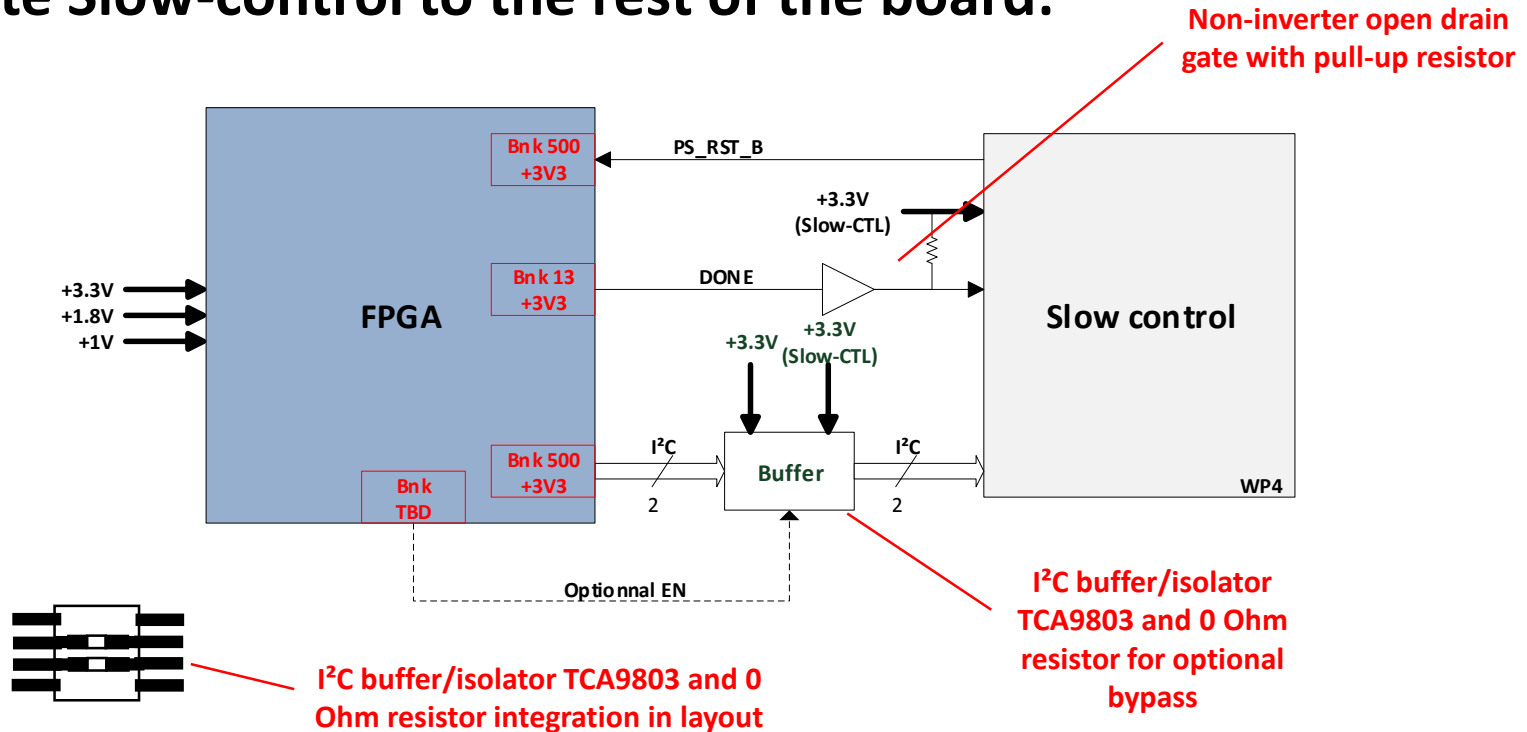
ECR 4, 38 & 46 : FPGA protection

The slow-control starts the first and send voltage to FPGA when it isn't powered:

Dangerous for FPGA

Isolate Slow-control to the rest of the board:

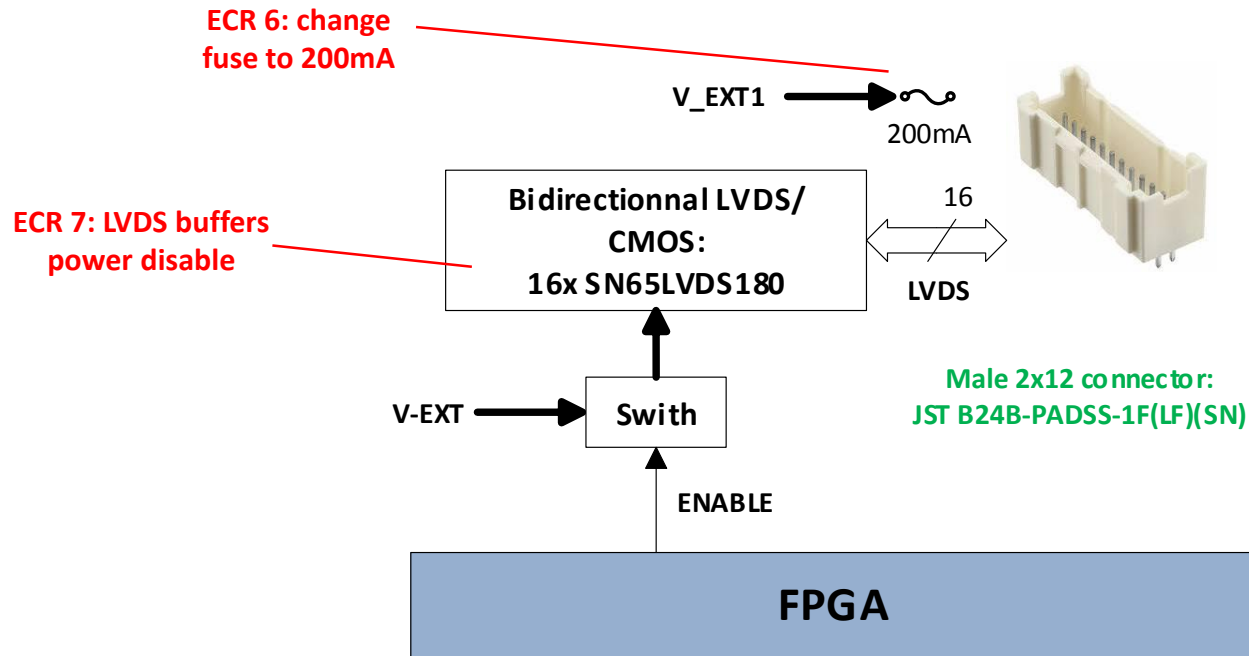
ECR 6 & 7 : Digital connectors

less power consumption

When Digital connectors are unused, the buffer power could be disable:

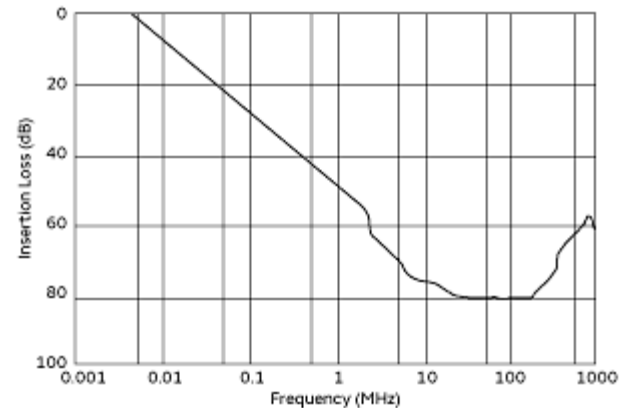
ECR 11, 47 & 48: UUB EMC noise

Noise is generated by UUB and transmitted by the cable

A EMI filter will be added after the main UUB power connector:

- The 24 Volts provided by UUB on digital connectors should also be filtered. These connectors will power external devices
- External cables should be shielded. They transmit the noise everywhere

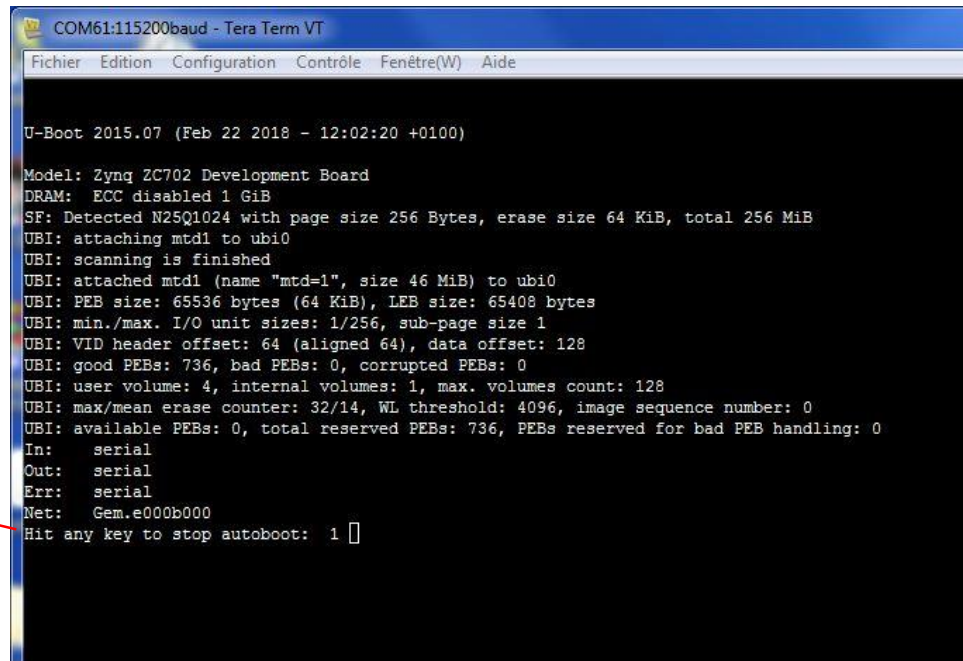
ECR 20 : FPGA frozen when no USB PC connected 1/2

- Several hardware solutions (v1 & v2 schematic, added buffer, ...) was tested, but no one solve this issue for all boards.

Tested with V2 hardware schematic and a specific software where the U-BOOT can't be interrupted: the issue is solved

Software update and MAC address could be made with Peta-Linux

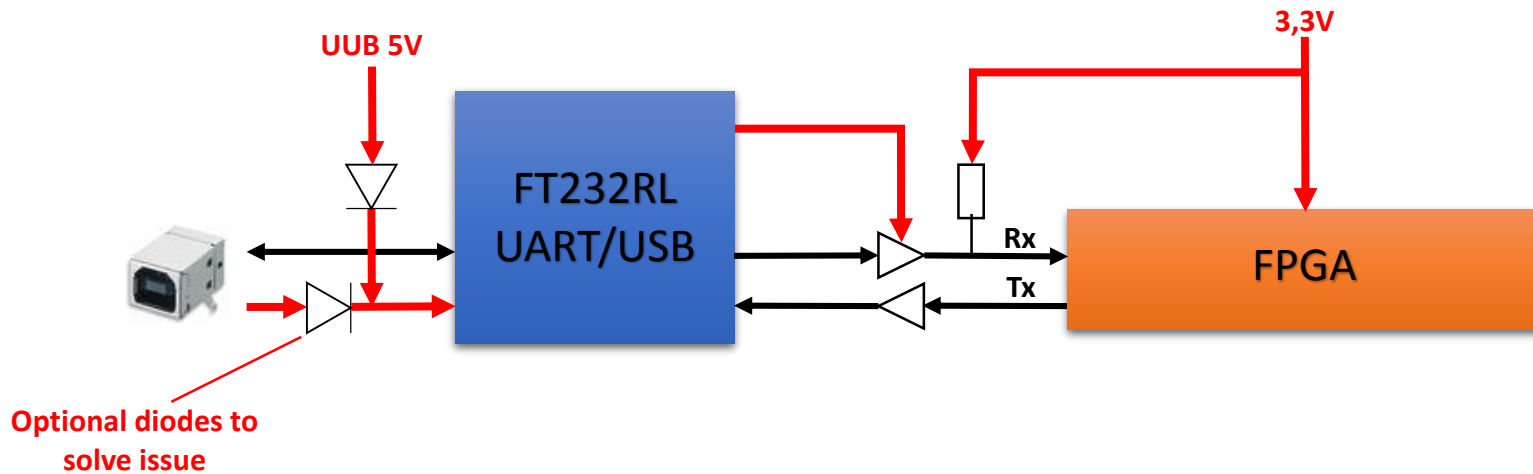
ECR 20 : FPGA frozen when no USB PC connected 2/2

- The FPGA must have protection against external voltage from USB interface

Buffer open-drain must be added for FPGA protection. VCCIO pin powered by UUB 3,3V, it's not enough.

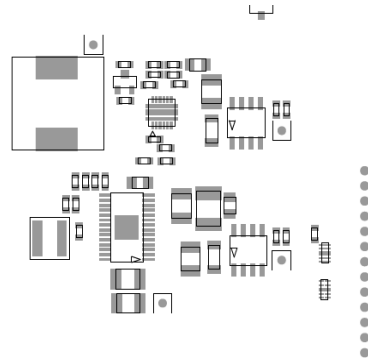
ECR 26: TRACO DC/DC modification

They are too noisy. But the Enable function works.

Less noisy but up to now a relay is used for Enable/Disable function. It could generate problem, like spike in channel 9.

If it is possible, the Relay should be changed by a new electronic: **In work**

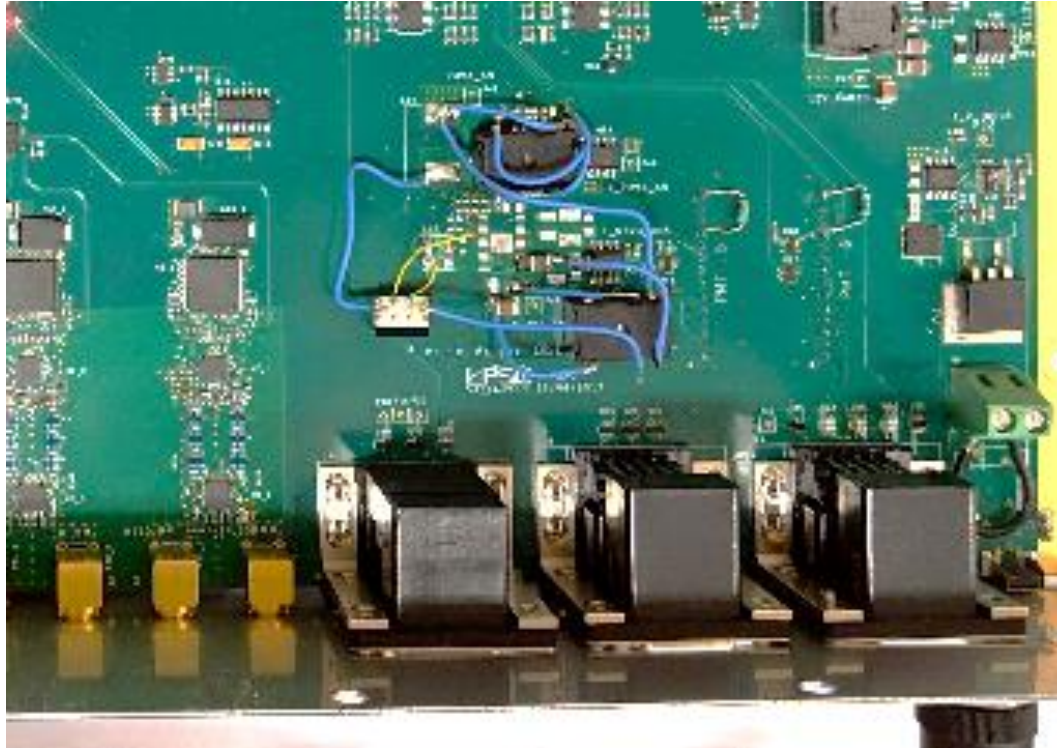
ECR 40: Spikes on channel 9

Spikes come from DC/DC Position. They are on the back, with their internal coil close UUB PCB.

Relay doesn't generate spikes

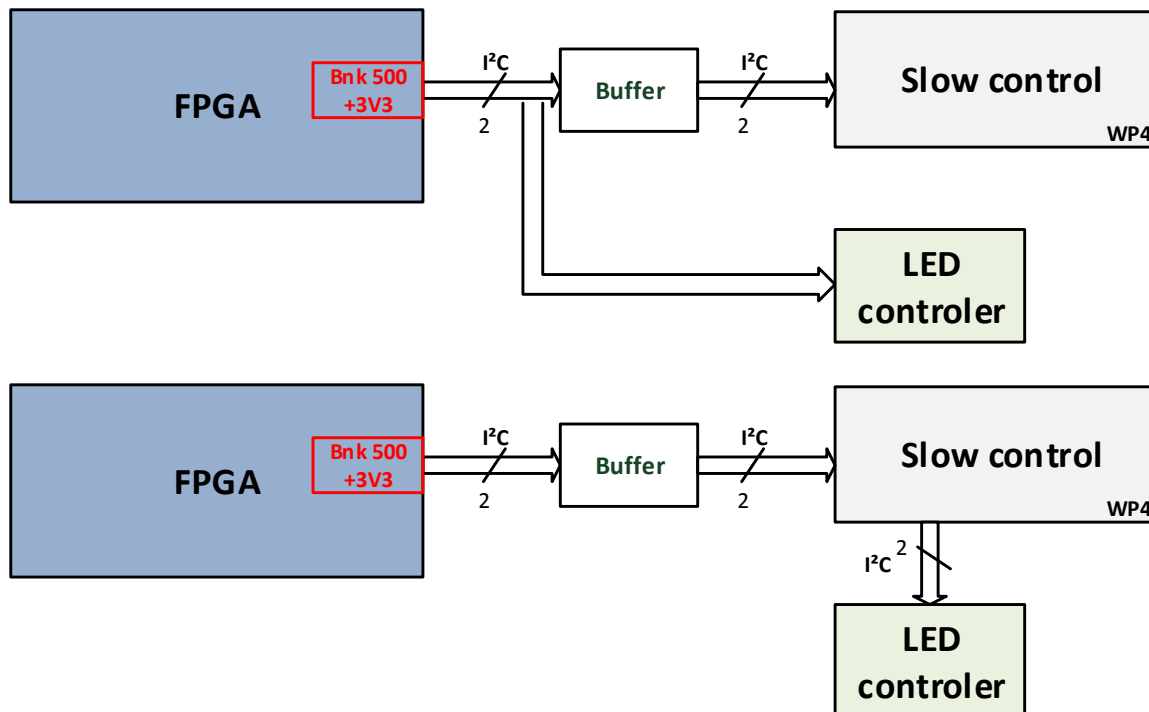
ECR 44, 45 & 49: UUB restarts & I²C

Sometime the UUB restarts in DAQ mode:

I²C communication with LED DAC problem generates Watchdog restarts the UUB

2 available channel in Slow-control could be used for LED-controller
