Pierre Auger Observatory

**Surface Detector Electronics Upgrade
List of ECR
for UUB Version 3**

Abstract:
This document is the reference list of the ECR for the UUB Version 3

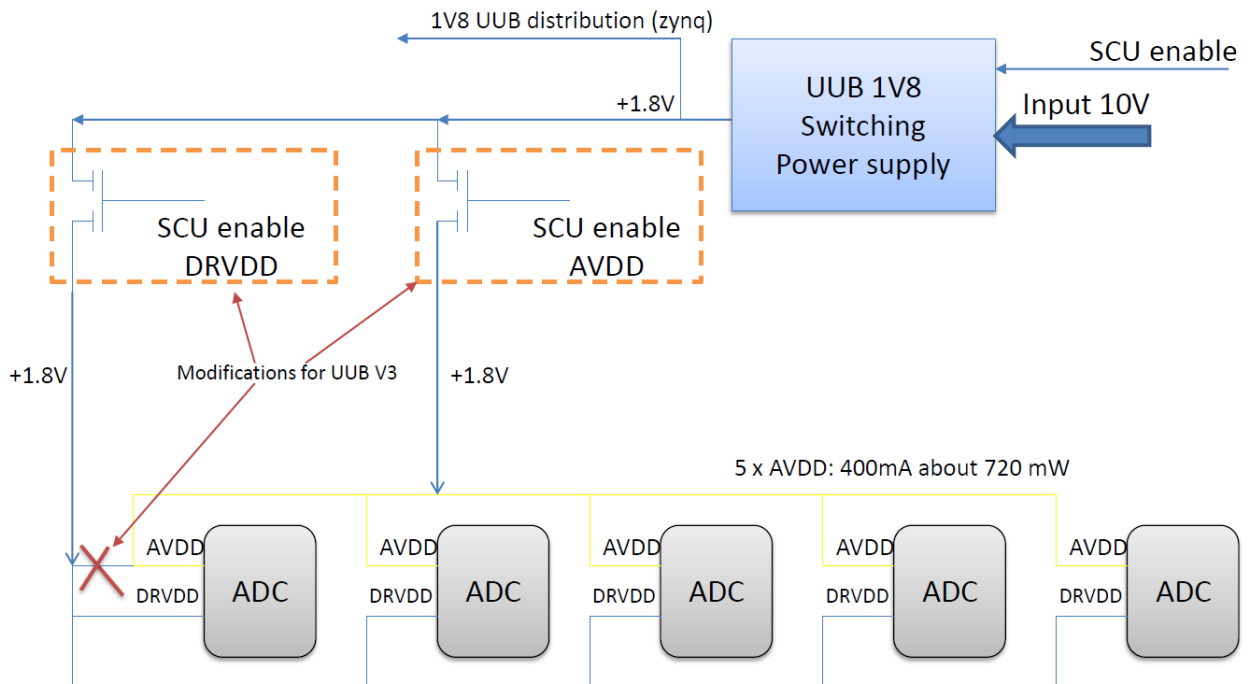
ECR 3:

AD9628 power supply

Switch on/off by mosfet

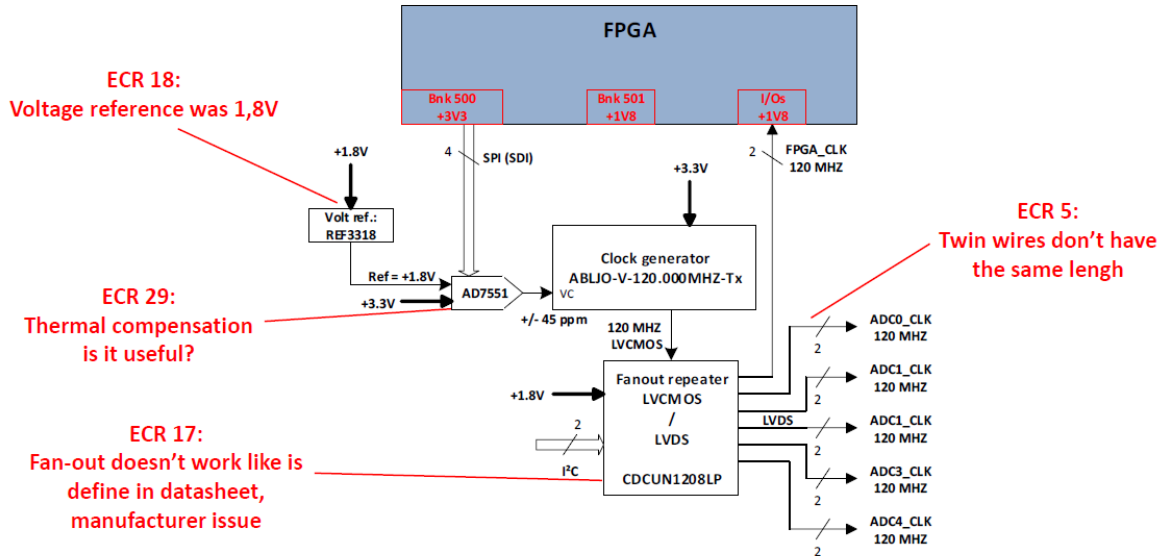
Present V2.0 Schematic:

ECRs 17 & 29:

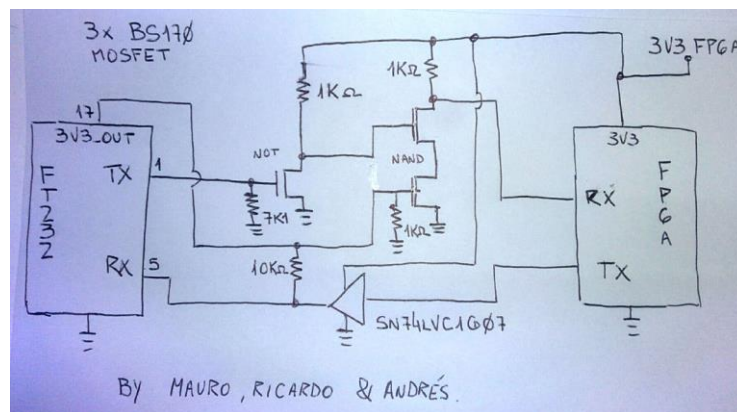
Buffer open-drain must be added for FPGA protection. VCCIO pin powered by UUB 3,3V, it's not enough.

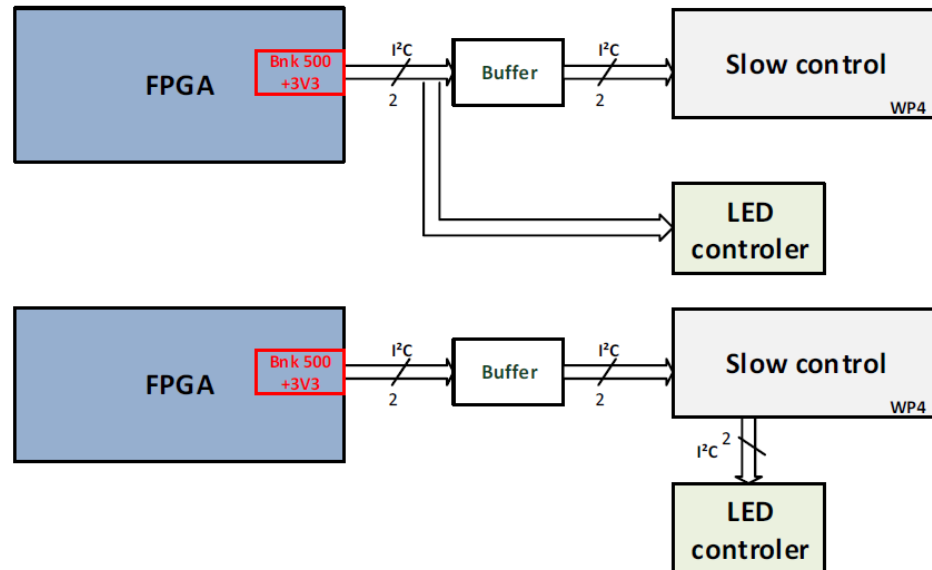
ECR 44:

I²C communication with LED DAC problem generates Watchdog restarts the UUB

2 available channel in Slow-control could be used for LED-controller
