ATS Instrument Update

N. Mondrik

DESC PCWG Meeting

Paris 07/09/2019

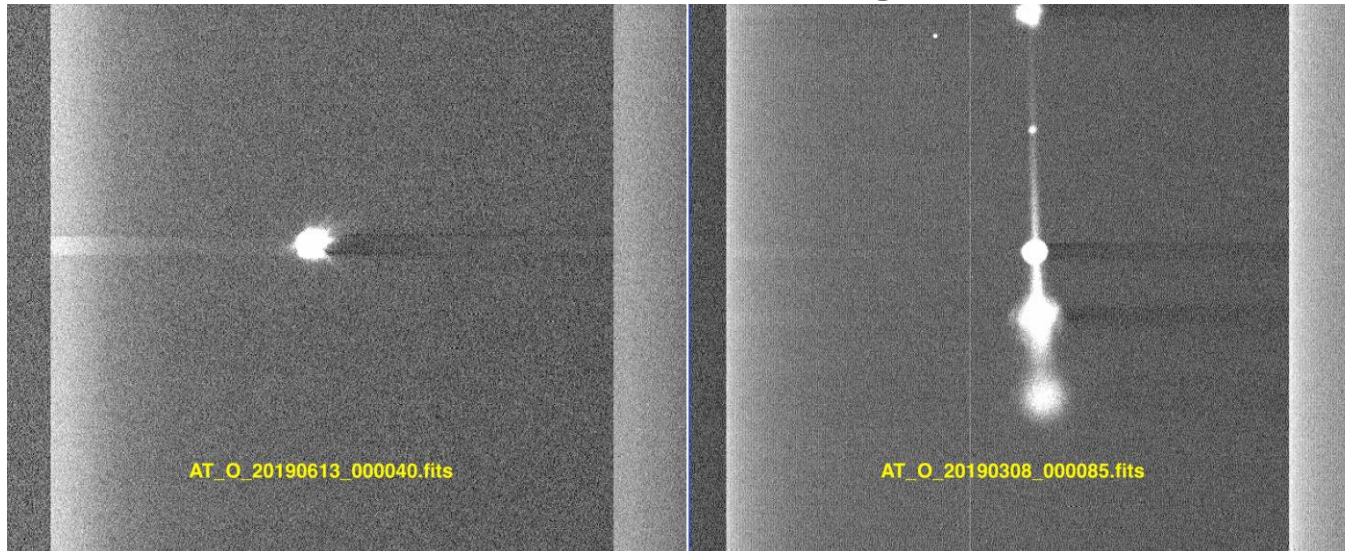
Deferred Charge (Image credit: C. Lage)

- Original CCD showed numerous issues:
 - Jumps in bias voltage (seemingly common to LSST sensors – see Claire, Pierre Astier et al. for more information on that. Can be solved by changing ASPIC gain → software fix)
 - Also an issue w/ deferred charge:

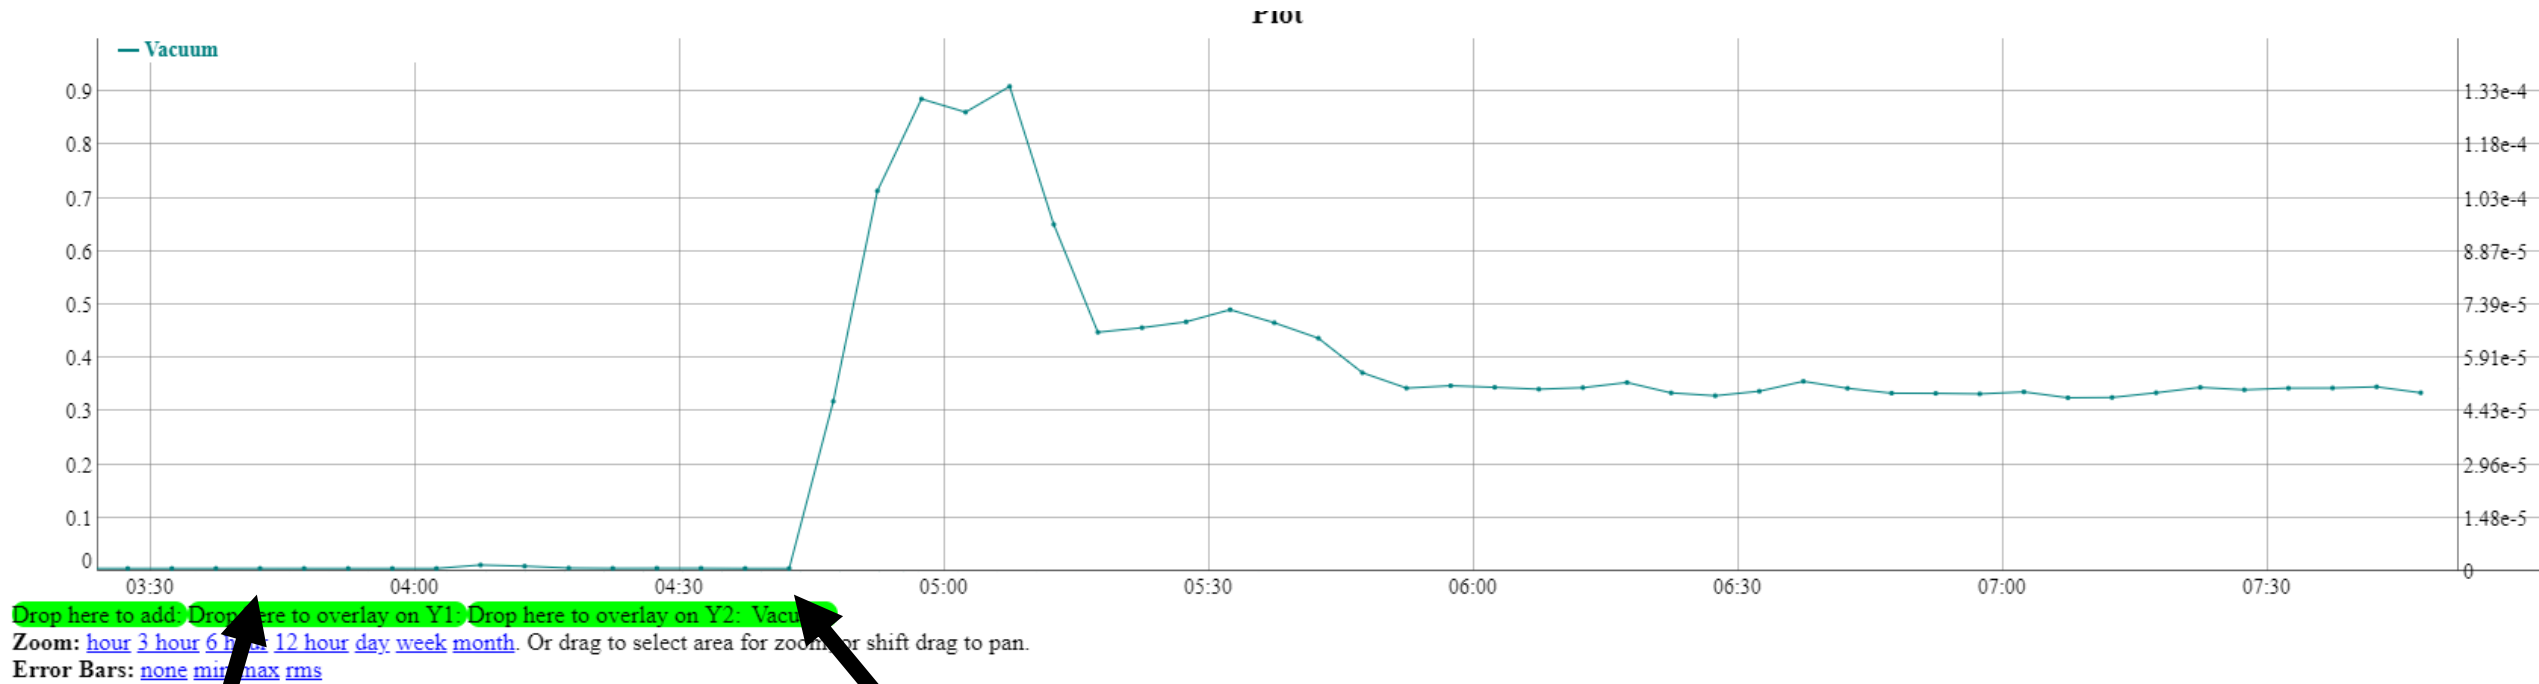
Dewar behaving well,
running on ion pump w/
cooler active

???? Leak appears from nowhere. Seems to be an actual leak rather than a pocket, since it did not pump back down, even after putting the system back on the turbo pump.
