# DIRAC2 2009 Testbeam Preliminary Results

R. Gaglione

Laboratoire d'Annecy-le-Vieux de Physique des Particules,  
Université de Savoie, CNRS/IN2P3  
FRANCE

November 17<sup>th</sup>, 2009

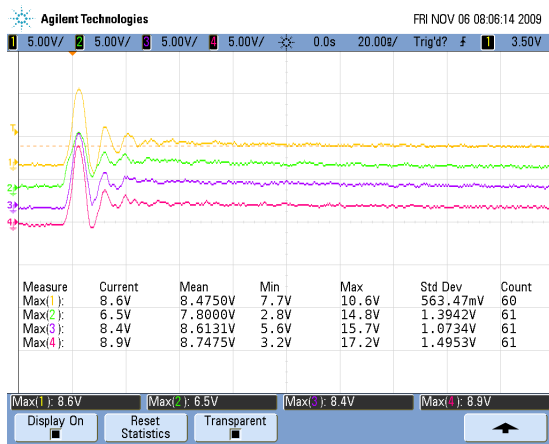
# Voltage monitoring

- 30 oct: first data to check beam and trigger quality with DIRAC stack “out of the box”;
- 31 oct: unable to see coincidence on the 4 chambers, very low efficiency;
- 1 nov: electronic check: wrong DC point at the input of the chamber 4 and 3... all chambers are damaged !
- 2 nov: one chip has been exchanged with the only one spare;
- 5 nov: beam profile versus time, input voltage measurements.

The maximum voltage for AMS C35B4 is 5.5 V and the gate oxide breakdown voltage is 8 V...

- Repair the stack for cosmics;
- Prepare new chambers with stronger protections;
- Protection testboard !
- Diodes engineering.

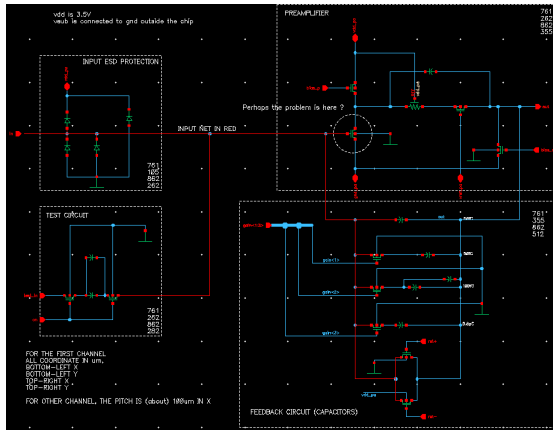
# ...to SEM inspection !

With a 800 $\times$  magnification: nothing to see...

SERMA technologies will inspect the input net of the chip to check for defects in polysilicon/metalizations.

The result is expected in about 2 weeks.
