The Infrastructure Team

AGATA Week, GSI - September 19, 2025

AGATA@LNL

DSS status

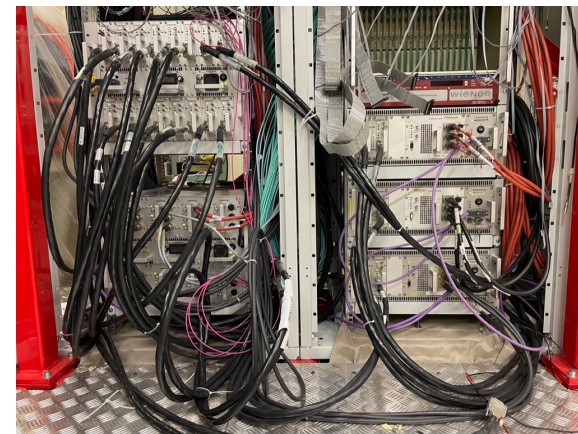
- 4 new systems available at LNL (32 LV channels) + 1 maintenance system at CEA Saclay
- New Test tooling for LVPS first-level maintenance (local Diagnostic)
- Authorisation to purchase obsolescent components to complete 4 π : amplifiers for micropower instrumentation INA126P and fans for additional 4 groups

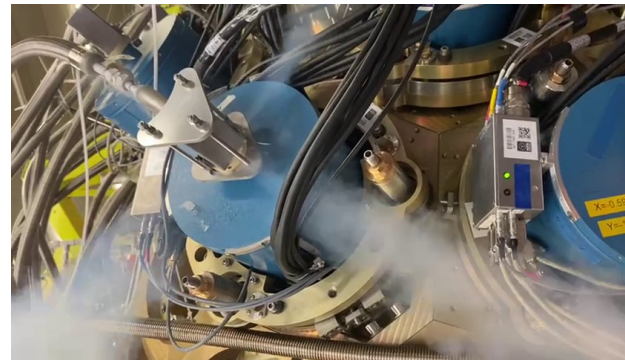
LN2 level
feedthrough

- Fragile sealing of level capacitor feedthroughs
Not resolved yet

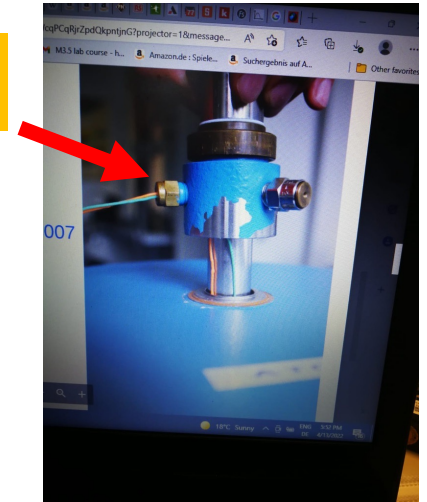
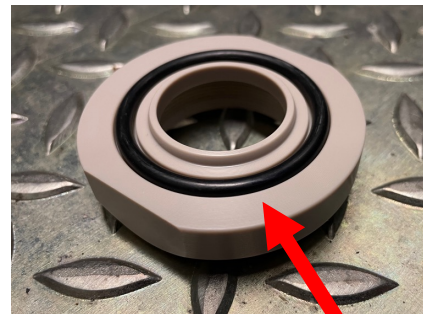
Additional
O-ring

- Very thin bayonet O-ring

New peek adapter with additional O-ring

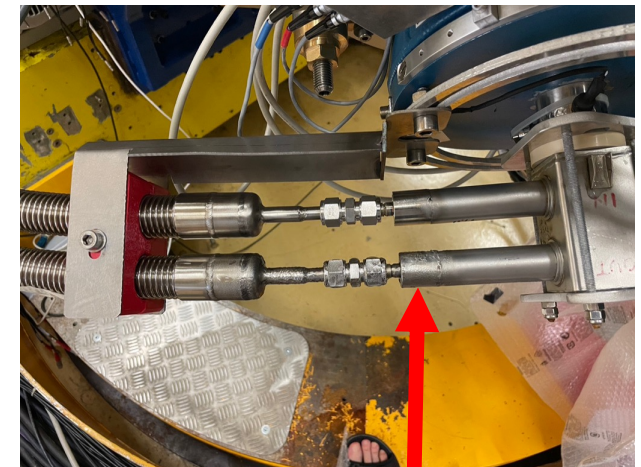
Welded bayonet
extension

- Rigid metallic hoses

Added insert to reinforce bayonet connections and fixture holding bayonet and metallic hose in place

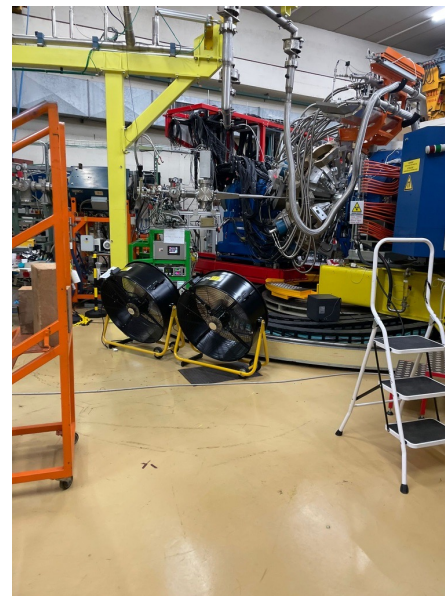
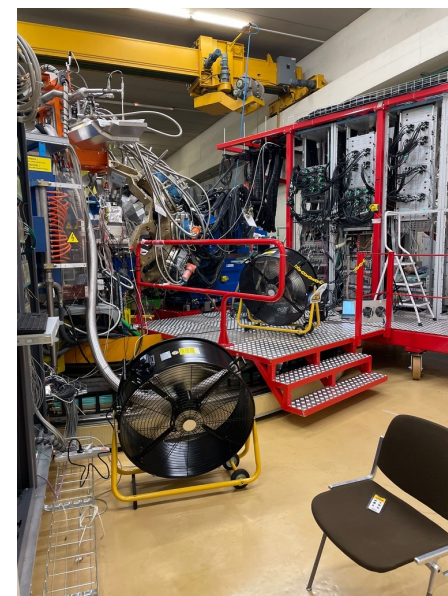
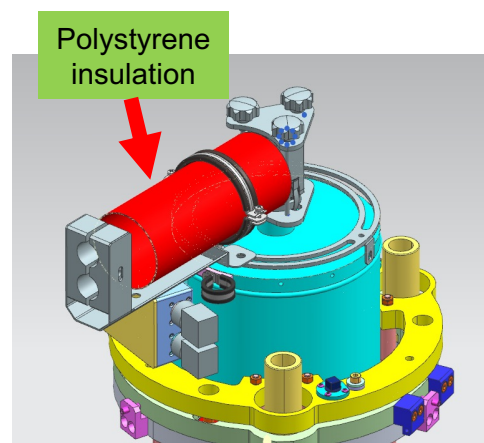
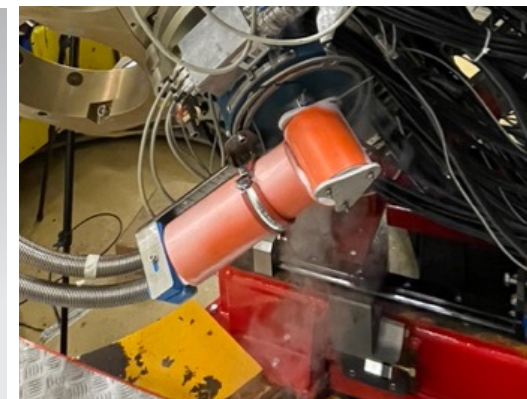
- Humidity
- Frequent HV shutdown

- Damaged digitizers from corrosion of Al plates and pipes

Additional isolation around the bayonets and improved air circulation

*Anodized aluminium components. Installed heat exchanger using “**non-corrosive**” cooling fluid*

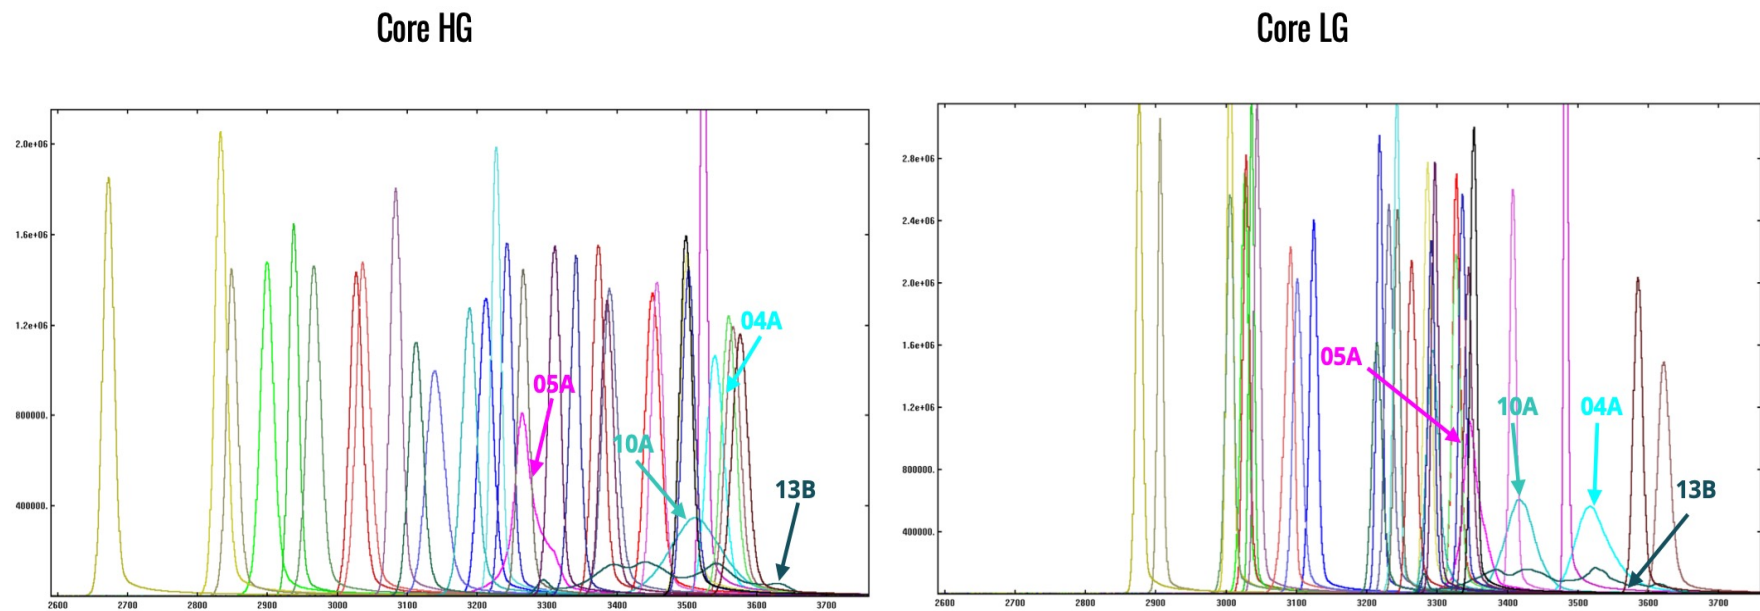
Figure 40 → Global Baseline Spectra of all Cores. 13B, 04A, 05A and 10A had the worst core resolutions.
