SiW ECAL **Technical report** from 2017 Beam Test

A. Irles

LLR, Palaiseau 11th July 2017

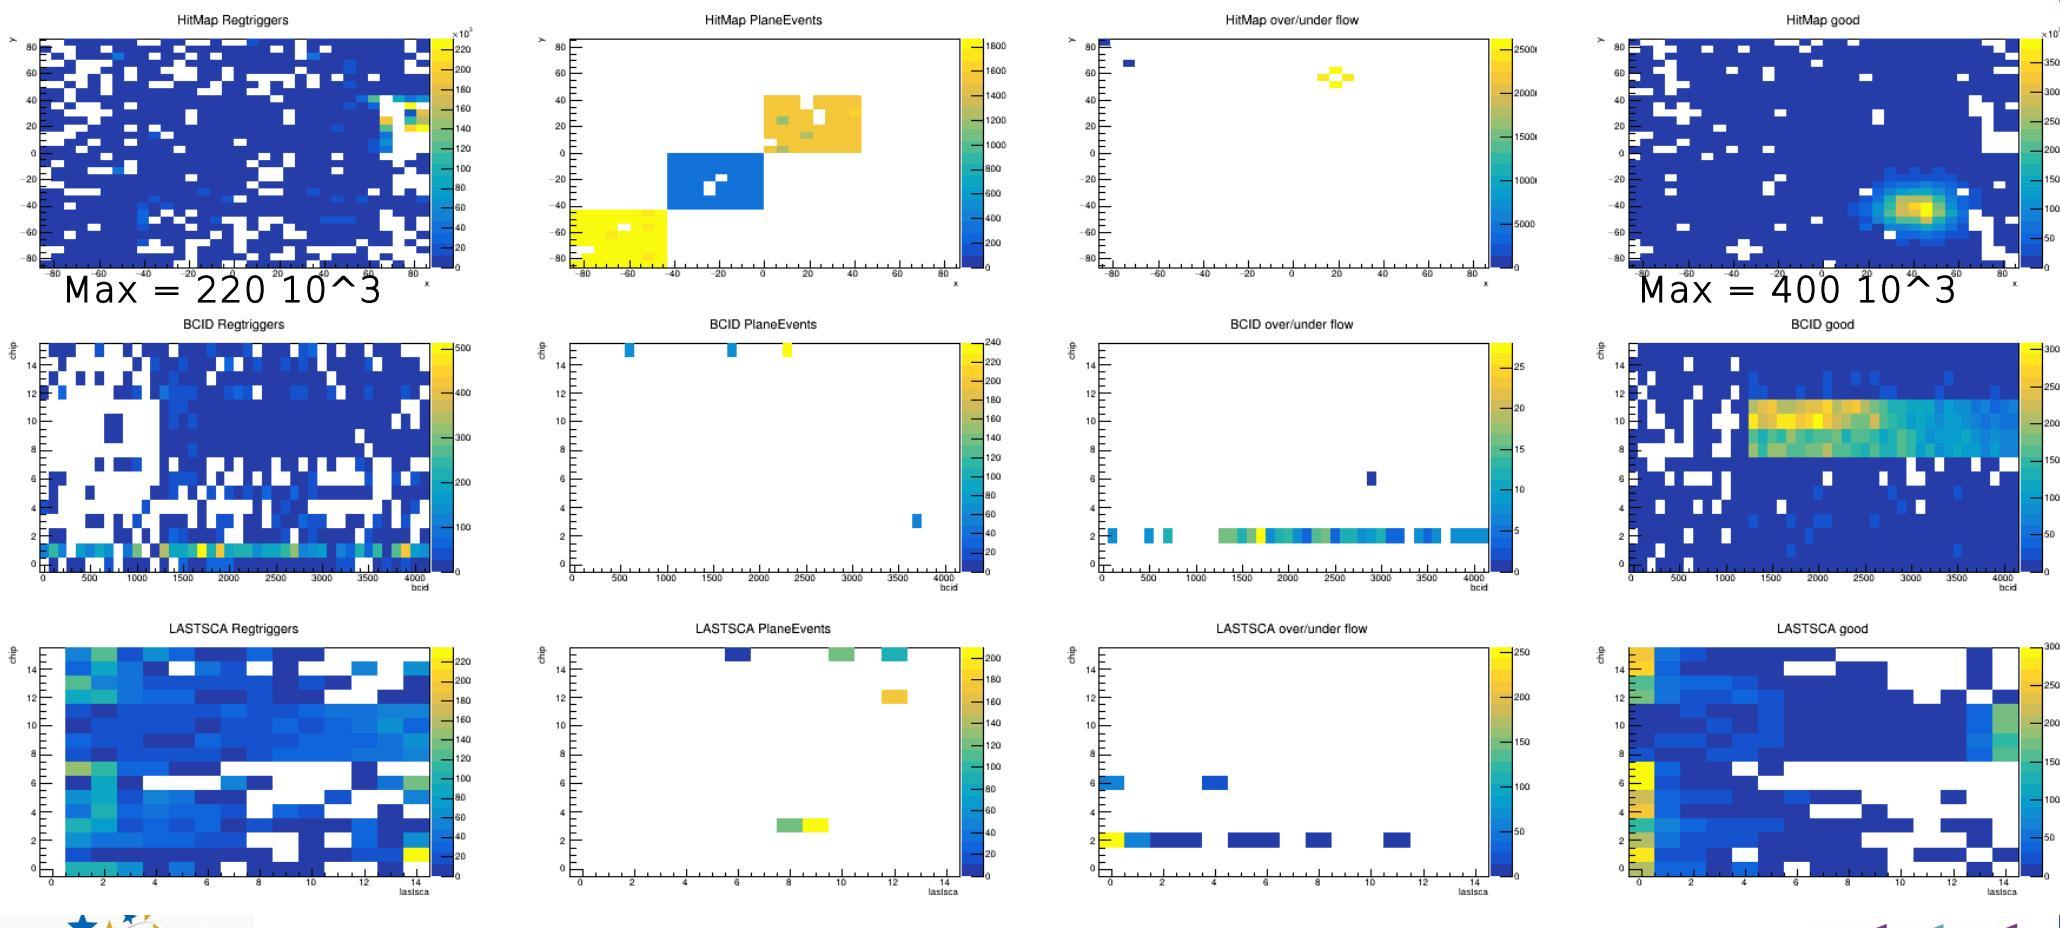
- ADC = 4 channels, retriggers, plane events. Seems that we are in the same situation than in 2015 ?
- Once that we know the issue: it is easy to bypass them: masking adc=4 channels (conservative approach ?) and filter events offline.
- These events have been monitorized

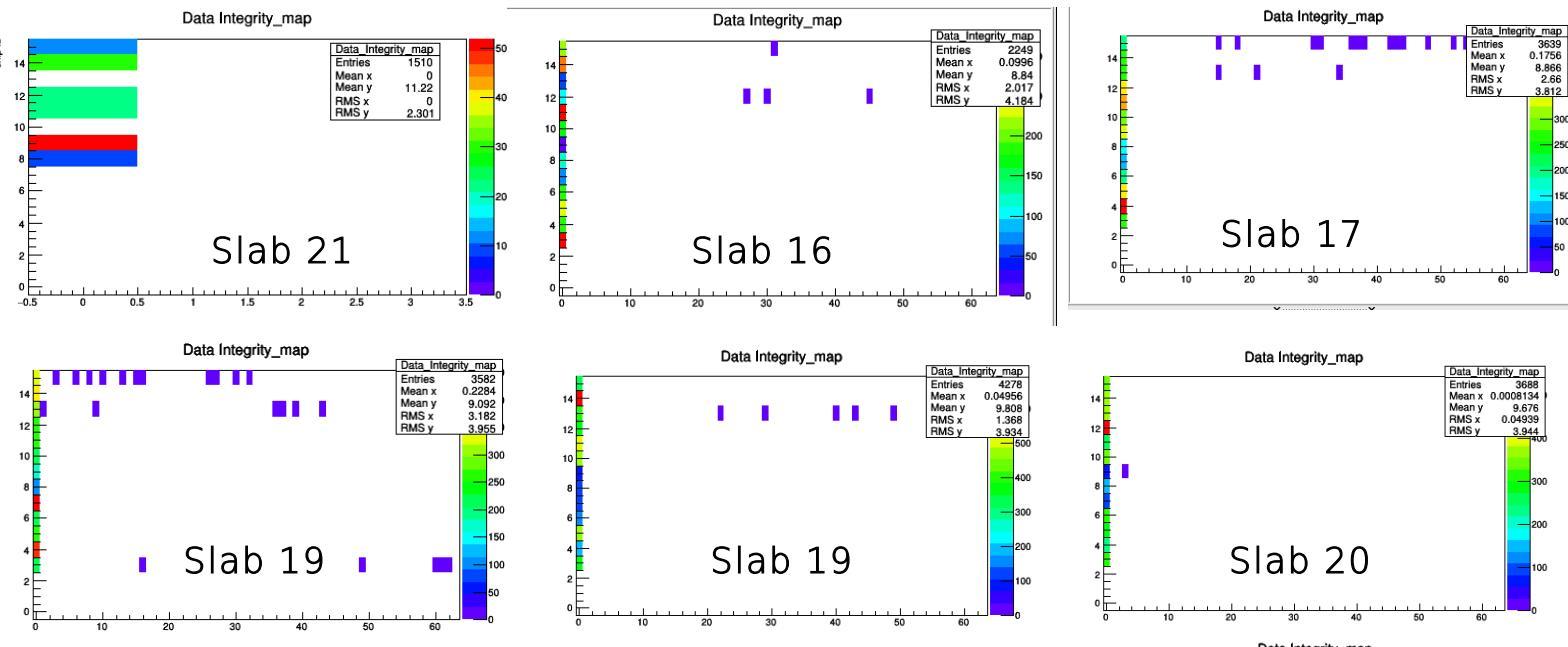
Why there are no errors in chips 0,1,2?

Are these chips superseeded by other sources that are not chip-taggable (i.e. bad number of columns, bad chip id, bad number of words)

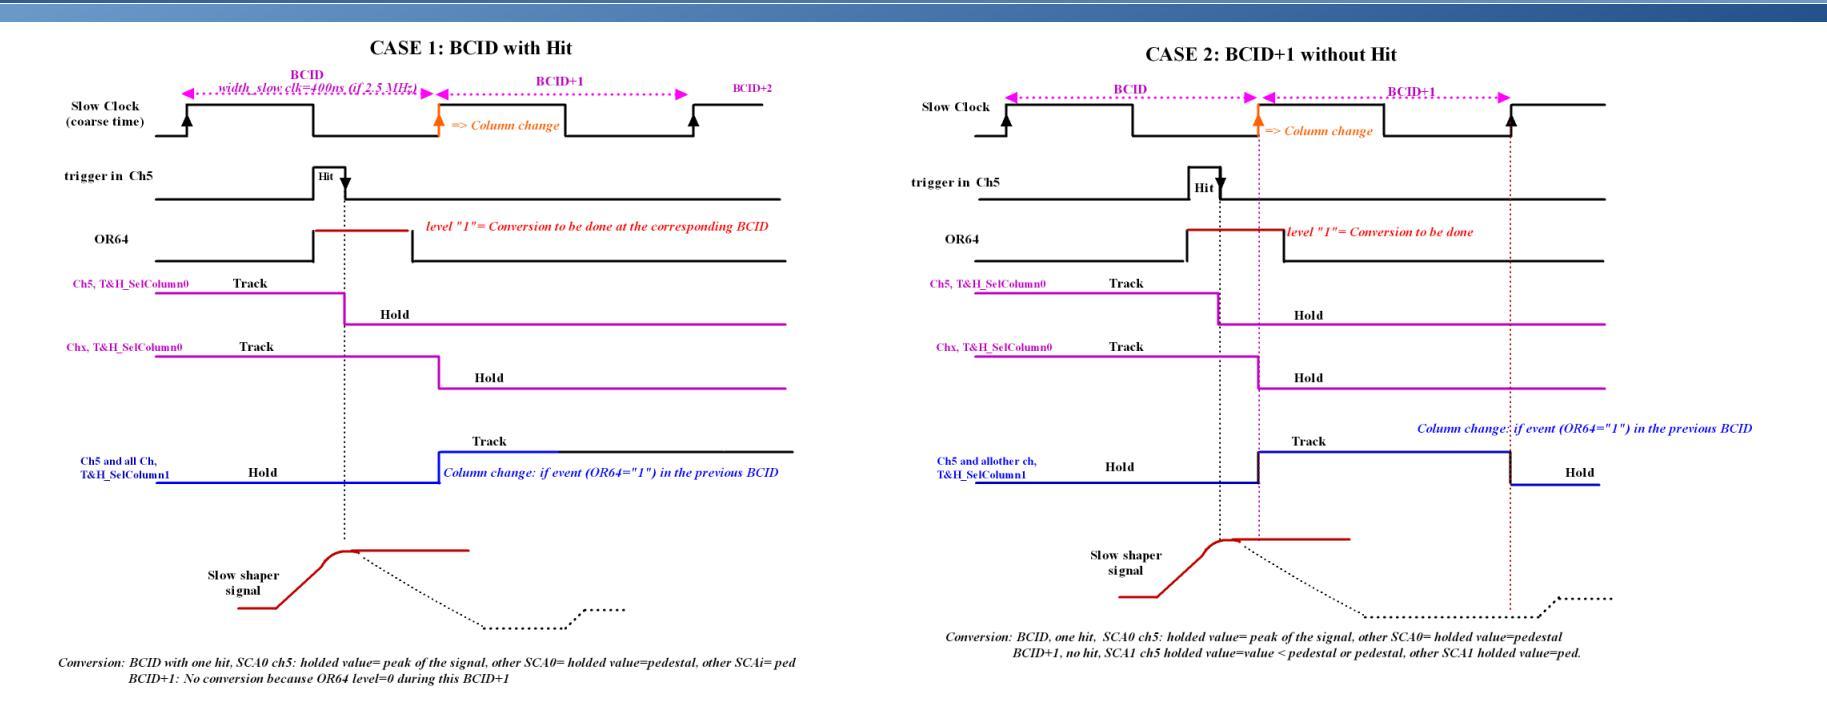
BCID+1 events

This are not bad events !!

■ Next SCA (NSCA+1) is filled with a zero, but SCA=NSCA is usable \rightarrow not remove from analysis !

$\blacksquare \sim 15\%$ of chances of happening (reduced to ~ 0 in skiroc2a)

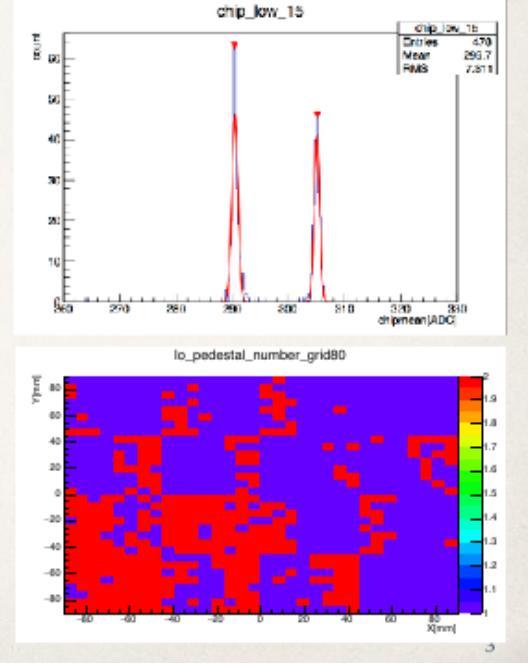
- When we produced histogram, double pedestal was seen !
- Double pedestal was seen at RED region
- Data

run number : 20170616_175712 MIP scan : 1800 seconds Beam shout point : grid 80 Beam energy : 3 GeV DIF : 1_1_4 Memory cell : 0 only Charge : low gain Tungsten (W) : none
