Slow control

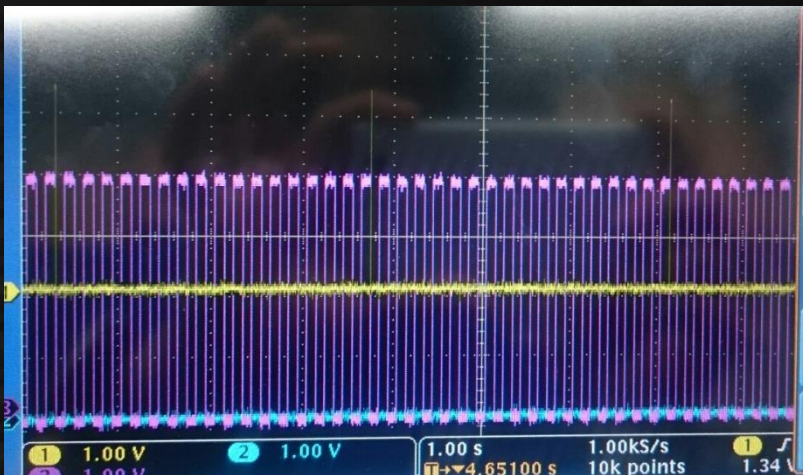
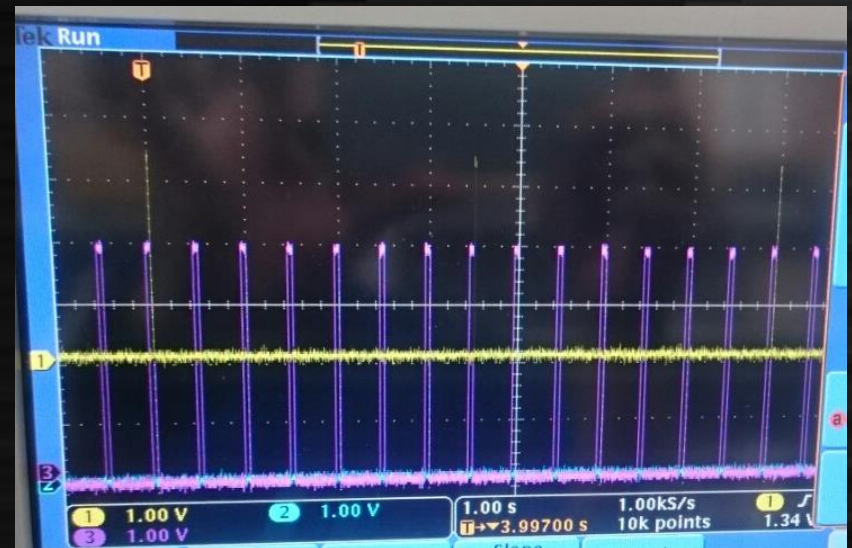
Problem on start_acq

- Start_acq only comes > 3.4 sec later than the previous start_acq
- Regardless of frequency (confirmed in 2/5/10 Hz)
- HDMI input OK (see pulse every 200 msec)
- Reason unknown

Yellow: start_acq pink: spill

- SPILL go down \rightarrow start acq going up
- Start acq going down to end_readout1: ~ 150 ms
- Start_convb: $14 \mu\text{s}$ after start_acq going down
- Start_readout1: $700 \mu\text{s}$ after start_acq down

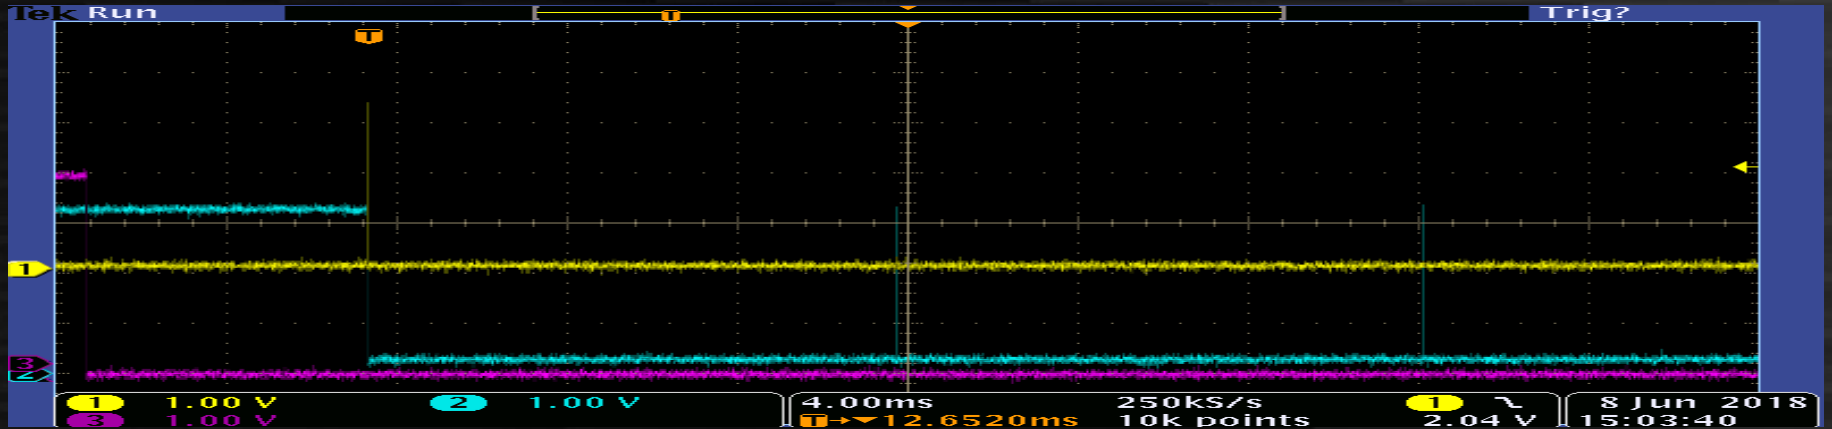
Data at end of each spill collapsed.

SPILL header instead of SPILL trailer found

Data Collapse

Transmiton1B (blue) and start_readout (yellow)
