Coupler fabrication for low-beta cavities

TTC Meeting at CEA-Saclay
6 July, 2016
Masao IRIKURA

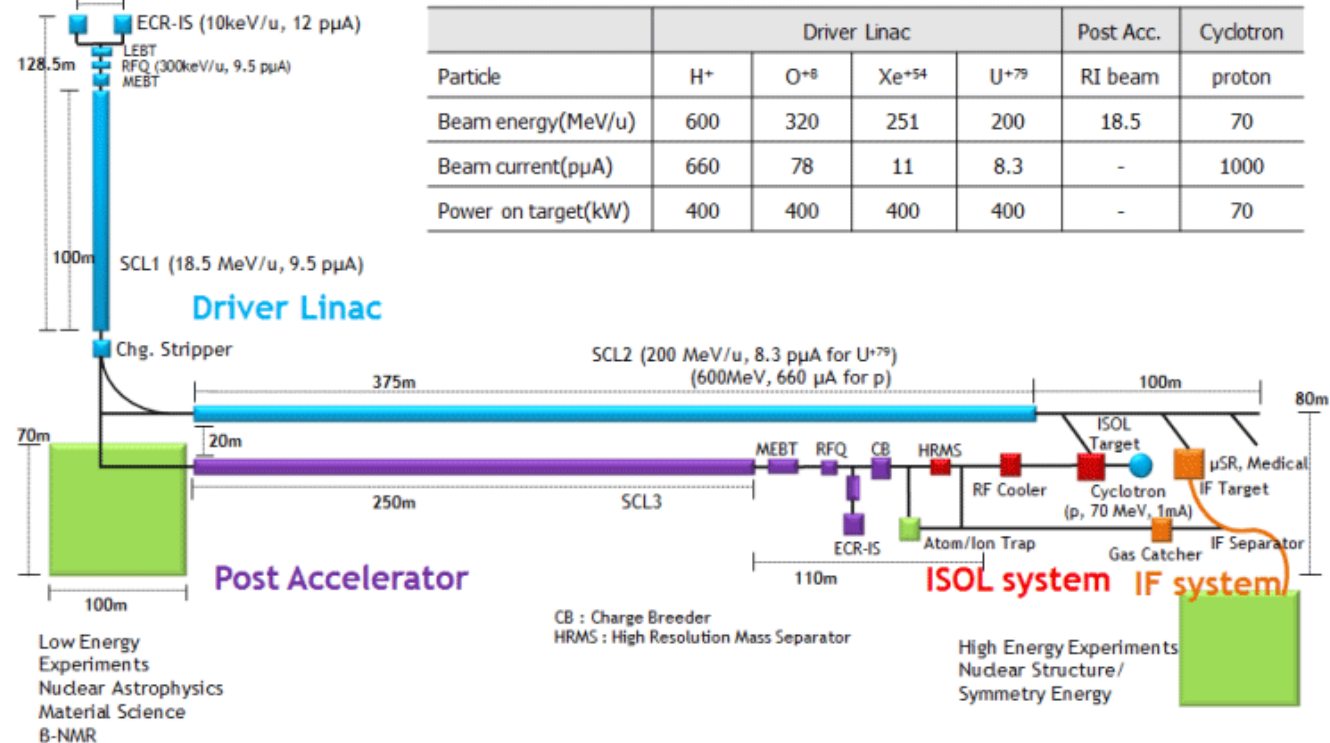
Rare Isotope Accelerator Conceptual Diagram

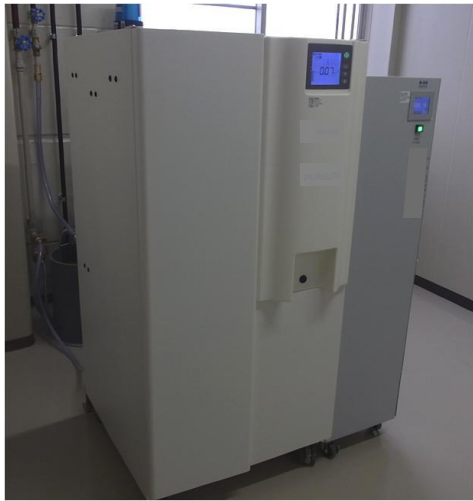
Ultra-pure water generator

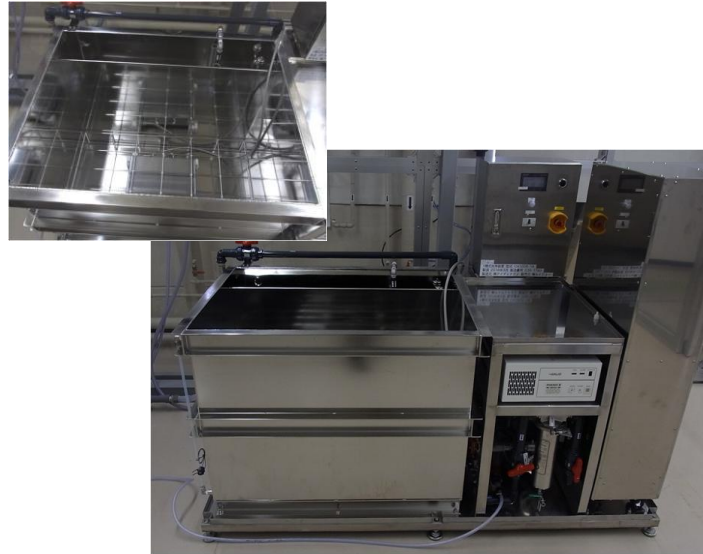
Ultrasonic bath

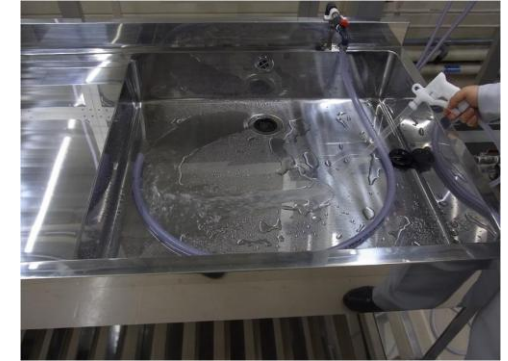
Sink for rinsing

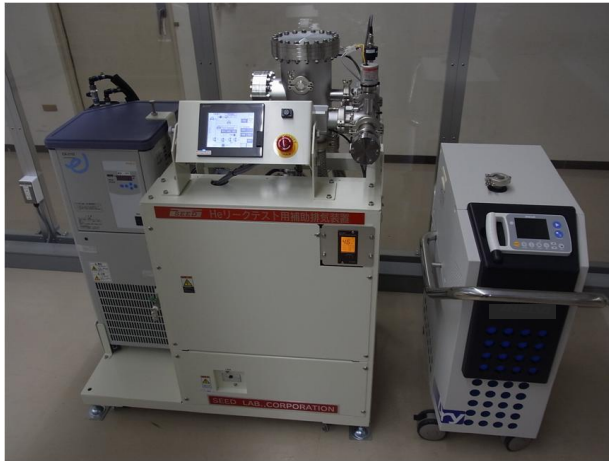
Leak detector and auxiliary vacuum system

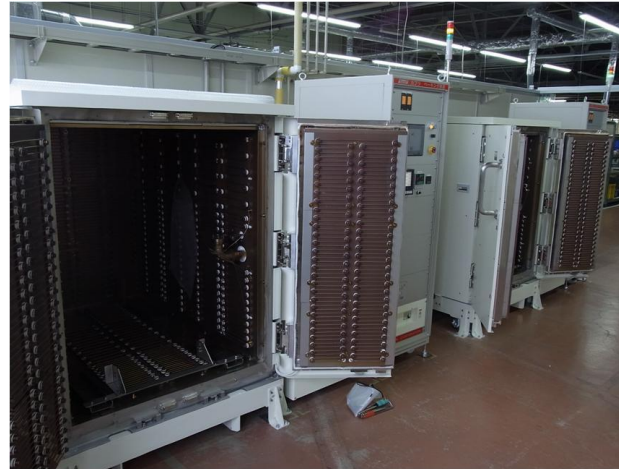
Baking systems

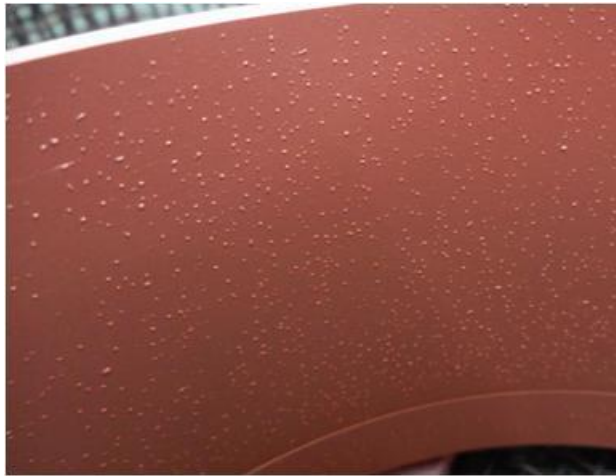
- Heating processes after copper plating sometimes gave many blisters on cylinder and bellows of outer conductors. Investigations was made with KEK and our subcontractor.
- The relation with plating solution became clear. The subcontractor is controlling a parameter.

Many large blisters on the inner surface after heating

- **TETD delivered prototype couplers for ESS(CEA-Saclay), IBS/RISP and MSU/FRIB in 2015 - 2016.**
- **TETD introduced a clean room and some equipments for coupler production.**
- **Some technical improvements was made in our prototype coupler production.**
 - Blisters on the copper plating after heating is found to be related to plating solution, and our subcontractor is controlling a parameter successfully.
 - Oozing of brazing alloy is unavoidable, but we keep on trying to avoid oozing it by controlling the amount of brazing alloy and other conditions.
- **TETD will start manufacturing FRIB HWR couplers in this summer.**

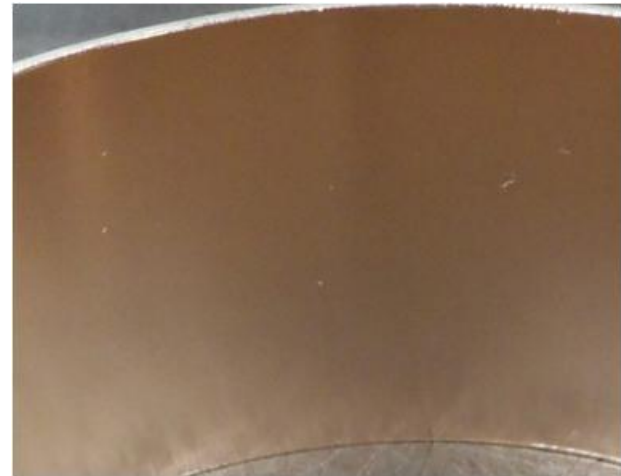
Normal surface after heating

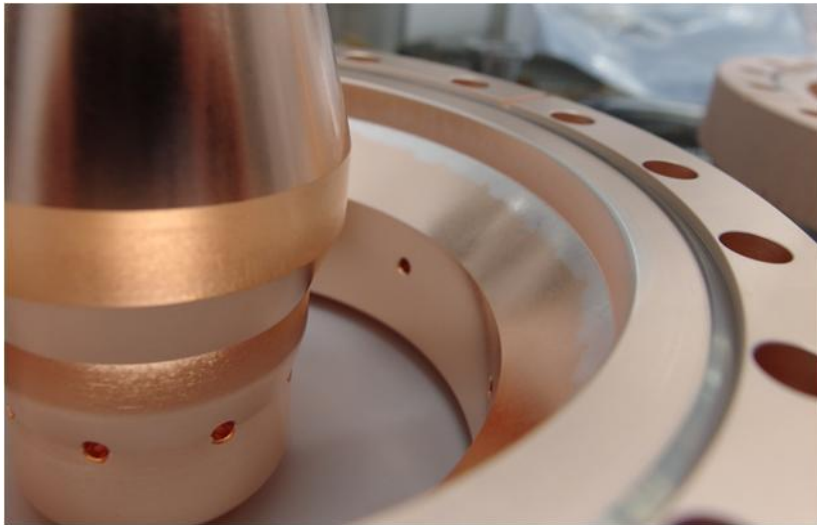
- **Ag-Cu brazing alloy was sometimes found oozing through brazing joint on RF surface.**
- **We try to control the amount of the brazing alloy, but it's difficult to avoid because it is affected by variation in smoothness of copper part and copper plating, brazing temperature, content of brazing alloy and so on.**

Oozed brazing alloy

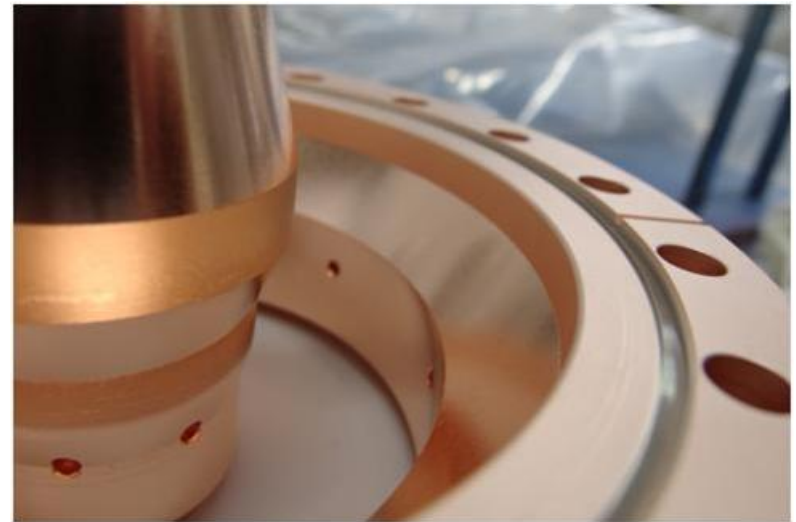
No oozing
