Test Beam 2020/03: Preparation Meeting

Adrián Irlés
IJCLab CNRS/IN2P3 (former LAL)

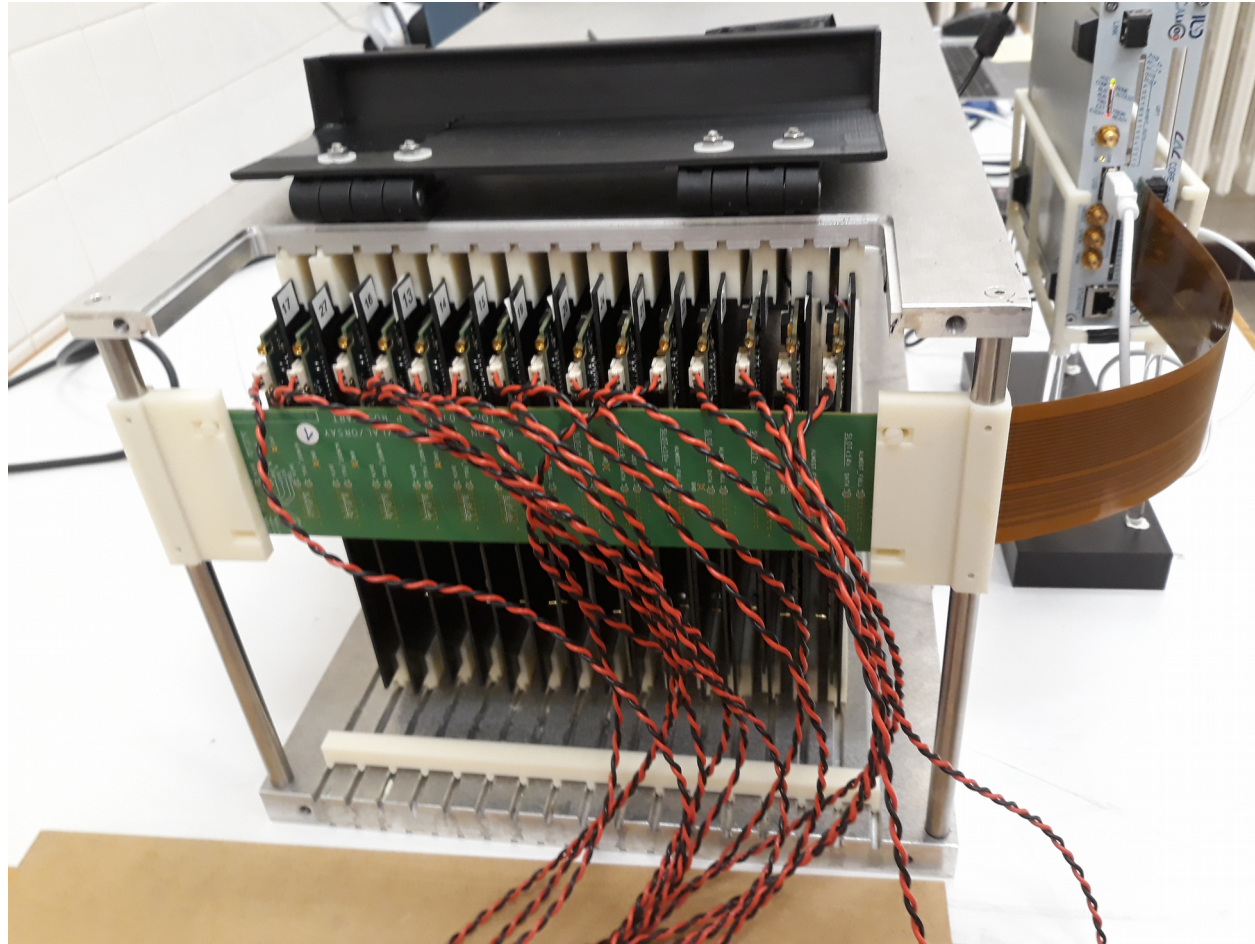
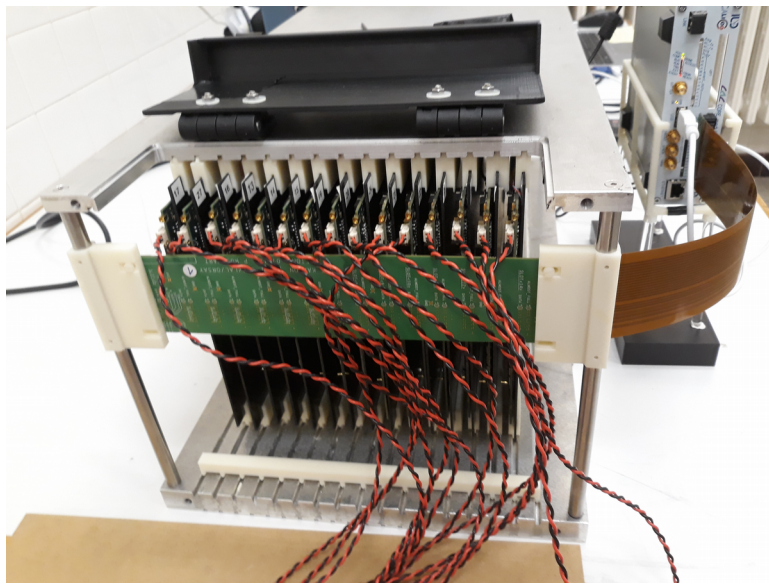
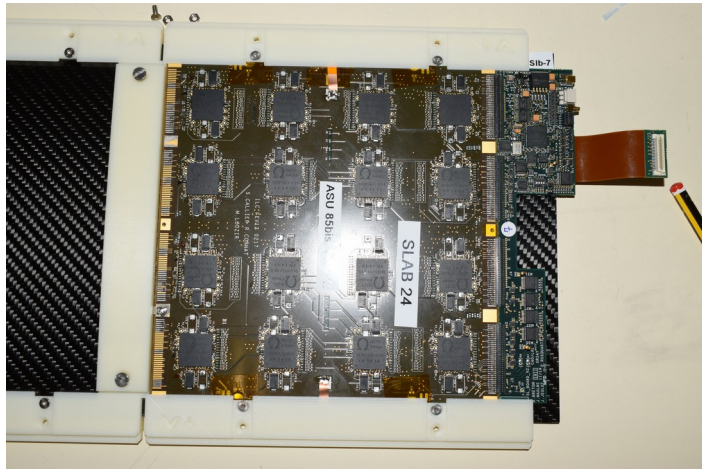
- ▶ Stack with 15 operative slabs since the end of the quarantine
 - 15000 cells
 - 13824 of them are equipped
- ▶ Some optimization works were needed to make it run
 - For the very first tries we couldn't control more than 8 slabs..
- ▶ Solved by improving the power distribution to avoid tension drops
- ▶ And by optimizing the clock signal propagation through the kapton core
 - By adding the right capacitances in the CoreDaughter (as foreseen)

- ▶ For the first time, we have 15 slabs together with common conditions
 - same power supply
 - Same DAQ
 - Same mechanical structure (i.e. same grounding etc)

- ▶ Robust and flexible box!
 - Easy to cable, uncable, remove or swap positions

- ▶ Also robust and flexible slab conception on the carbon frame
 - Easy to access to the chips, soldering points,
 - Easy to plug or unplug from the SLboard

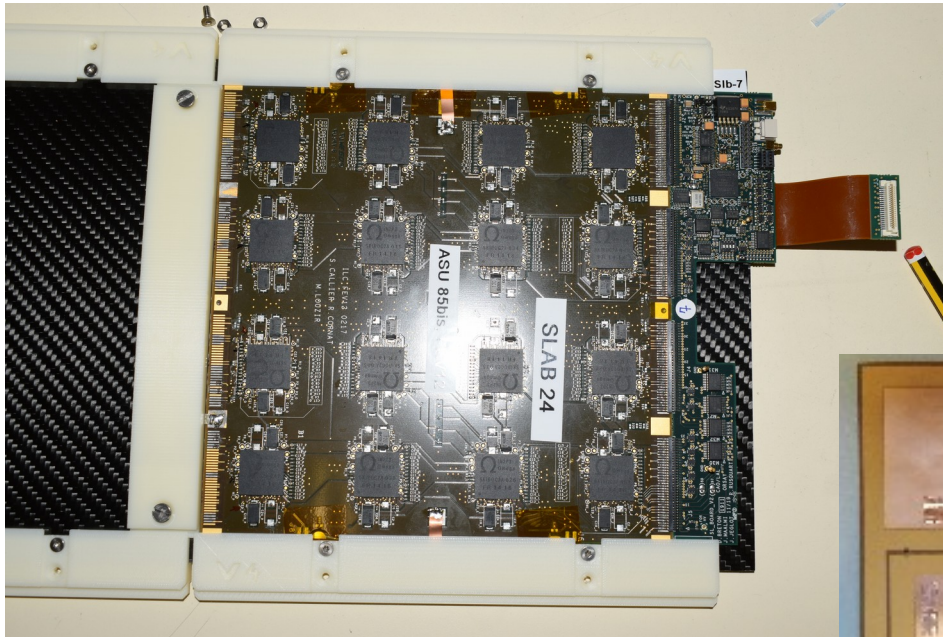
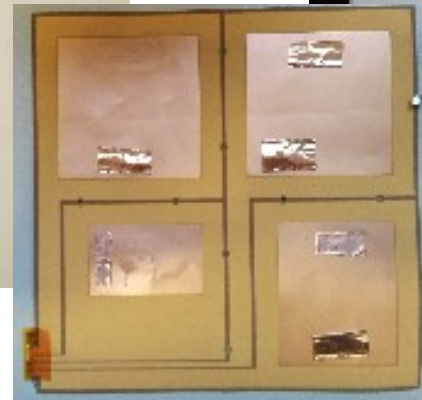
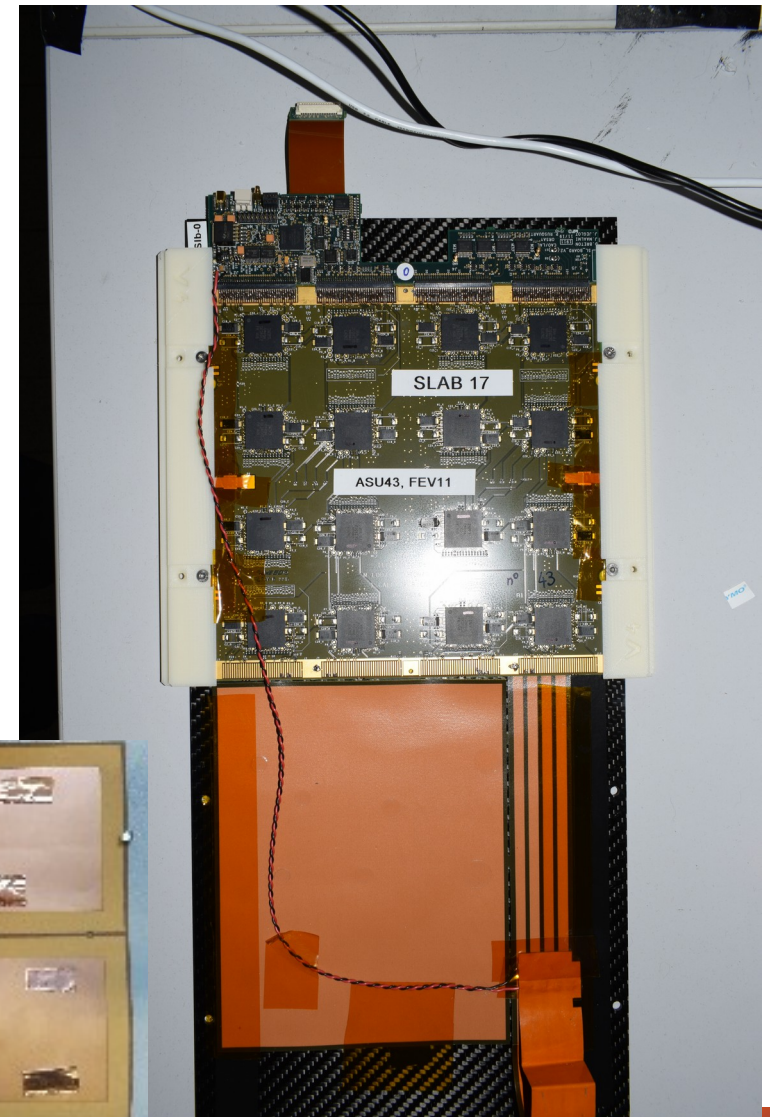
Report on the slabs (I)

- ▶ Due to the COVID, the new HV kapton sheets didn't arrive on time.
- ▶ Therefore, the stack has slabs with two types of HV power delivery.
 - No difference on performance observed so far

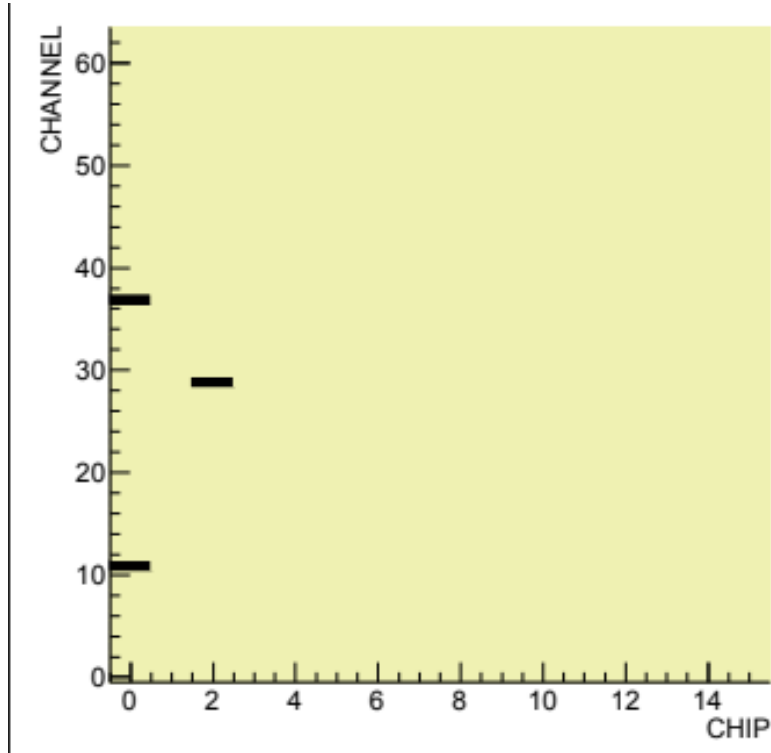
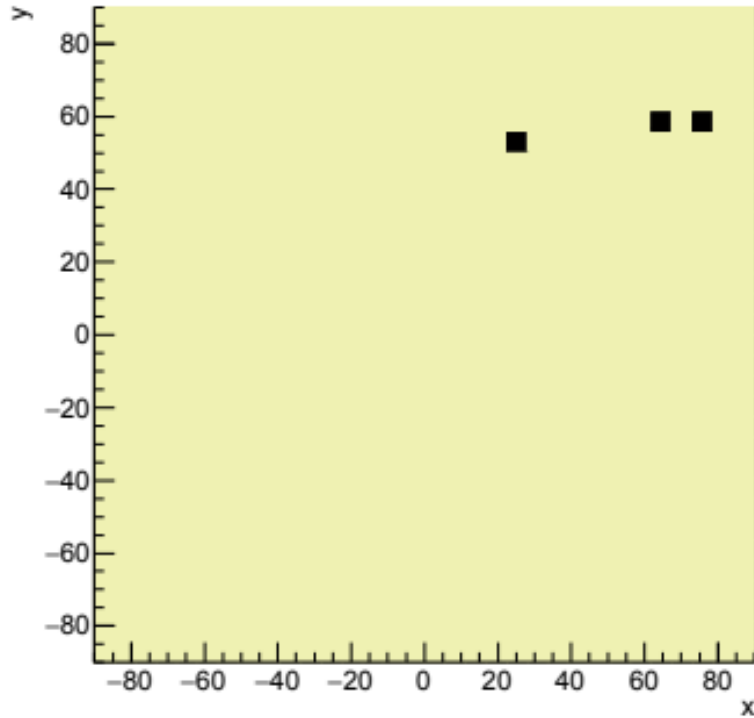
FEV12: Results of the masking procedure

► SLAB 25 (24 is very similar)

- black is masked

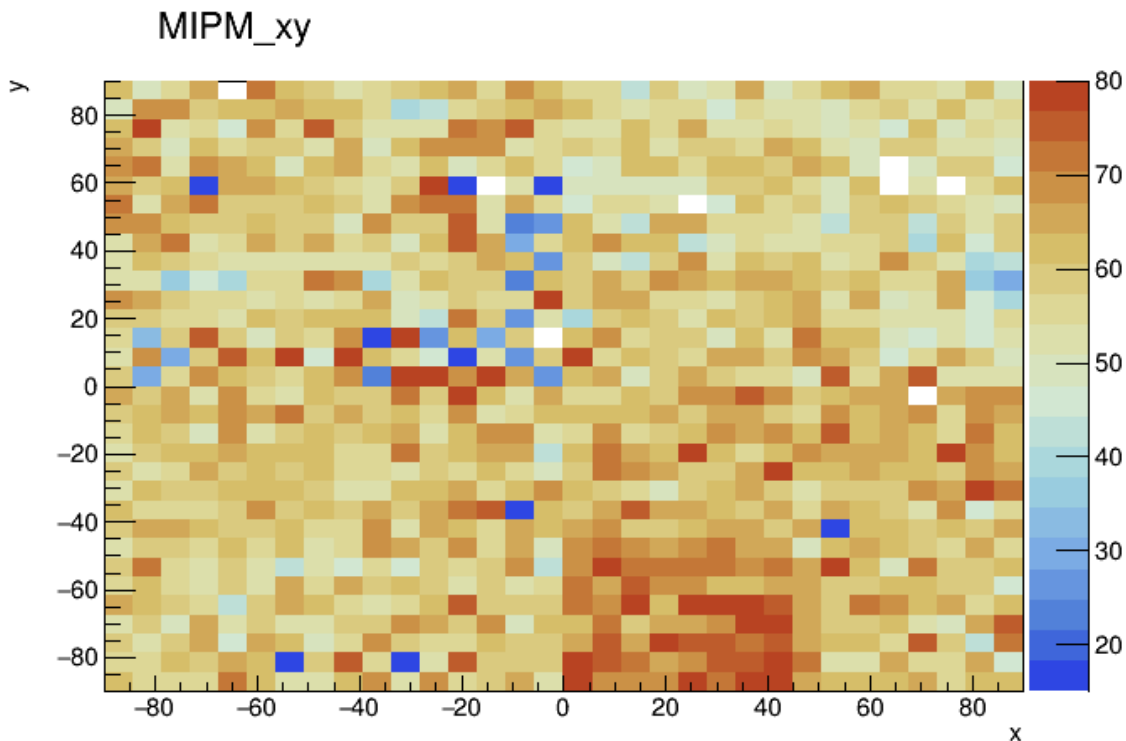
FEV12: Results of the cosmic run

► SLAB 25 (24 is very similar)

- Quite homogeneous response

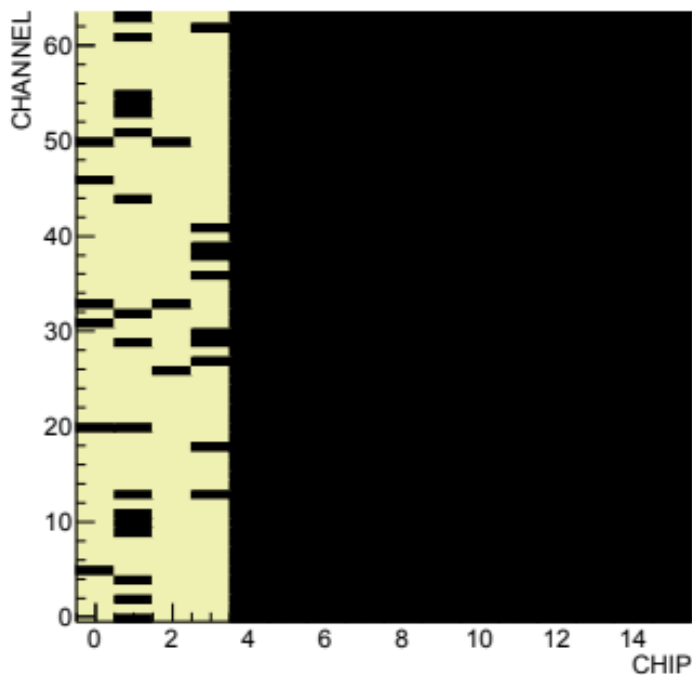
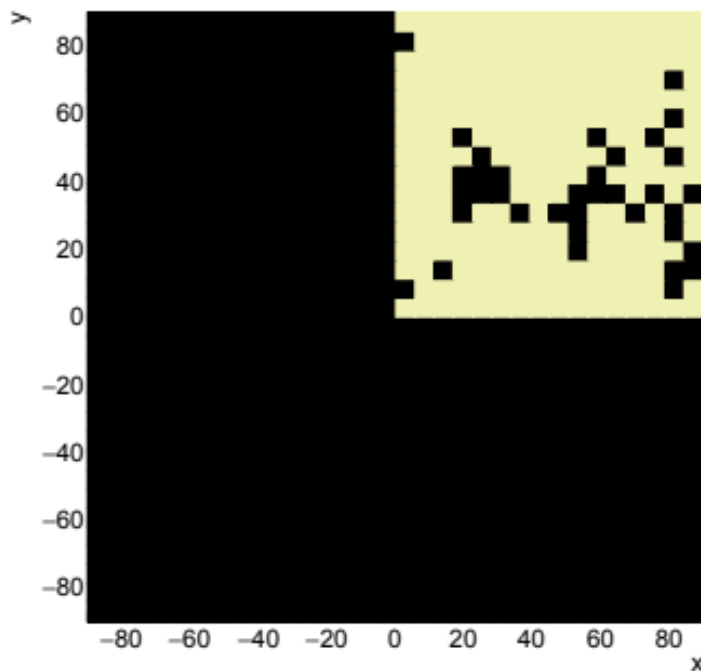
COB: Results of the masking procedure

► SLAB 27 (28 is very similar)

- black is masked
- Remember: the wafer is partially disconnected from the PCB

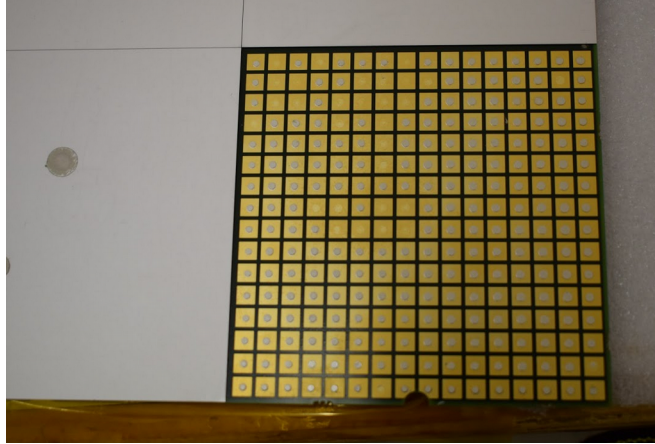
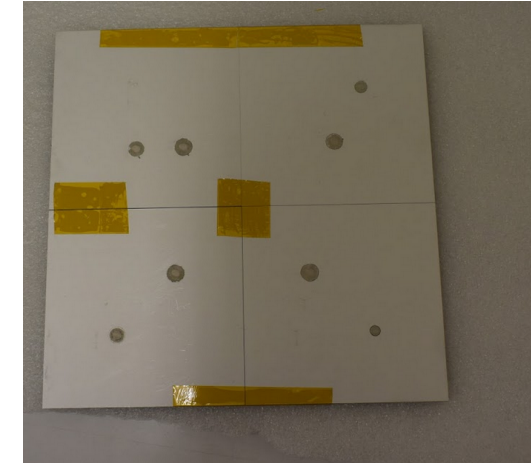
A very bad FEV11 → slab 17

▶ SLAB 17 (FEV11)

- Travel Europe/Japan several times
- Arrived to France just before the quarantine. After several days in customs it arrived to France very well packed and protected.
- However... the wafers were simply partially detached from the PCB. One of them was completely detached.

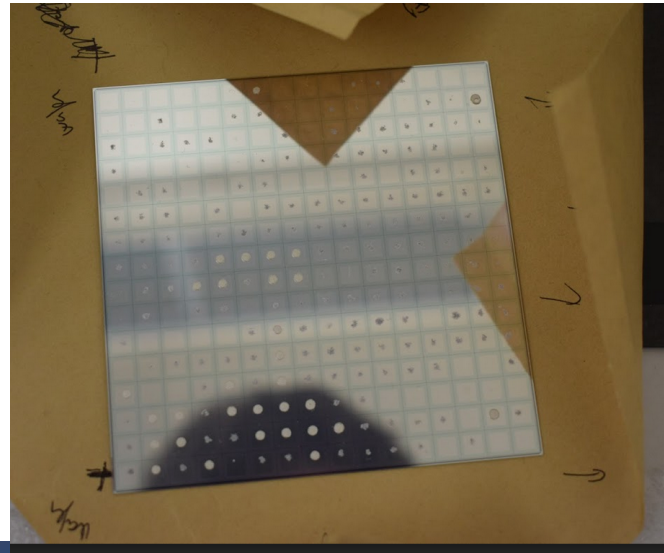
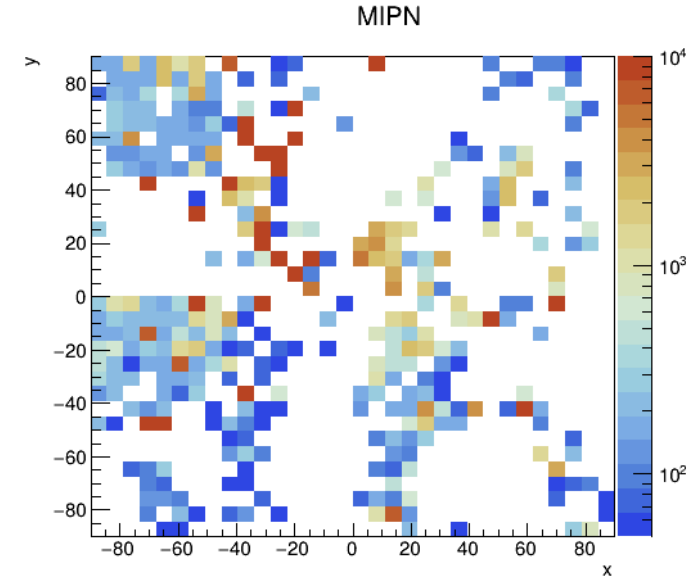
▶ Some bricolage done trying to recover it...

- It is not broken but only few channels are connected.

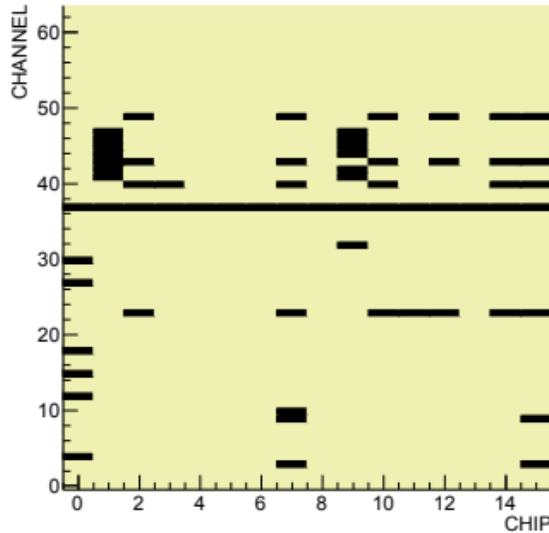
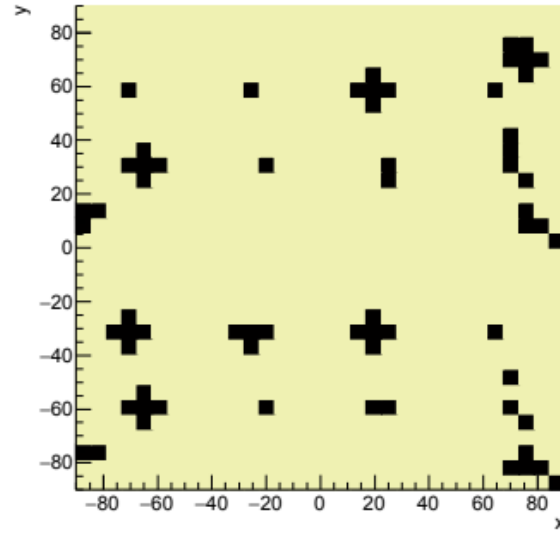
Standard FEV10/11: Results of the masking procedure

► SLAB 19 (FEV11)

- black is masked
- Crosses are around the channel 37
- Basically the same channels that were masked for TB2017 →
- But few more because we more conservative for cosmic data taking.

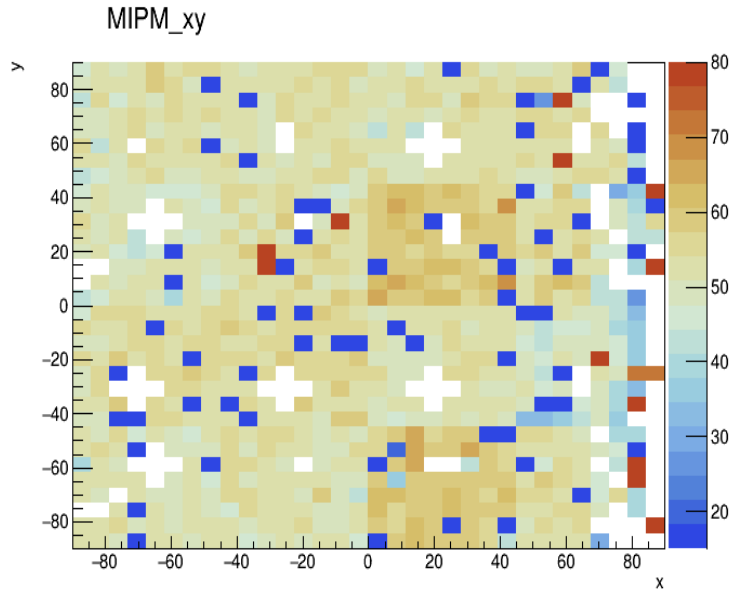
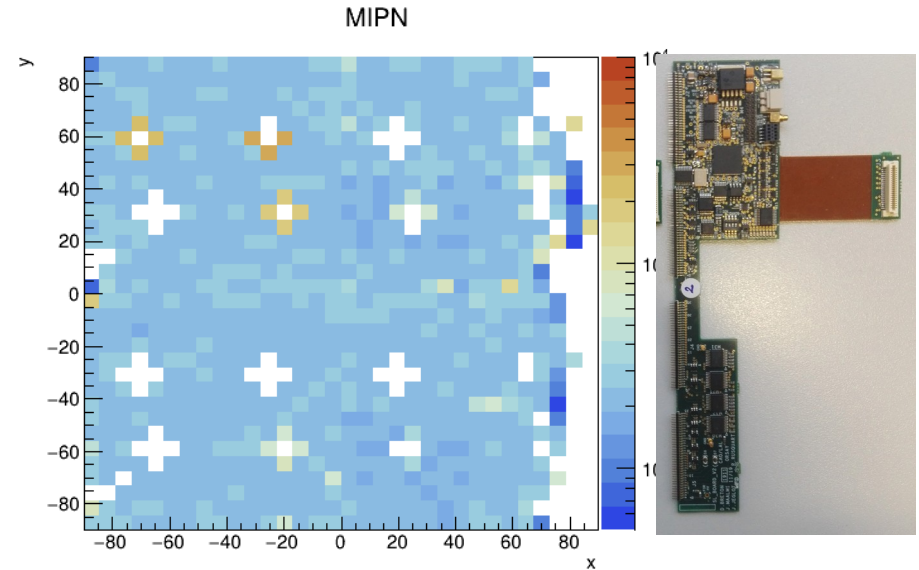
Standard FEV10/11: Results of the masking procedure

▶ SLAB 19 (FEV11)

- Satisfactory results of the cosmic run for most of the slabs

▶ Lower performance on the edges of some boards? Effect seen in the past in several slabs (TB2018 CERN)

- Worst wafer adherence? (i.e. glue aging issue) ?
- Or just a noise/signal competition issue ? → Remember that the ASICs near the connectors are historically the ones much more noise sensitive

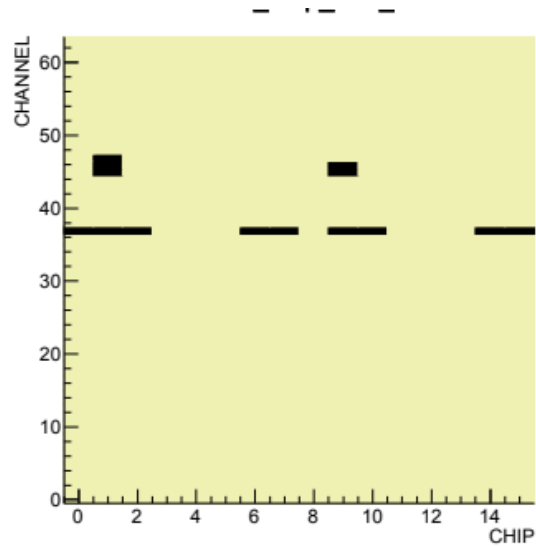
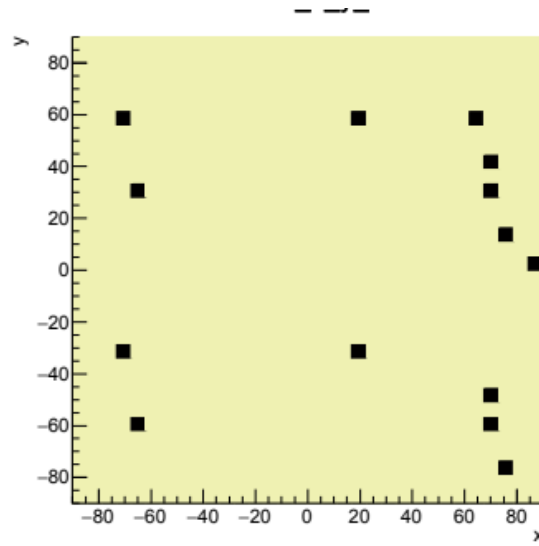
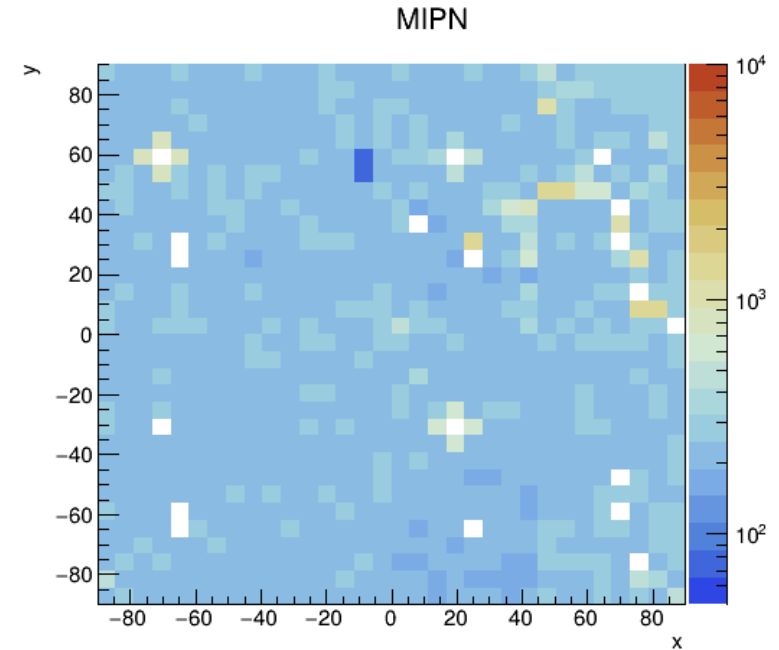
A very good FEV10: Results of the masking procedure

- ▶ SLAB 23, SK2, 320um
 - Never connected to a DAQ interface before
 - Similar performance than the FEV12

- ▶ SLAB 23, SK2, 320um
 - Never connected to a DAQ interface before
 - Similar performance than the FEV12
- ▶ Why? Only difference with the FEV11s is on the decoupling capacitances
- ▶ 68uF for DVDD
 - Instead of 33uF in the other FEV10/11
 - Instead of 120uF in the FEV12
- ▶ Can we further optimize the decoupling capacitances?
 - To be tested this afternoon

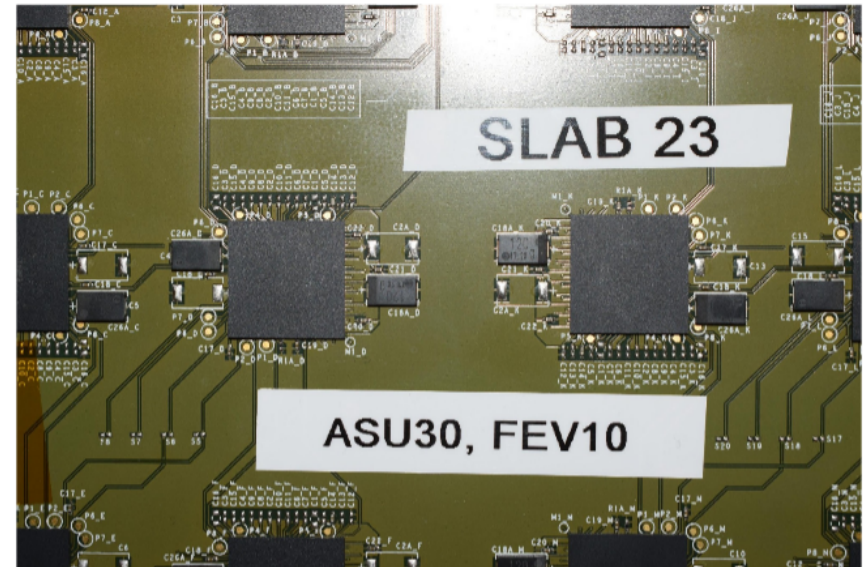
Photos : CHIP capacitances

- 120uF for AVDD, 68uF for DVDD in all ASICS

Other components : C14, C25, C24, C23, C22, R1, C20, C21 (all chips)

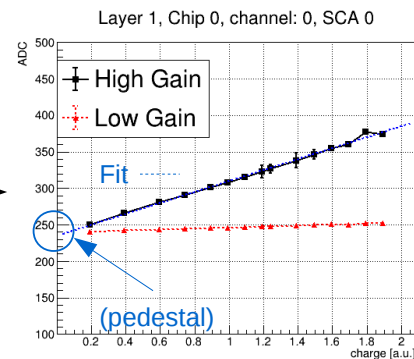
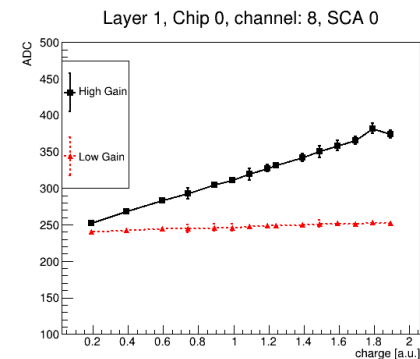
- ▶ Study in more detail the time correlations...
- ▶ Prepare more DQ tools
 - i.e. even some tracking/event displays
- ▶ Linearity /pedestal studies
 - I took enough data to repeat these studies systematically
 - Volunteers to analyze the data?
 - We can compare the forced trigger pedestal with the autotrigger pedestal and this one with the pedestal measured by linearity checks...
