# Phase 2 Power Supply and Mechanics

V. González

i2N – ETSE - University of Valencia

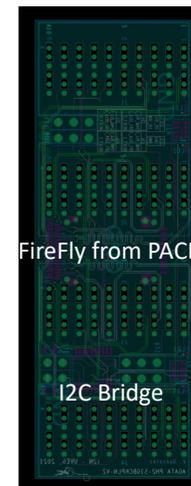
### SIGNAL BACKPLANE

- Distributes to CLKs, SynPat, SPI, I2C to DigiOpt12
- FireFly connection to PACE
- Additional local I2C Access
  - Through I2C bridge
- SIGNAL BACKPLANE redesigns

#### V2\_t11

Missing Enable connection for i2C bridge  
Improved SILKSCREEN information

#### V2.4

Firefly connector wrong pinout affects DigiOpt12 SYNC\_PATTERN & CLOCK signals

#### V2.5 production

Firefly cable crosses signal pins. Corrected

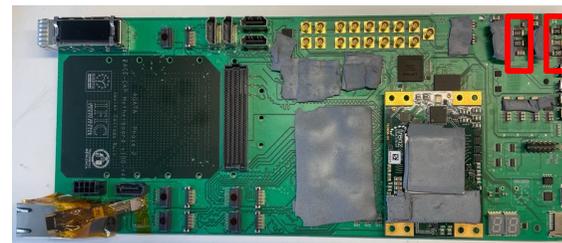
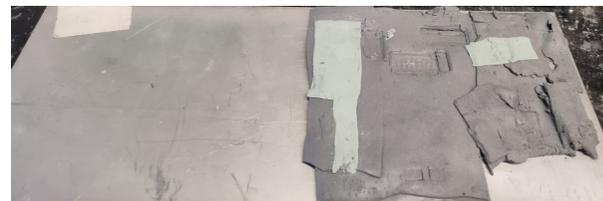
- Increase heat dissipation using side plates

- Thermal Pads on top and bottom layers. Use bottom plate as heat spreader

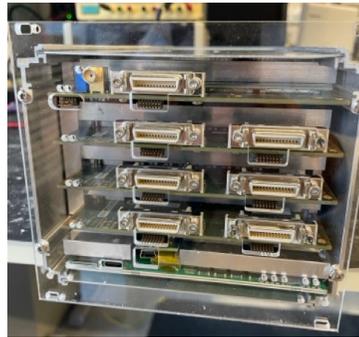
Plastic prototype

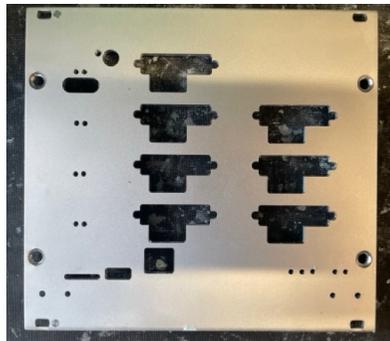
Aluminium prototype

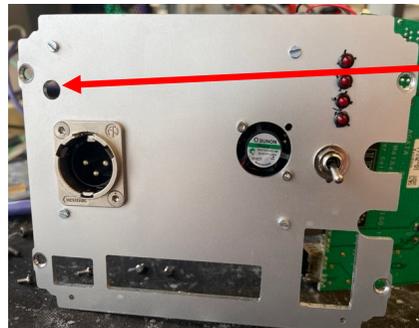
Aluminium prototype

Possible rework in the PACE cooling block to allow for a connection to an external trigger input.
