PPM-DOM.

by Jan-Willem Schmelling on behalf of the optical team.

An overview of the items showed during the DOM-ReX related to optics and integration.

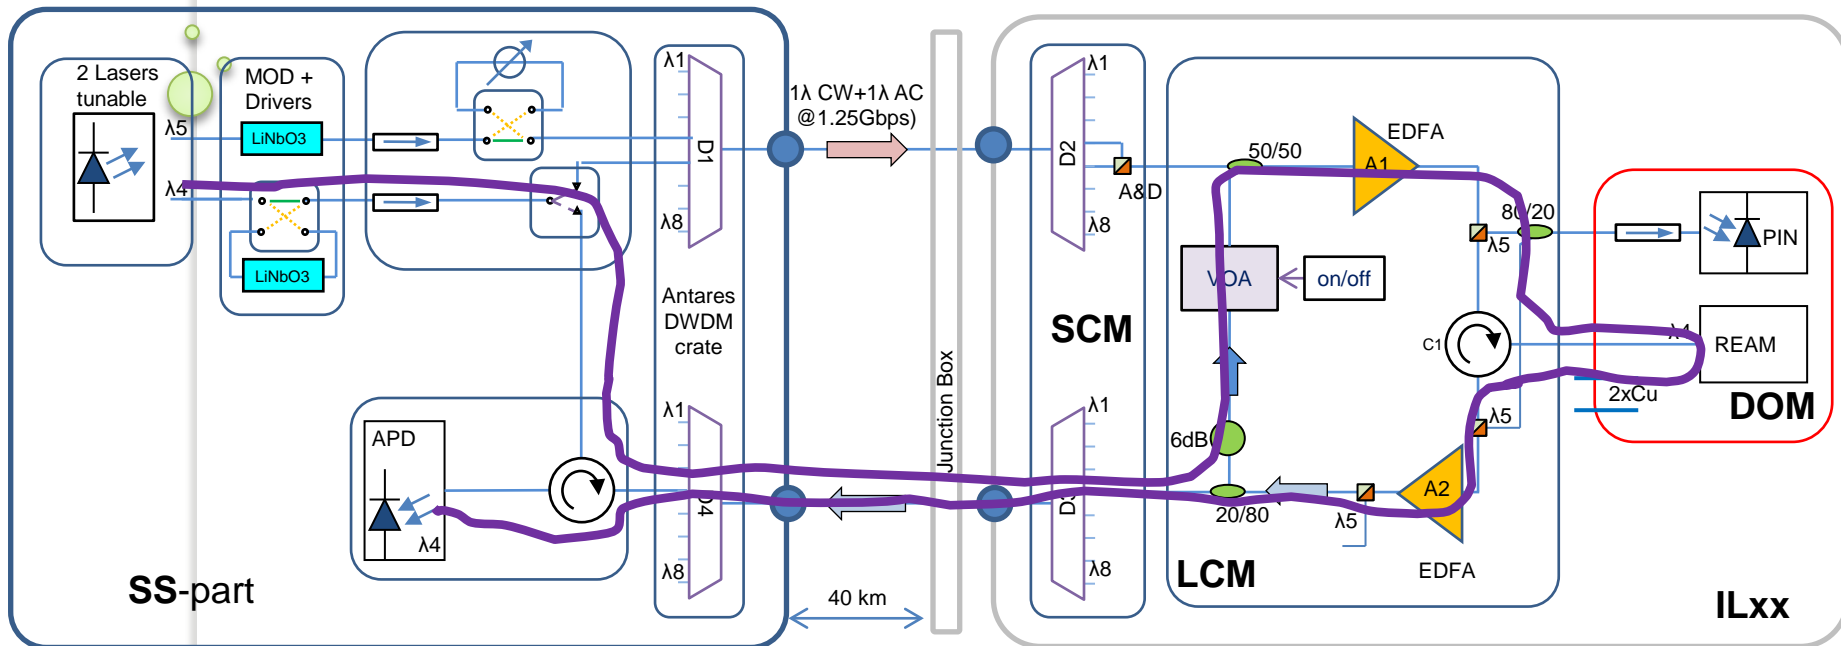
Optical network.

Time calibration: **optical pulse**

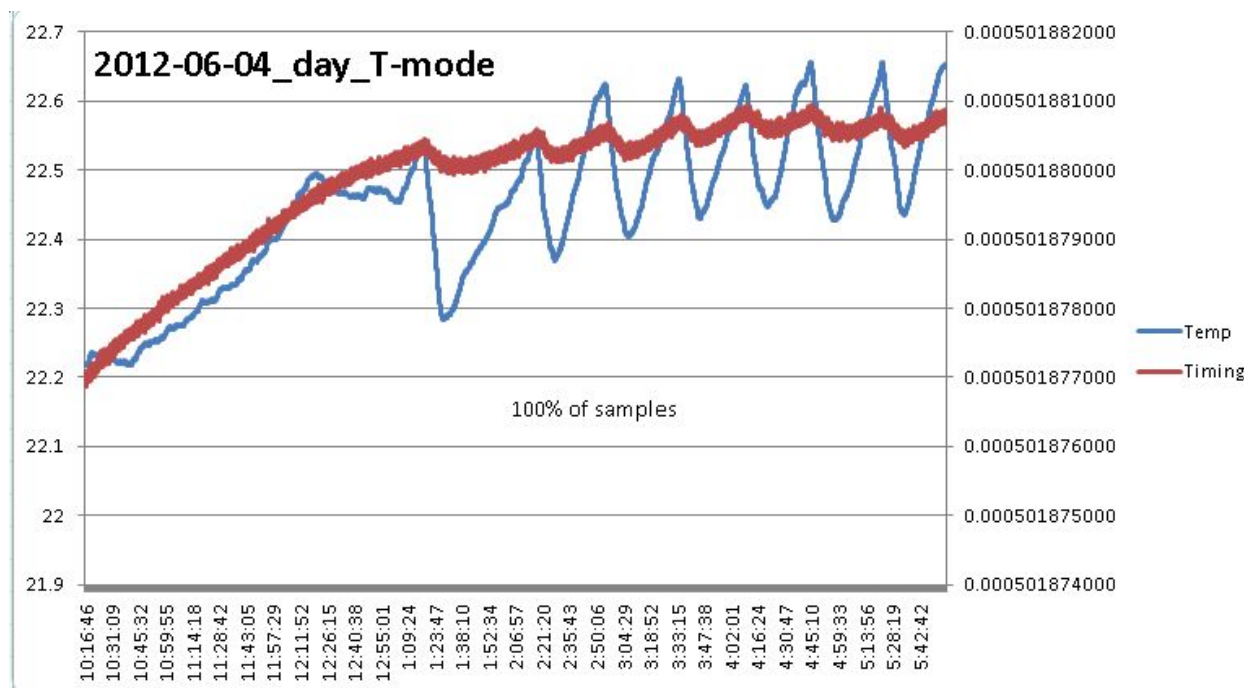
Lab test of optical time calibration.

During lab test it has shown that the optical time calibration:

- In principle works very well!
- Is sensitive for reflections (for example wet mateable connectors).
- Has a low average optical power (small pulse width).
- Components show un-expected behavior (reflections).
- A long fiber length can measure temperature very accurately. 😊

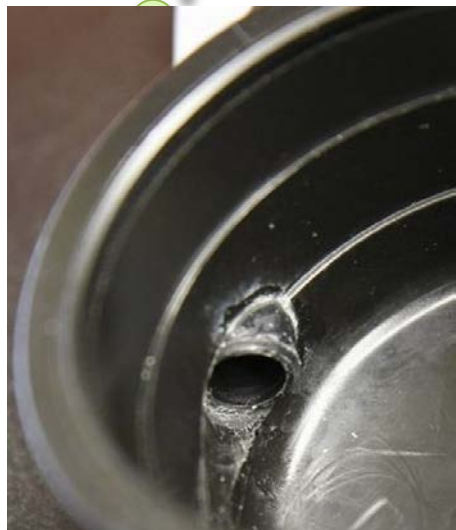
Close up of glue connection with “one second” glue.

First attempt with primer and “one second” glue. This failed a dry pressure test at 3 bar. Adding extra glue did not make it leak tight.

Gluing of the tubes to the BOB was not easy. Both the BOB and tubes are made from polyethylene (PE). This is very hard to glue.

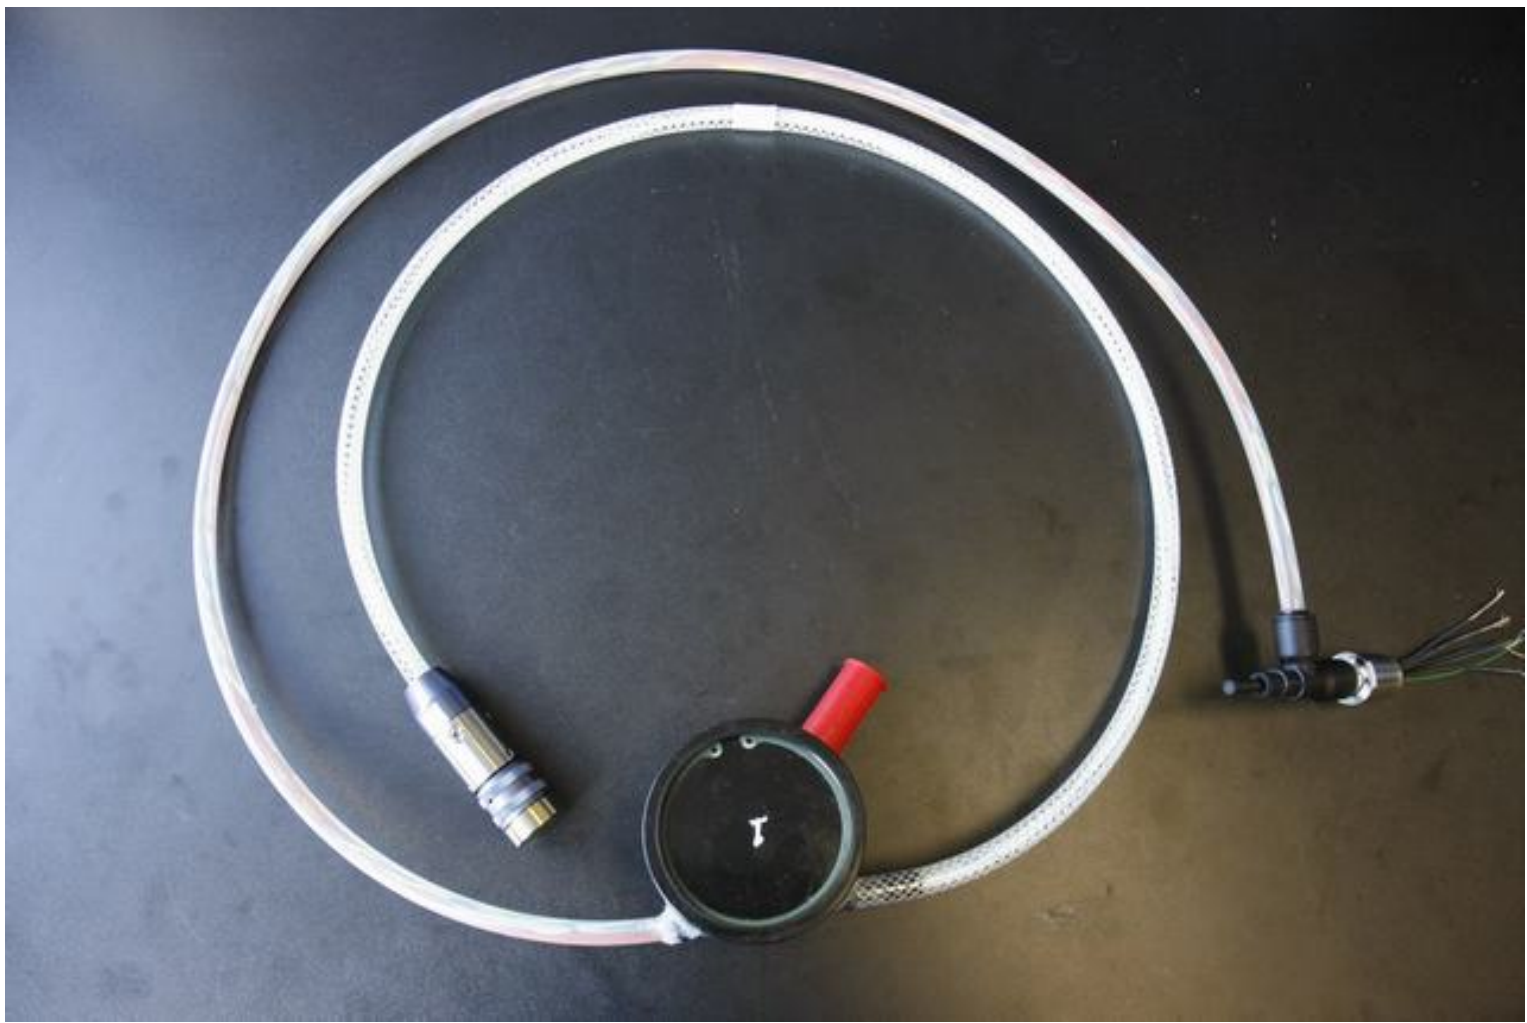
The completed BEOC.

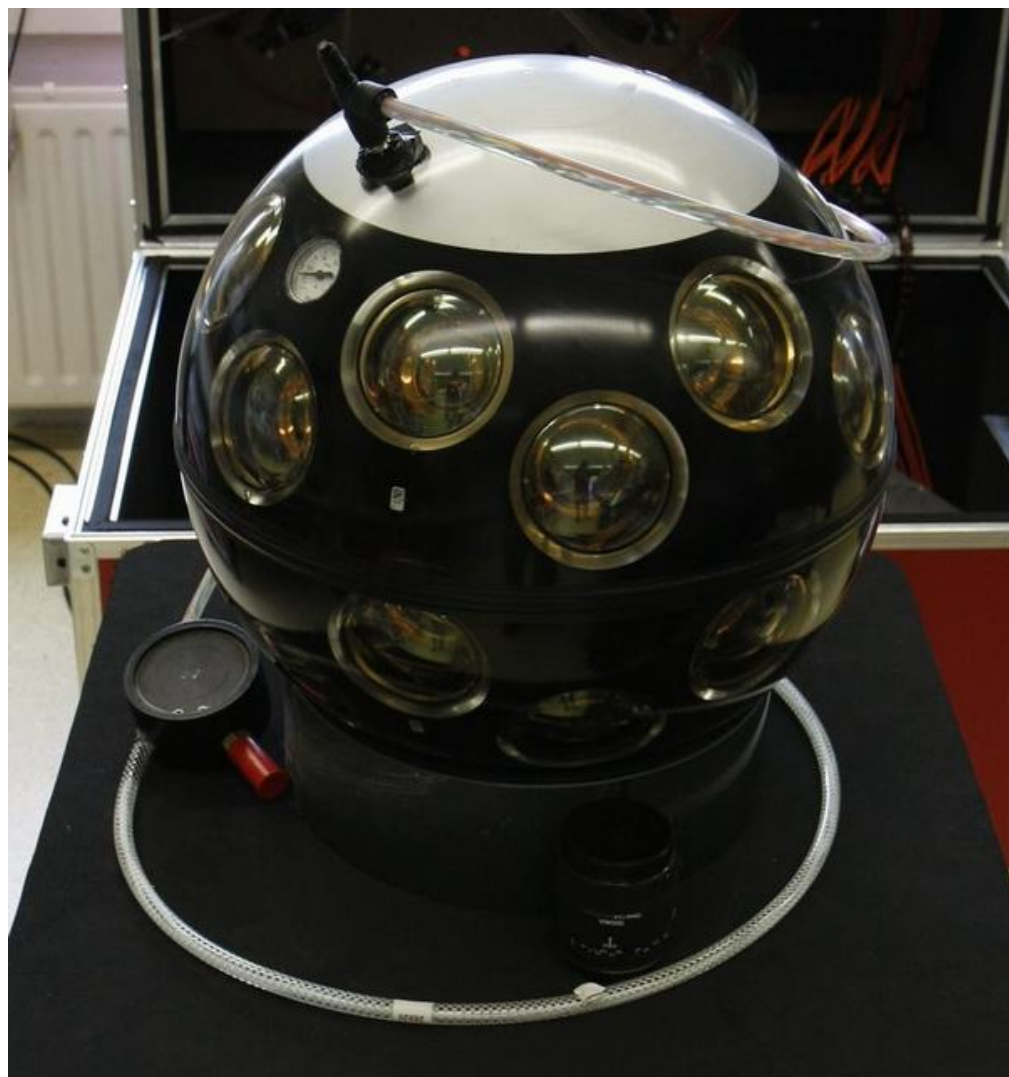
BEOC connected to the DOM.

- After the DOM had been closed the fast fuse inside the BEOC DC/DC converter blew during tests. This resulted in:
 - The BOB had to be drained of oil and opened.
 - The fuse is now short circuited by a wire to prevent this from happening in the future.
- Because the 400V supply from the SPM itself has a limiter, shorting of the fuse should no problem in-situ.

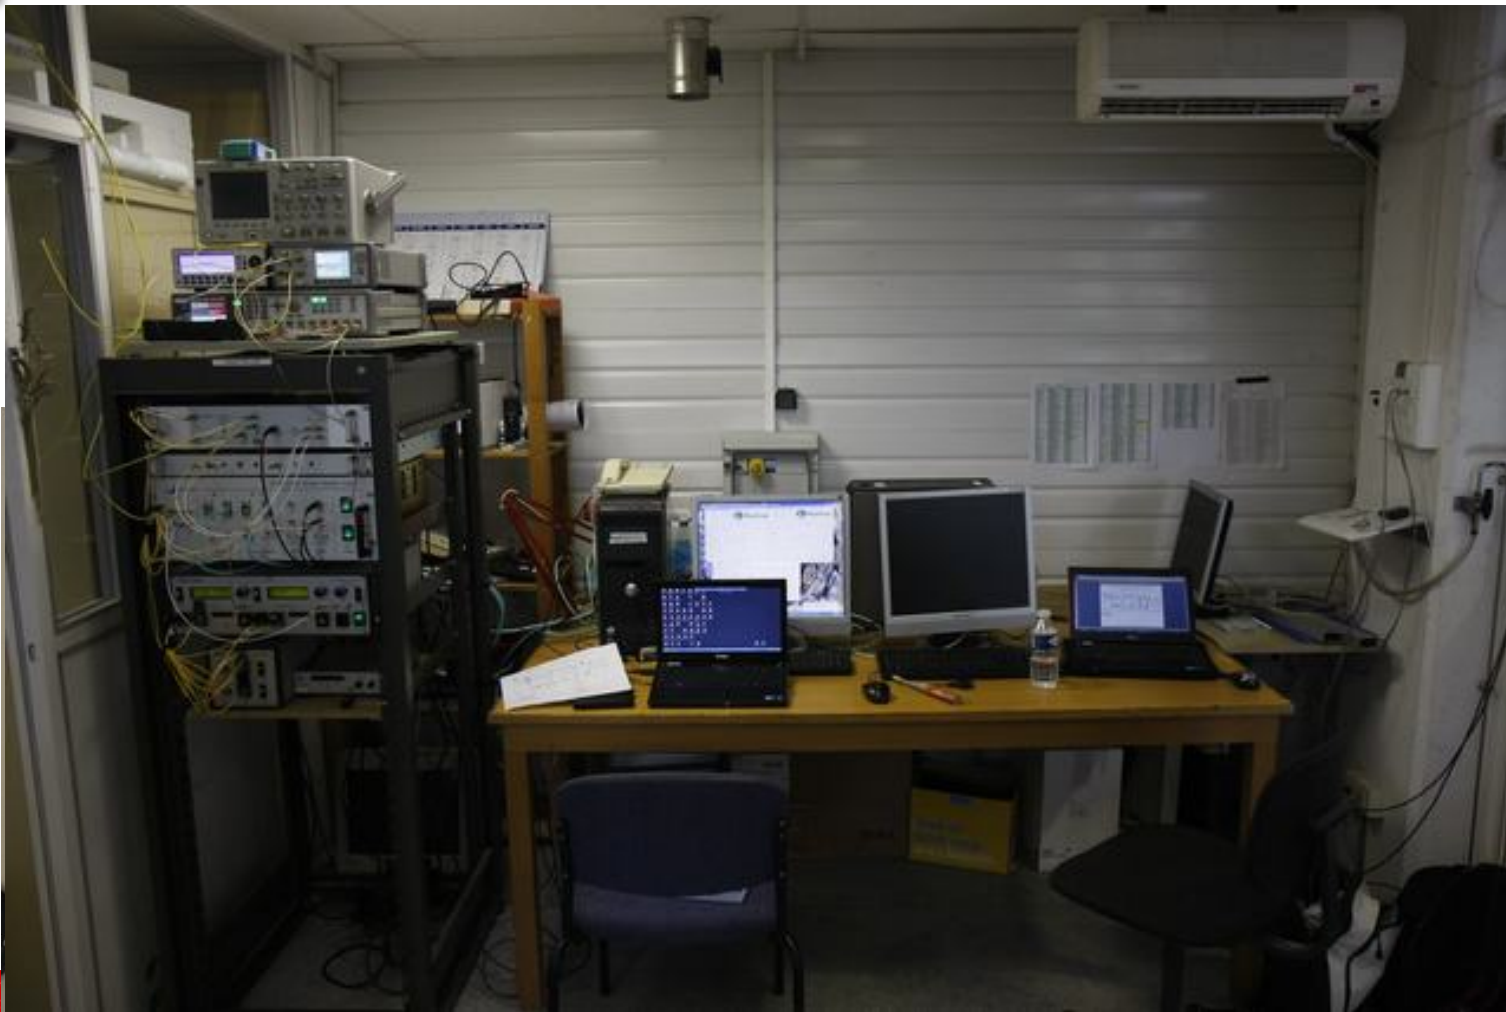
DOM integration @ CPPM.

Shore station equipment:

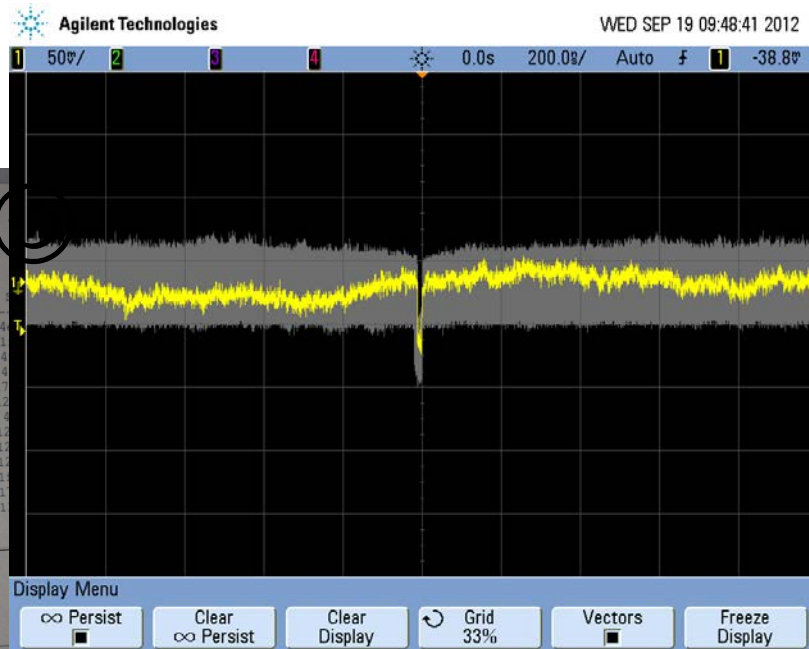
DOM integration @ CPPM, results.

- Normal communication no problem.
- Problems with optical timing calibration.
 - Optical margin NOT sufficient for time calibration, receiver sensitivity low.
- EDFA slow control not available (would provide more flexibility).
- Shore station receiver.
