D0 Calorimeter design, maintenance and long term operational experience

R. Dean Schamberger
Stony Brook University
for the D0 collaboration

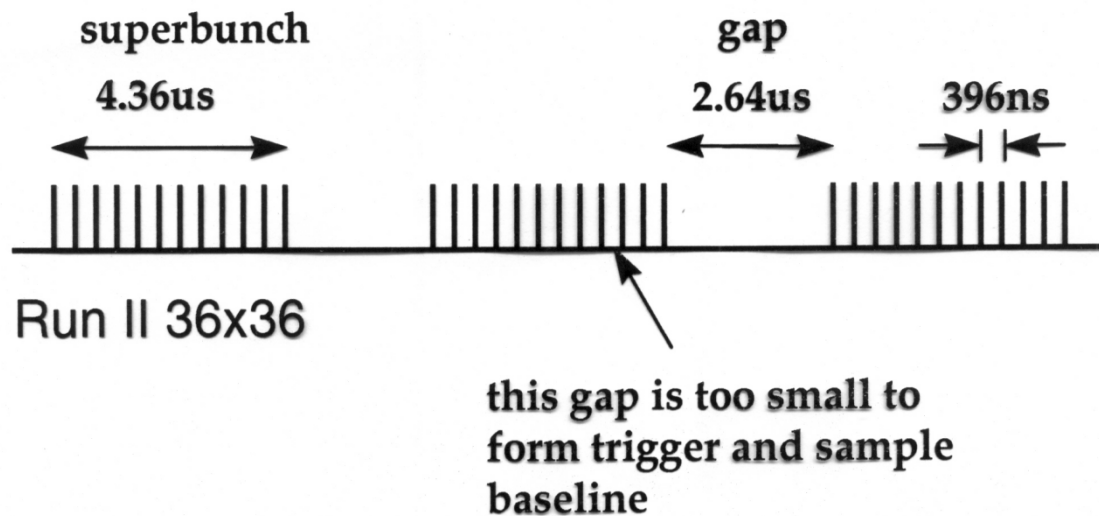
Run 2 2002-2011

Peak Luminosity $\sim 3 \times 10^{32}$

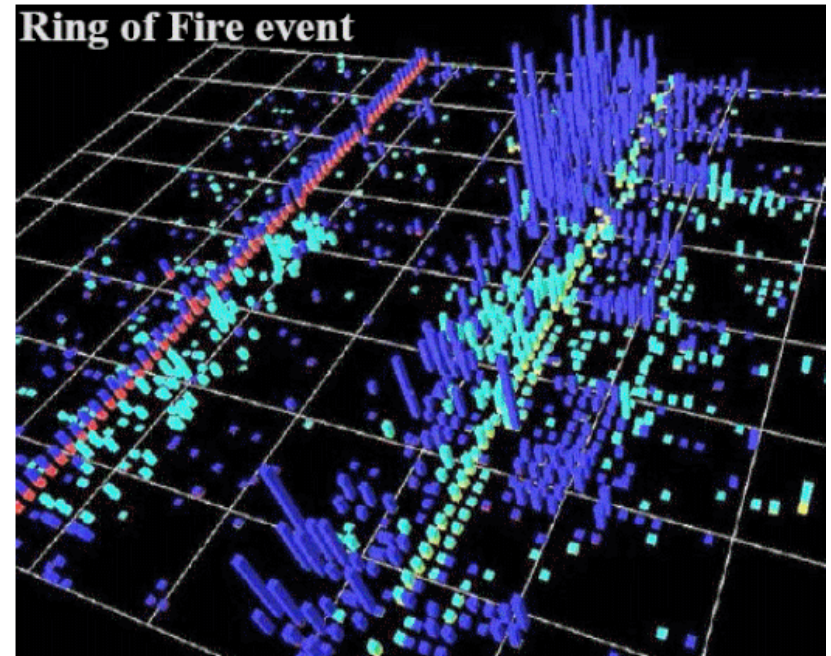
Ring of Fire

- Distinctive signature of external noise being injected into the end cryostats do to the assembly of the EC EM modules HV distribution.
- While not seen very often, the ring of fire flag is an efficient flag.
- Grounding issues were worked on during the first two major shutdowns in run 2. DC shorts have all been eliminated (as of November 2004). AC coupling has been reduced.
- Still see the flag being set about once every 1-2 hours of running until the extra 'safety' ground was found and eliminated.

Only noise source seen in Run 1

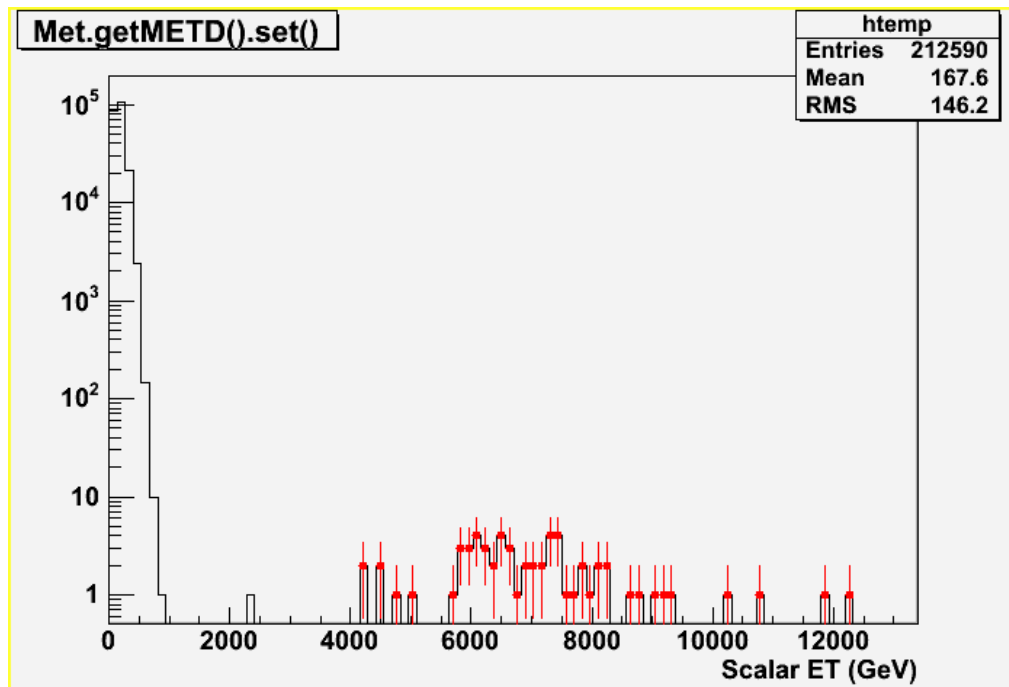
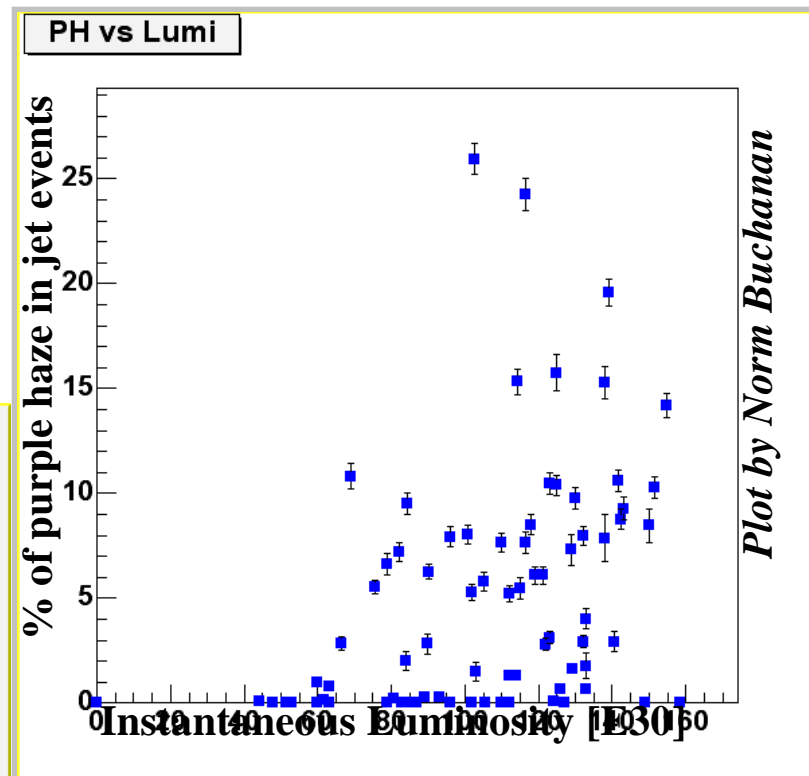
Purple Haze

appears when lumi. > 70E30

asymmetric in ϕ (no obvious boundaries)

also present in L1CAL Trigger

Only seen in CC channels

apparently worse for 1st bunch in superbunch
comes in bursts (maybe 50 events in an hour)

Disappeared over the spring
2006 shutdown for the Run IIb
Upgrade.

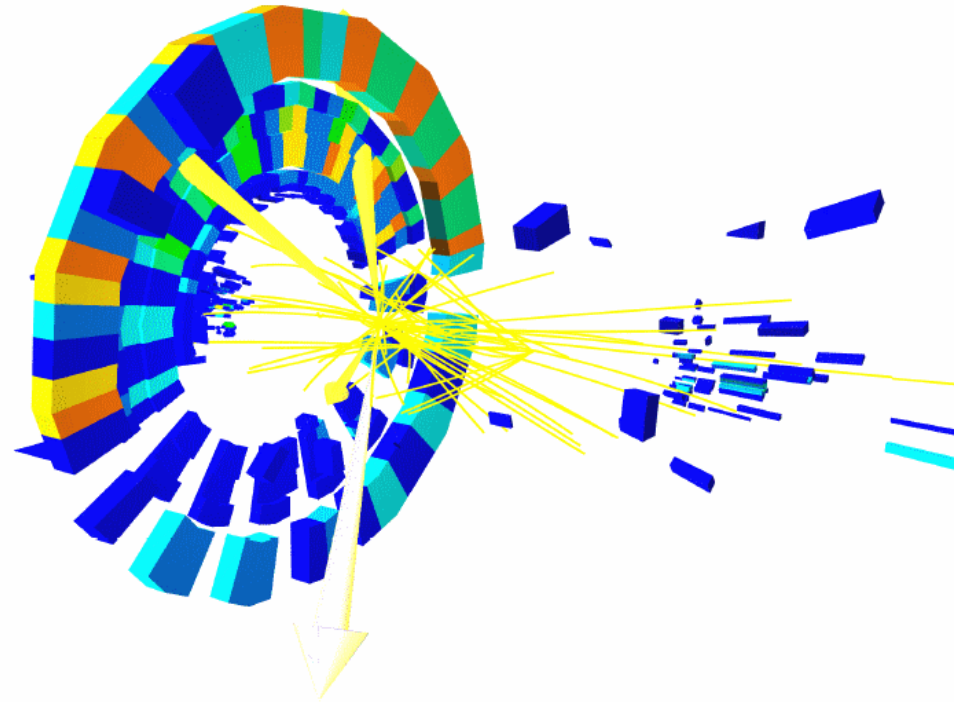
Spanish Fan noise

- Seen in CC channels closest to the ends of the cryostat (north or south), all layers.
- Disappeared when Purple haze noise fixed.
- Might be the very early stages of the Purple haze effect.

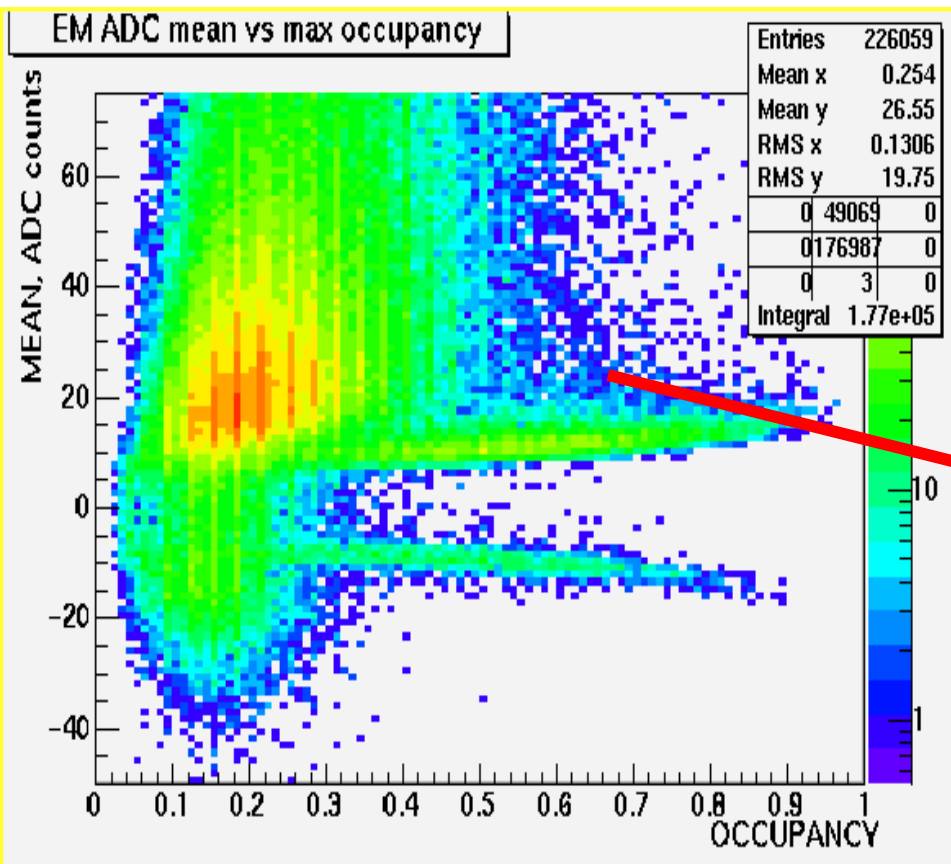
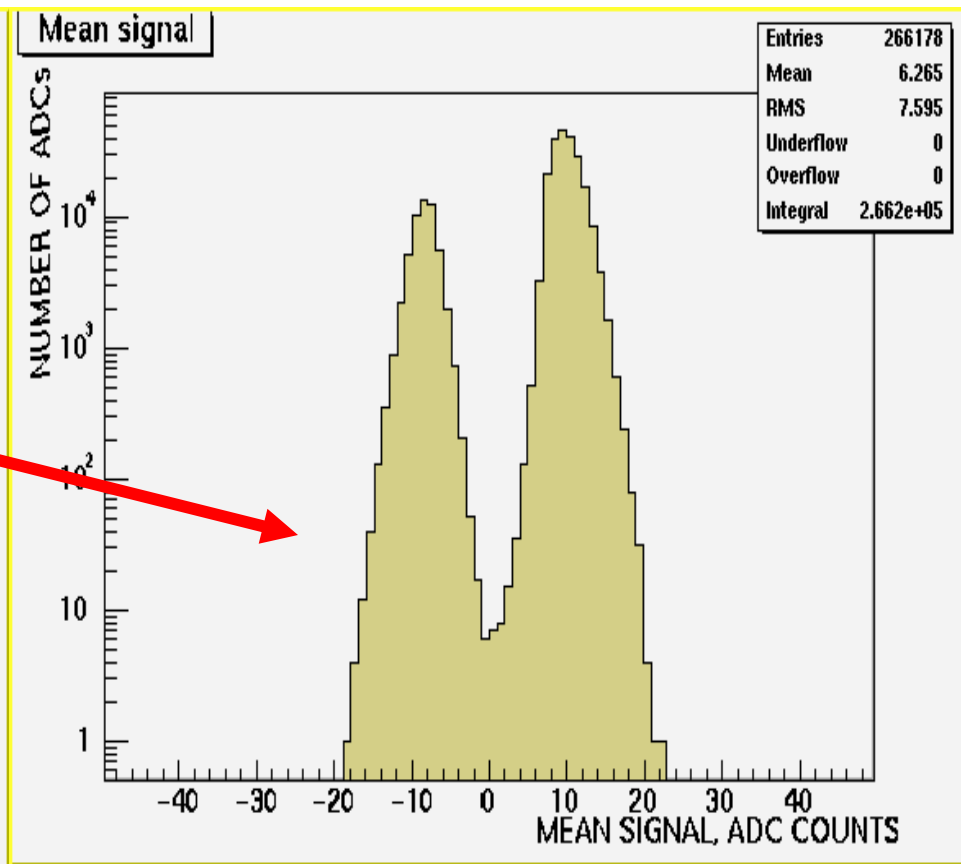
Run 2 Coherent Noise

- What we know
 - Generated internal to the Calorimeter readout system
 - Approximately +/- 0 to 1 millivolt offset added to all channels in a given BLS crate
 - Proportional to the L2 accept rate
 - Associated with triggers occurring while a previous trigger is being digitized
 - Effects (pairs) of ADC cards (usually more than one set)
 - On average (not including trigger bias) effects 5×10^{-5} times the L2 accept rate in Hertz (typically about 2.5% at 500 Hz)
 - Seen in the test stand but cause not identified

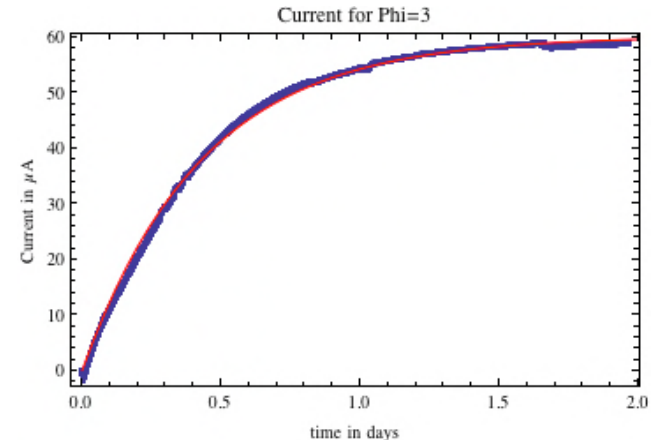
- The current draw in the CC is very different from the EC
- The CC (upper plot) takes ~2 days to reach equilibrium current while the EC (lower plot) is less than 5 minutes
- Note the very good exponential fit to the CC data

CC current draw. Red curve is fit $60.3(1 - e^{-2.32t})$

- Most likely difference between the EC and CC is in the Uranium plates
- The EC had the UO₂ removed with a high pressure water jet before assembly while nothing was done to the CC plates
- The readout plates were processed in the same manner for both detectors
 - Shape is different (long-thin in CC, more square in EC)
- The UO₂ coating can explain the unusual CC behavior

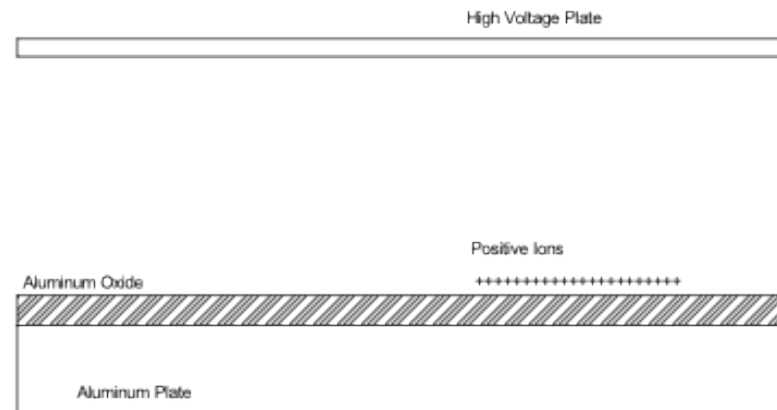
Malter Process

- ions accumulate on oxide layer
- field extracts electrons from base metal increasing current
- oxide eventually breaks down and discharges surface

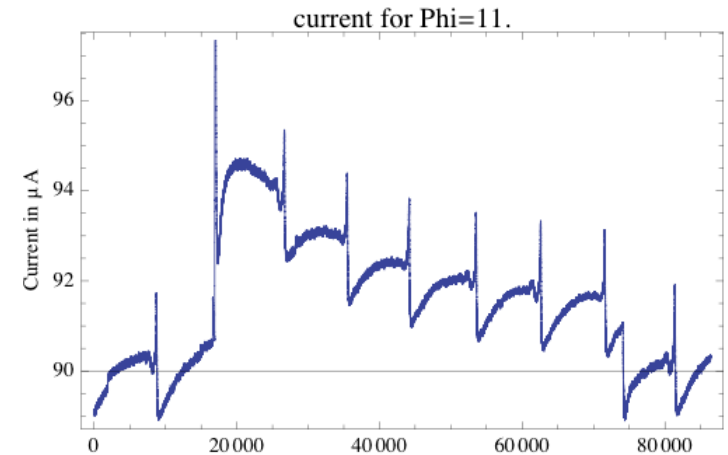
Malter Breakdown

- Lower fig. shows breakdown detail
- FWHM of peak is ~ 200 s
- Downward slope time is ~ 70 sec
- RC time constant of HV supply is < 10 sec
- Not a supply affect
- Neutralizing surface charge takes longer than bringing the charge through the oxide
- Small E field in transverse direction so charge movement is very slow

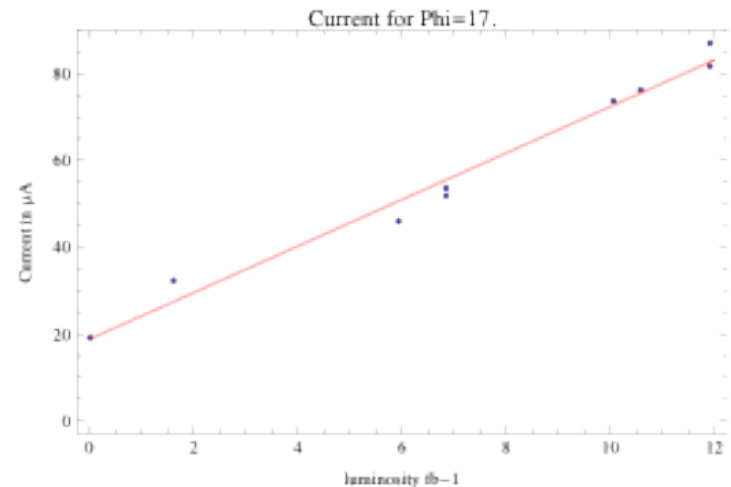
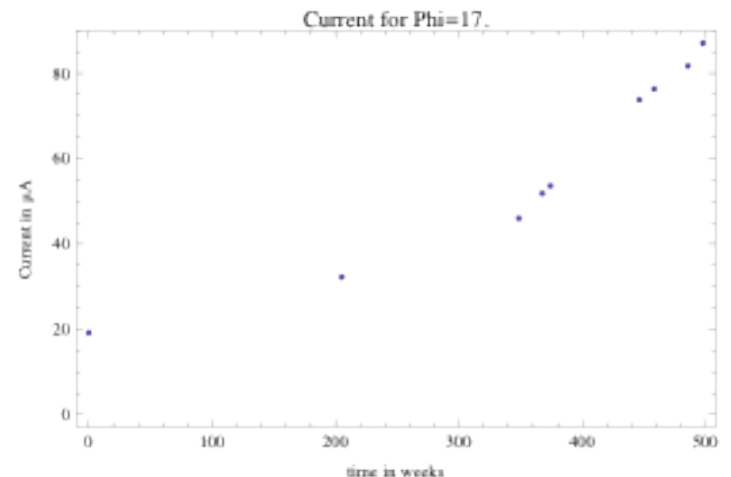
Current vs Luminosity

- Current increase is proportional to delivered luminosity (upper plot)
- All channels have a similar behavior
- Clearly not linear in time (lower plot)
