# CHALLENGES TO ASSEMBLE 100 CRYOMODULES FOR E-XFEL

SRF13 | Catherine MADEC

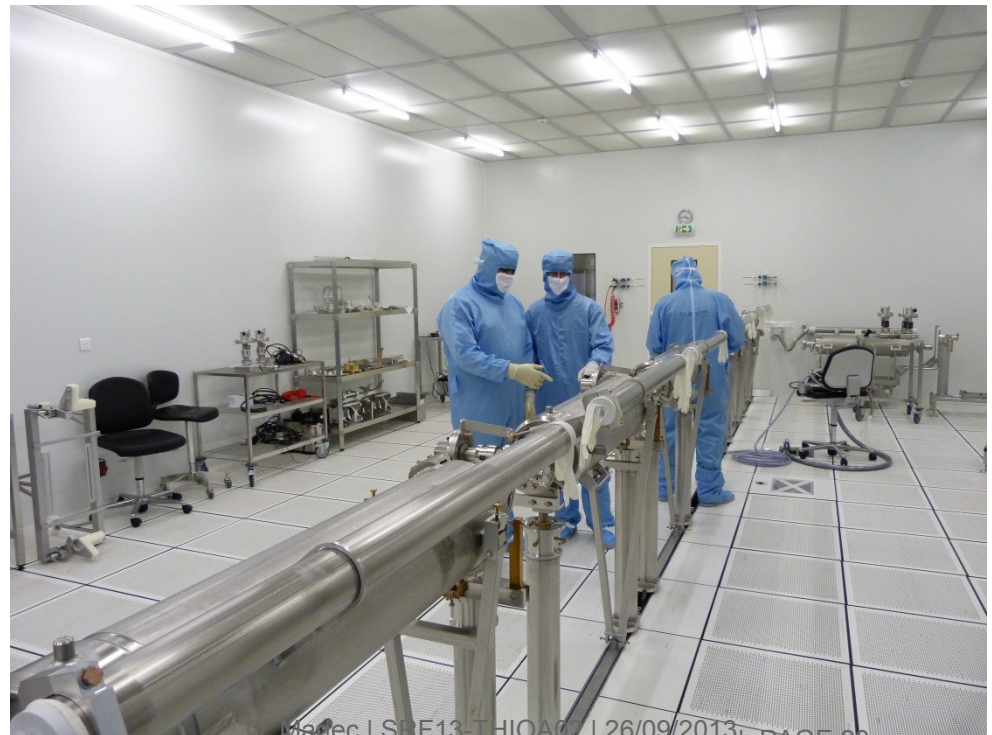
# INDUSTRIAL CONTRACT : XM-3 NCR

**XM-3** first pre-series module is made with parts from **XFEL production lines**, except for **cavities** (large-grain RI cavities) and **couplers** (TTF3 RI couplers).

- ✓ Average individual cavity gradients reaches 32 MV/m
- ✓ Gradient is 29 MV/m when cavities are powered by pairs
- ✓ Seven cavities are reproducing VT gradient
- ✓ cavity 1 is degraded from 31 MV/m down to 23 MV/m useable gradient
- ✓ Three cavities reached gradients above 38 MV/m.
- ✓ Cryogenics losses are lower than specified (MOP029)
- ✓ This successful test is qualifying CEA team and procedures and partially CEA infrastructure and industrial feasibility.
- ✓ The partial qualification lays in the fact that cavities and couplers are pre-industrial and the clean room vacuum system was not complete.
- ✓ Weldings certification would have to be reworked in order to install this module in the injector for 2014.

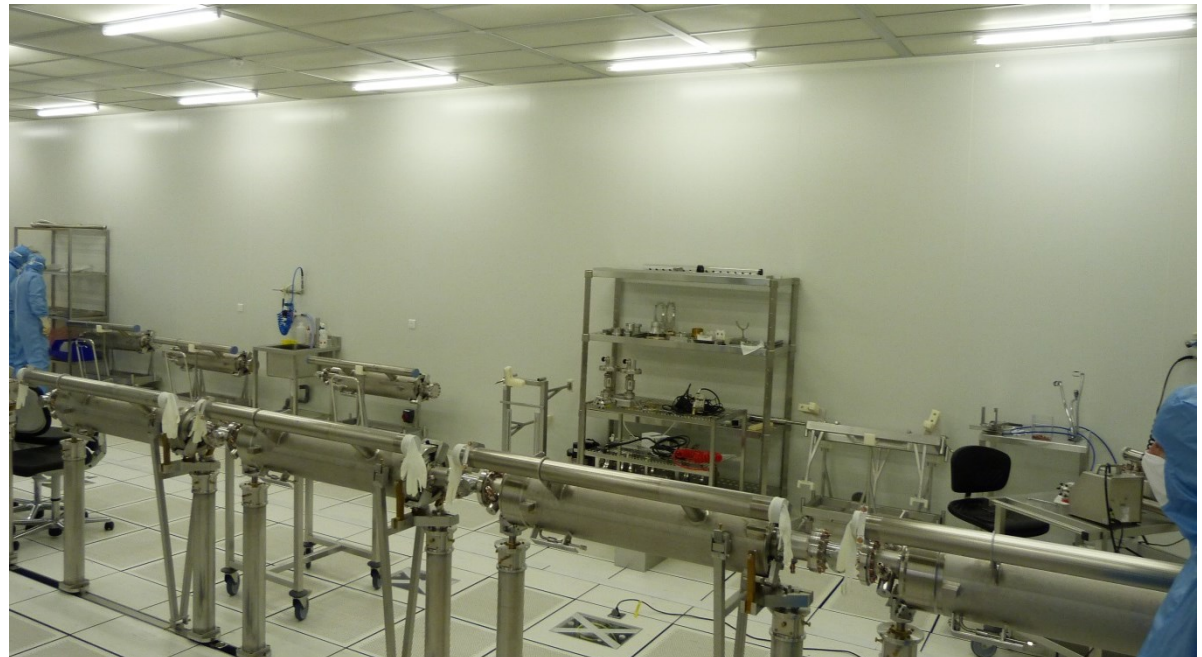
**Production phase** which covers the assembly of XM1 to XM80 by Alsyom from  $T2 = T0 + 9$  months (September 2<sup>nd</sup> 2013) till  $T2 + 24$  months (20 May 2015).

**Production phase (option)** which covers the assembly of XM81 and XM100 by Alsyom from  $T3$  (5 April 2015) till  $T3 + 6$  months (5 October 2015).

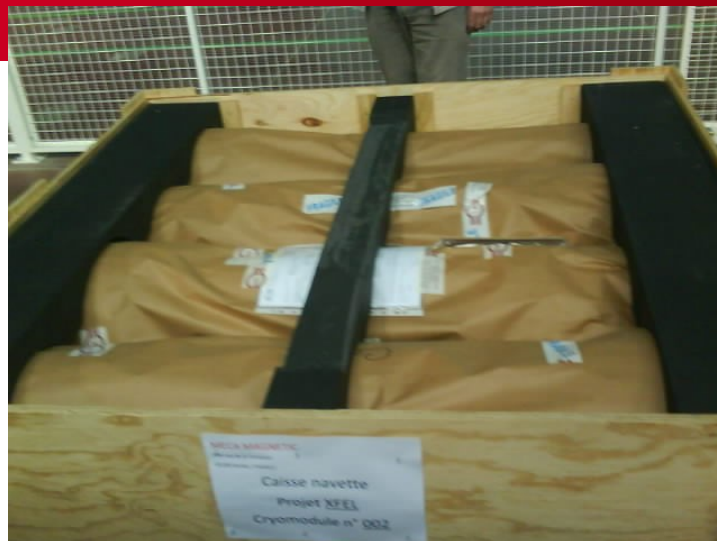
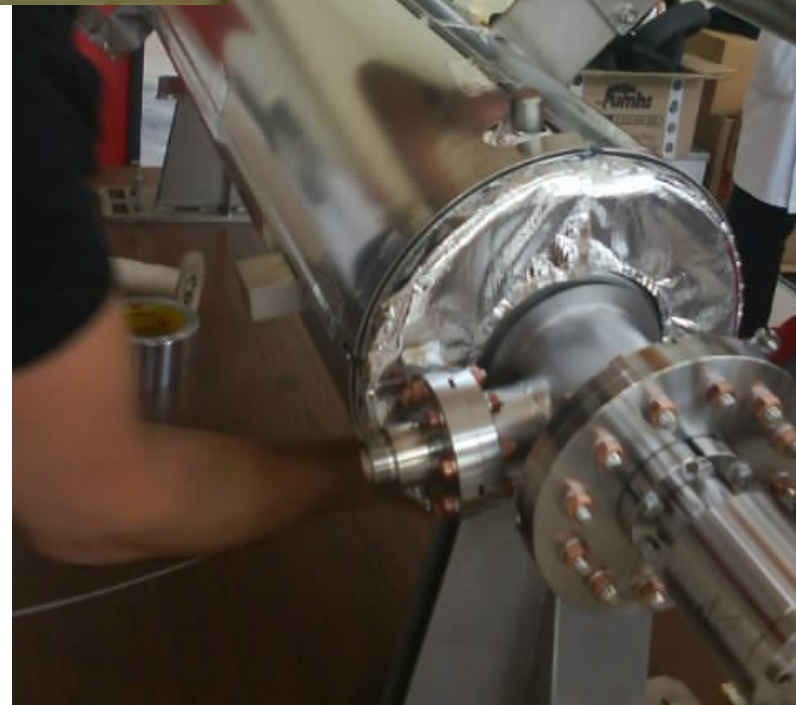
Pre-series by  
MecaMagnetic for  
XM-2 cryomodule

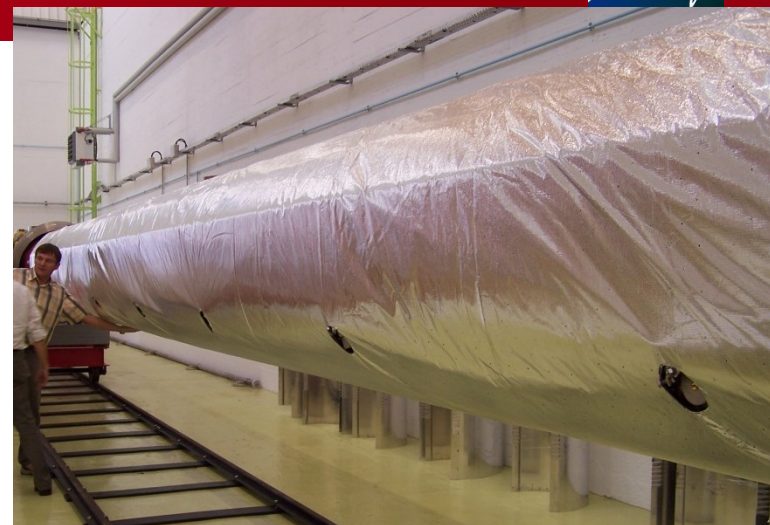
The 40/80 K super-insulation blanket (2x15 layers):

- costs about 4 k€
- saves 1 day on cantilever and about 7 p.day (balance at ~600 € / day)
- saves about 30 W @ 40 K with respect to multilayers (30 + 29 separators).

Cryo loss at	PXFEL 3	PXFEL 3_1 cooldown Dec 2011	PXFEL 3_1 cooldown Feb 2012	PXFEL 2_3 cooldown March 2013
40 / 80 K	134 W	96 W	97-102 W	95 W
