SiW ECAL **Technical report** from 2017 Beam Test

A. Irles

LLR, Palaiseau 11th July 2017

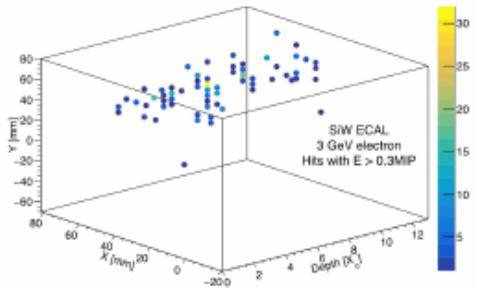
...but a lot of noise problems

- A lot of channels had to be masked
- Noise conduction problem
 - BCID 2500
 - All connection pieces had to be remade in plastic
 - The back plate had to be protected with kapton scotch
 - When the scotch had been scratched by W plates \rightarrow BCID 2500 appeared again

Layer 1, Slab 21 → 24% (one wafer)

Layer 2 – 6 , slabs 16,-21 ~6-7%

Layer 7, slab 22, ~ **8%**

3% are masked manually just before starting the commissioning (the adc=4 channels)

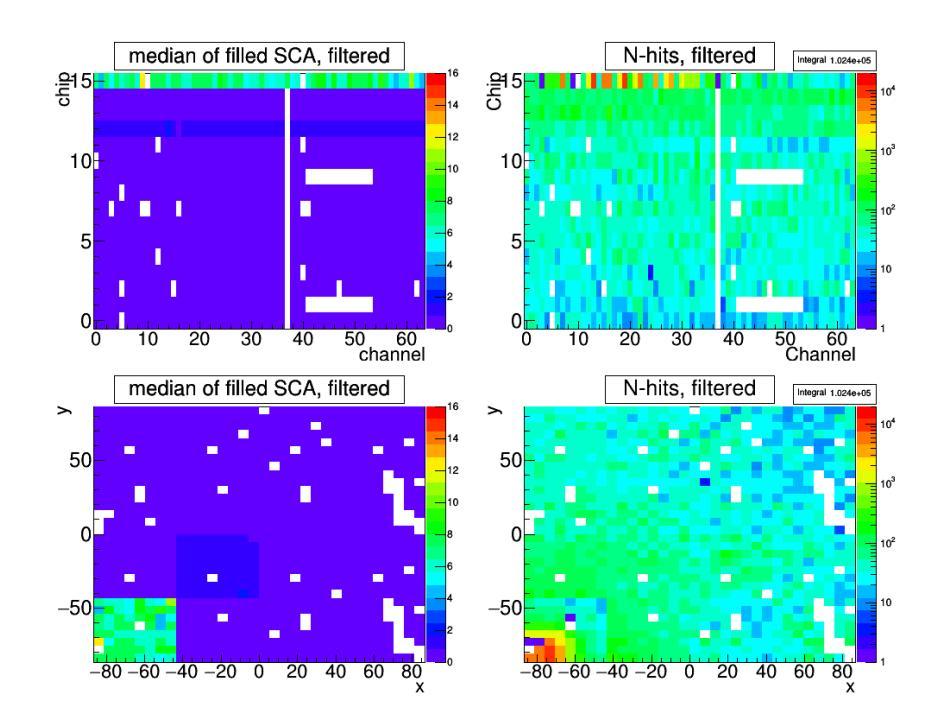
- Positrons of 3 GeV (~2 kHz rate, beam spot with slightly irregular shape and size <2cm diameter)
- Grid of 9x9 points separated by 2 cm → using the CALICE table and the scripts made by Frédéric !!
- Single acquisitions of 30 minutes
- Enough statistics (~1000 entries) in the corners f the beam spot (to be increased merging several grid points)

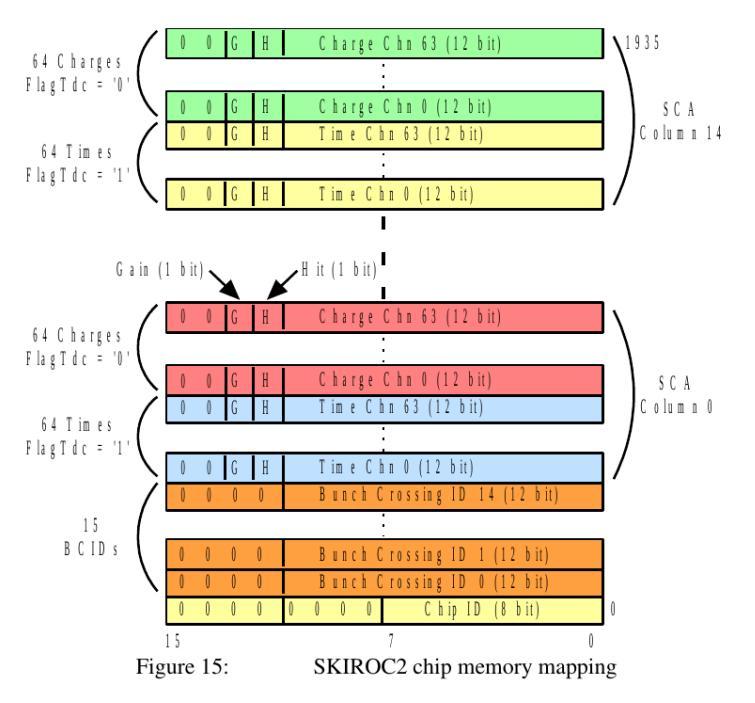
- If additional word is found: warning message and shift of the counter
- If no additional word is found but spill candidate packet has wrong length (in words) → error message and reject spill candidate (count)
- Else: if bad number of columns → error message and reject spill candidate (count)
- Else: if bad chip id → error message and reject spill candidate (count)
- Else: if error in bits → error message and reject spill candidate (count)

In this case, we also save (if possible) the bcid andsca were the error happened

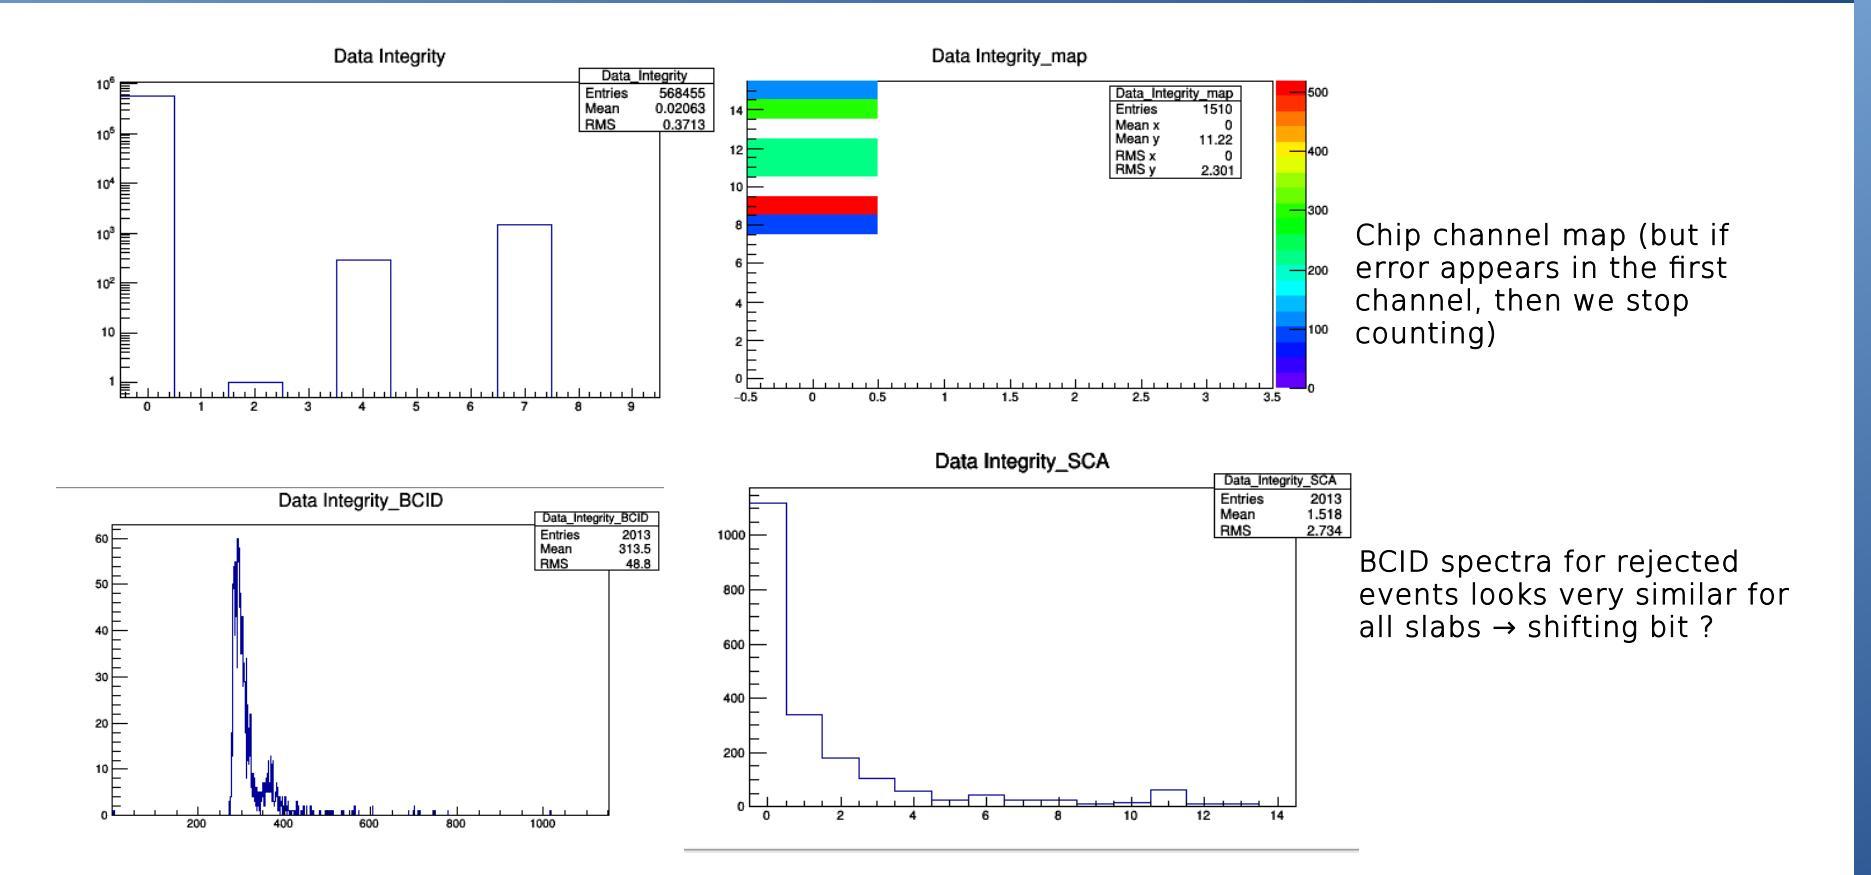
Example for layer 1 (slab 21): Full mip scan

Why there are no errors in chips 0,1,2?

Are these chips superseeded by other sources that are not chip-taggable (i.e. bad number of columns, bad chip id, bad number of words)
