SDE Upgrade

WP5 ECRs

ECRs (Dec 2018) for the next UUB version 3

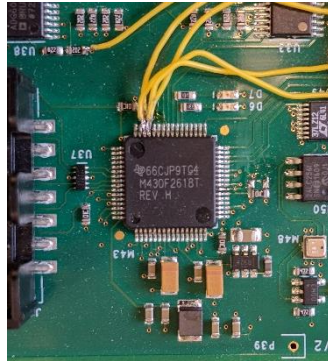
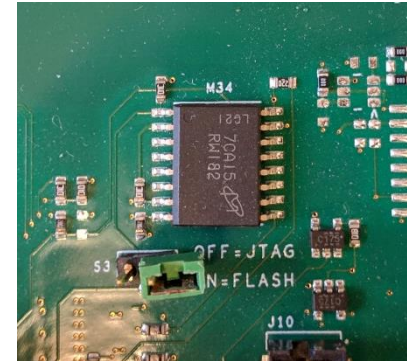
Slow-control μ C & Flash Memory:

Slow-control μ C:

- Programmed by manufacturer
- Optional package reference

Flash Memory:

- Programmed and repackaged by a subcontractor

Min 21 weeks lead time

Final software for Slow-control must be provide early

NO SOFTWARE UPDATE DURING MASS PRODUCTION AT SUBCONTRACTOR
