Le(s) Tracker(s) de l'expérience CMS

Gaëlle Boudoul (IP2I Lyon/ AICP)

20 Septembre 2023

The CMS pixel detector in a nutshell

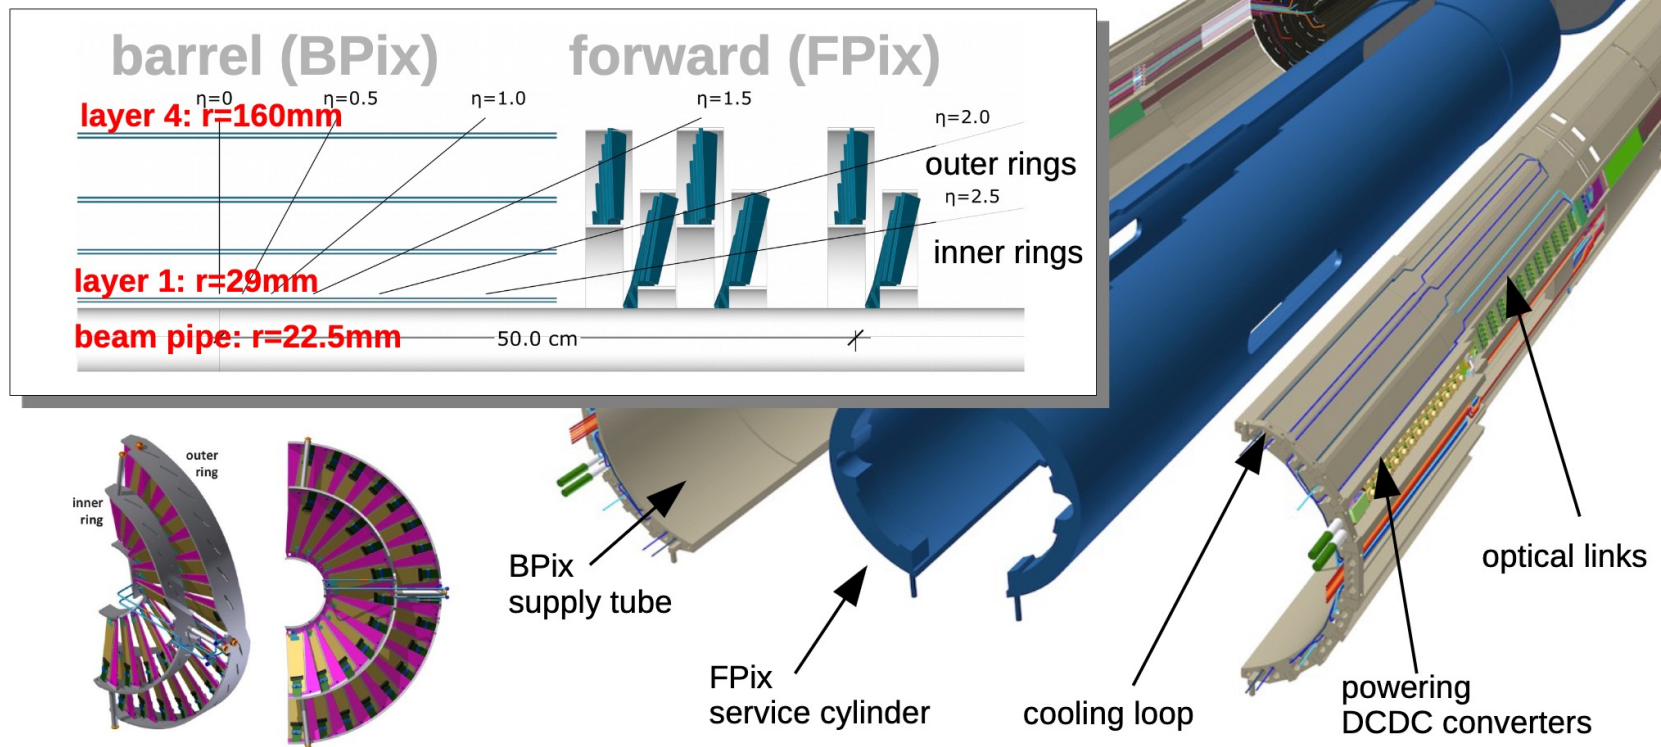
CMS Phase-1 Pixel Detector

- **4-hit coverage** up to $|\eta| < 2.5$
- first pixel layer **very close to IP**
- fourth pixel layer connecting better to strip detector
- **turbine-like module arrangement** in forward disks (inner rings tilted for optimal radial and azimuthal resolution)

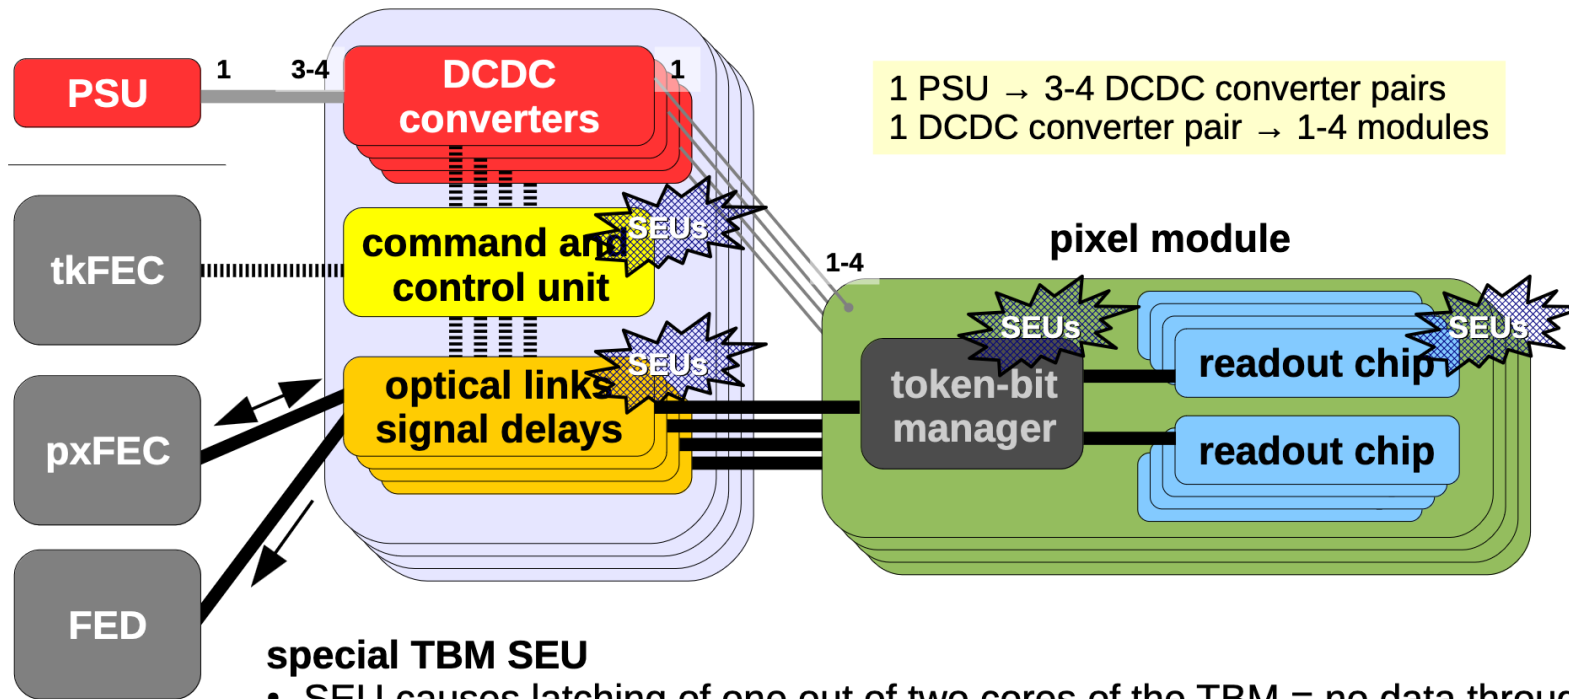
Single Event Upsets

- single event upset expected in high radiation environment
- SEUs observed in many components in 2017/2018
- normal procedure: download configuration parameters to the front-end regularly

- SEU causes latching of one out of two cores of the TBM = no data throughput
- reprogramming the TBM does **not** resolve the problem
- only powercycle recovers the TBM core and thus the ROCs behind
- in 2017: [command and control unit used to disable/enable DCDC converter](#)

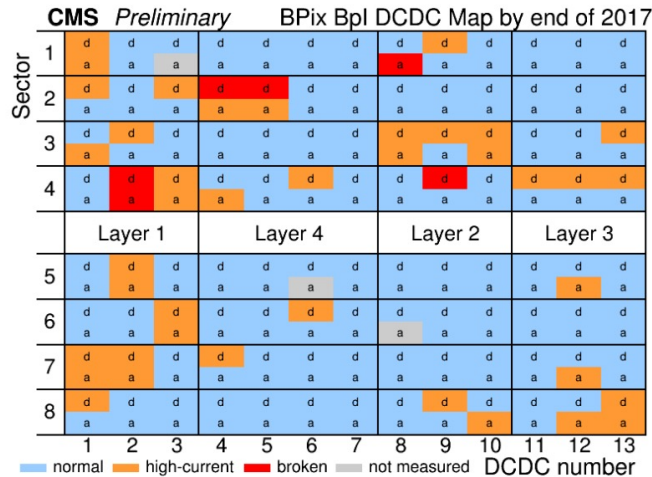
characterization of extracted converters

→ I-V characterization of all extracted converters:

- 65 not switching anymore
- 333 higher currents in disabled state
- rest (~1800) behaves normally

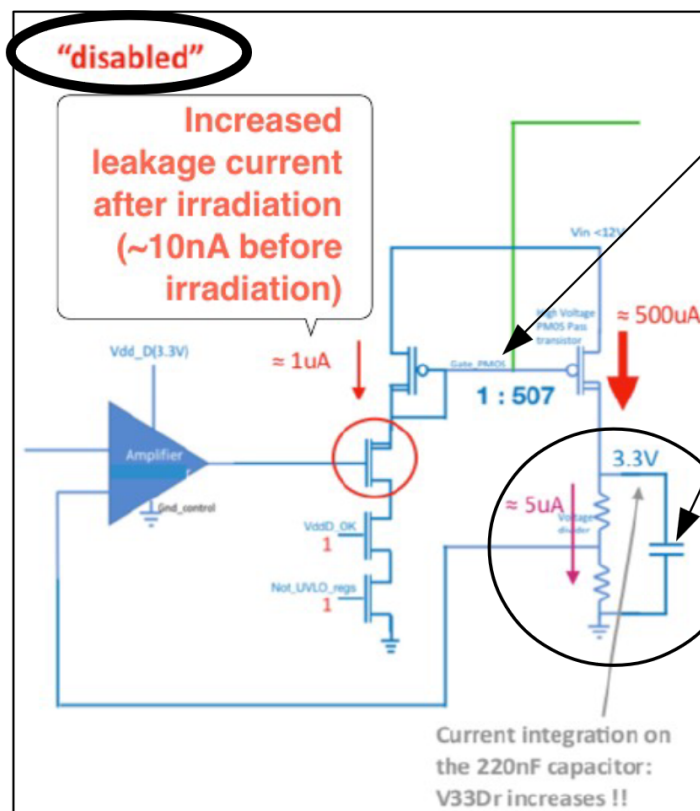
figure by Federico Faccio

amplifying
current mirror

capacitor
charging up in
the disabled
state causing
voltage spikes
well beyond
3.3V

part providing
current to the
drivers of the
power
transistors

two possible results

- high leakage current forms new ohmic path to ground (→ high current)
- converter breaks irreversibly (→ broken)

- chip designers of the FEAST chip found a way to reproduce the breaking symptoms
- once a feedback loop was established, breaking mechanism could be identified quickly

- A [detailed report](#) of the two irradiation tests performed at the CERN IRRAD facility, where it was eventually possible to reproduce the same damage mechanism observed in the CMS pixel system

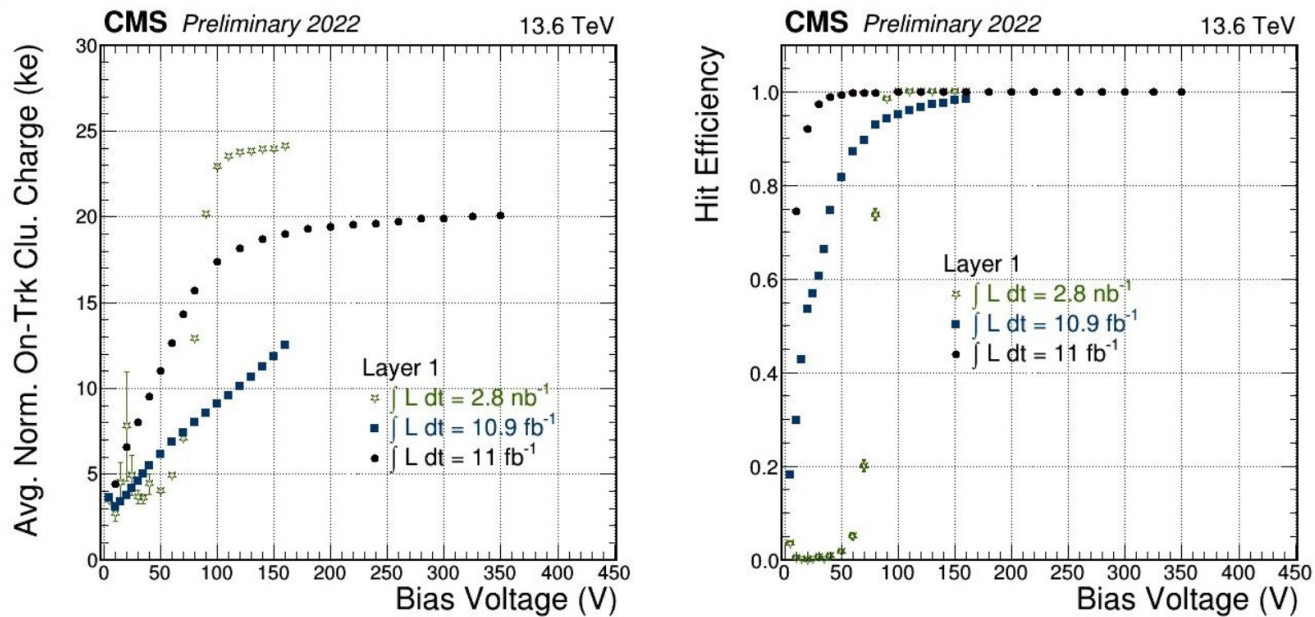
HV Bias scan Layer 1

Three mini bias voltage scans performed in 2022 are shown at the integrated luminosity of 2.8 nb^{-1} , 10.9 fb^{-1} and 11 fb^{-1}

- The effect of radiation damage is visible in the shift of the plateau in different scans.
- The complex evolution of the hit efficiencies with irradiation is understood to come from multiple effects some of which are the inversion of the charge carrier type in the silicon sensor and the annealing during the periods with no data-taking.
- Between the last two scans there was a ~ 4 week period without data-taking; detector was annealed which had a beneficial effect for charge collection efficiency visible in the last scan.
- Operation voltage in Layer 1 at the startup was 150 V. After the second scan, it was increased to 300 V.
