Short slabs production

Frédéric Magniette

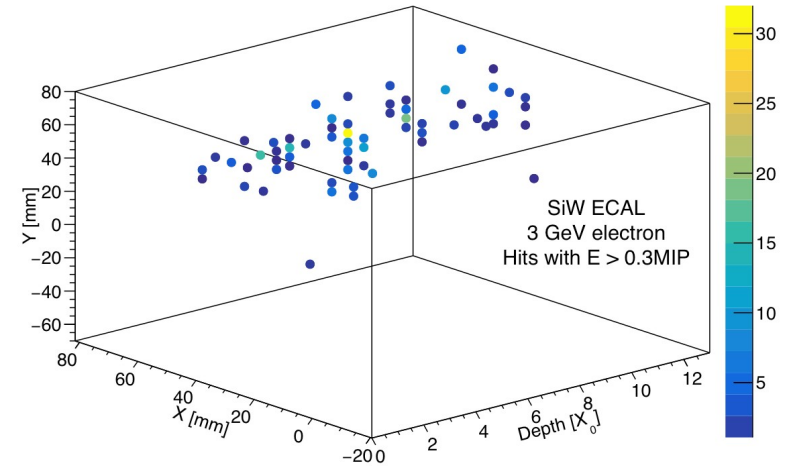
- Very good results...
- Perfect calibration pre-test
- Full position scan → good pedestal and MIP uniformity
- Shower tests with different W configurations
- A lot of coherent events
- Real-time monitoring
- 1T magnet experiment with remote hardware
